STRUCTURAL CONDITION ASSESSMENT

**SUDBURY COMMUNITY ARENA
240 ELGIN ST
SUDBURY, ONTARIO**

Our Project No.: 23131A

October 16, 2023

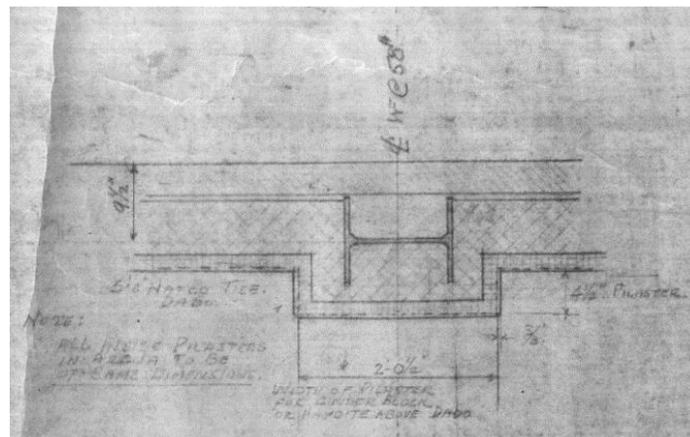
Figure 1: Anticipated masonry pilaster detail at perimeter steel columns (c.1951).

The lack of insulation in the walls and around the columns will allow the steel to cool as temperatures drop during the winter. Water vapour from the building interior that comes into contact with the steel will condense on the cold surface, creating an environment that could potentially promote accelerated deterioration of the steel and surrounding masonry.

Steel beams around the perimeter are similarly at risk. Where reviewed on the interior, we did not identify any obvious signs of deterioration or excessive condensation.

It would be prudent to expose several of these columns and beams by removing masonry on the interior (where applicable) and exterior of the building to determine the general condition of these members.

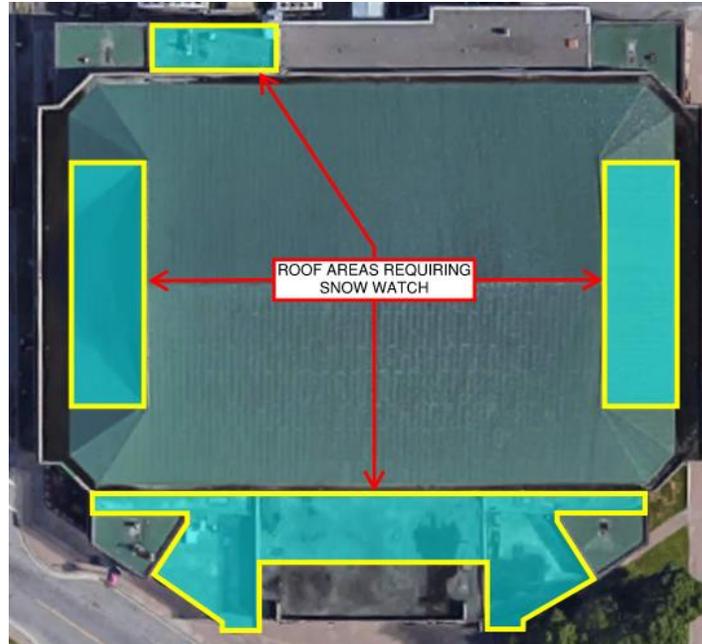
In addition to the low roofs that are currently under snow watch (refer our reports of November 2018 and March 2019 in Appendix C), the gable ends of the High Roof should be similarly monitored during the winter and snow removed once it reaches a depth of **575 mm**. Refer to Figure 3 below for roof areas requiring snow watch policies and procedures.

Figure 3: Sudbury Community Arena roof areas requiring snow watch.

Recommendations included in our previous reports included removing snow once it reached a depth of 400 mm, which included an allowance for the weight of workers on the roof during snow clearing operations. The current, revised, recommendation does not include such an allowance but is within safe limits and will result in fewer snow removal events and can be used at all roofs where snow watch has been recommended.

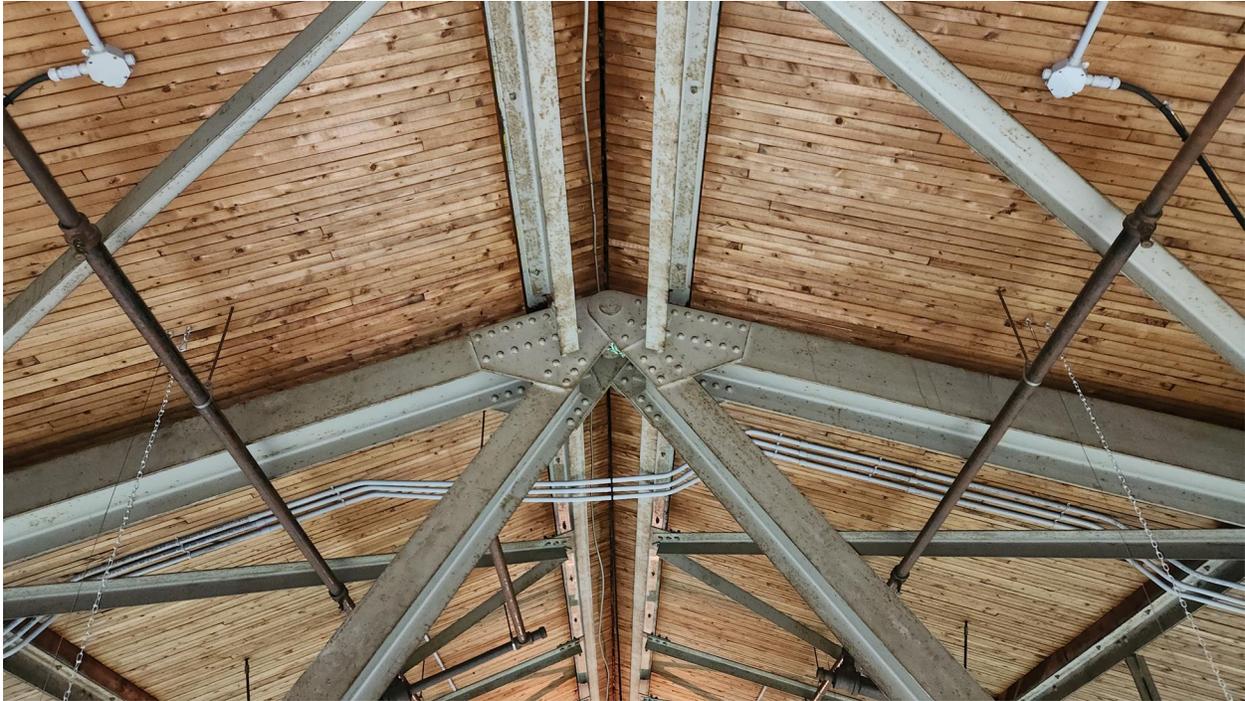
Light corrosion was observed on most structural steel members in the High Roof. None of the corrosion observed is indicative of an appreciable reduction in the performance level of the structure, in our opinion. Cleaning and repainting the steel structure, while not immediately or urgently required at this time, would improve the long-term durability of the members, and is recommended.

Photo 3: Typical High Roof structure exhibiting light surface corrosion (c.1951).

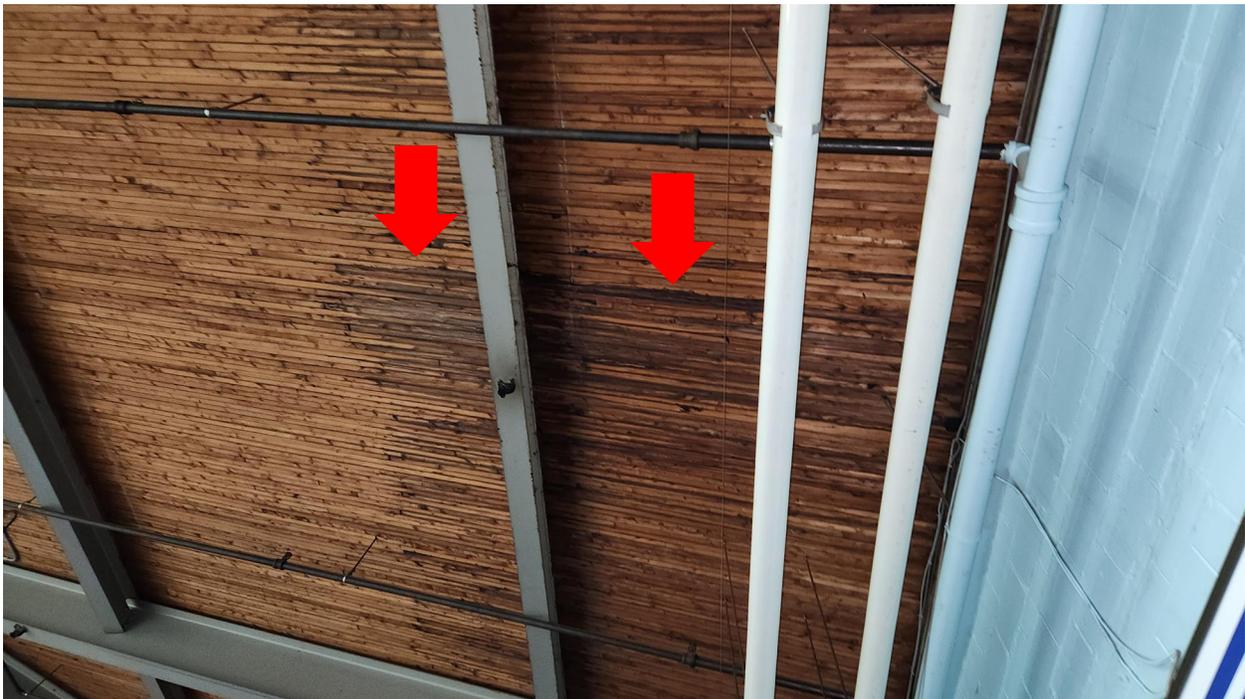
We noted several areas of apparent staining at the underside of the NLT deck on all sides of the building, closer to the low side of the roof, suggesting excessive exposure to water from above. Continued and prolonged exposure to moisture will lead to rot in the wood, reducing the performance level of the structure. Further investigation is recommended to identify if exposure has damaged the wood members, which could warrant localized replacement.

Photo 4: Water stains at underside of NLT deck (High Roof c.1951).

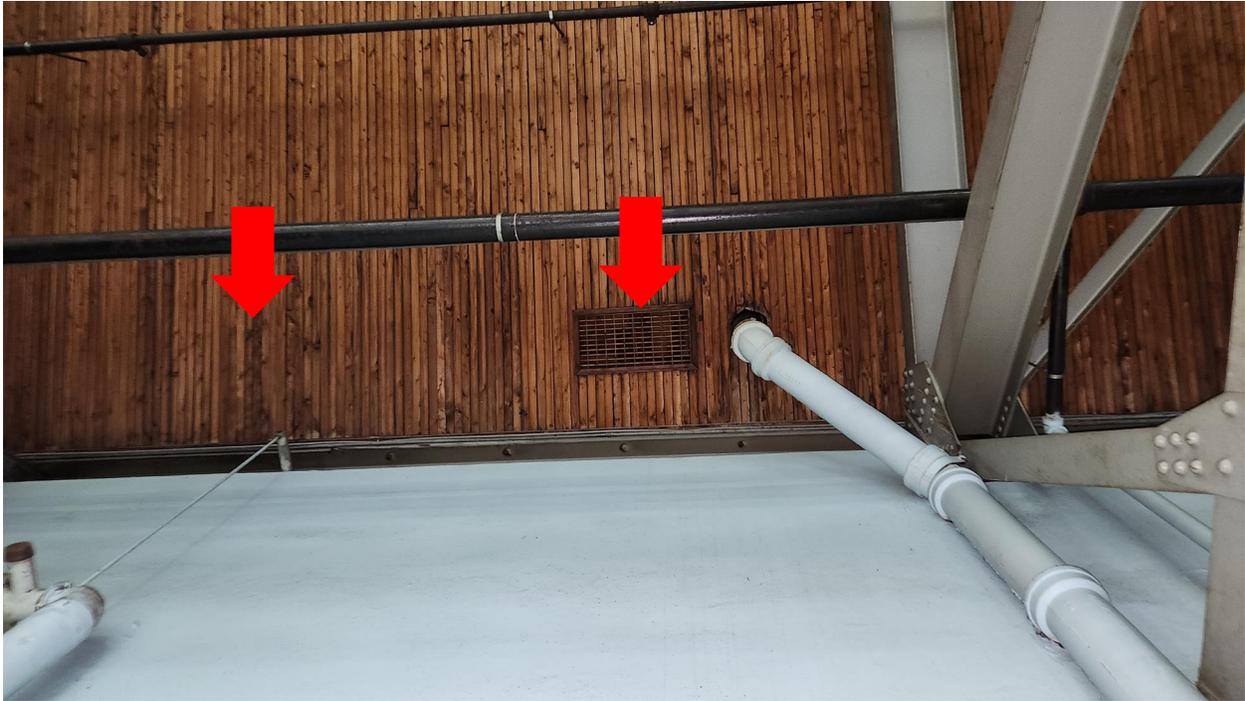
Photo 5: Water stains and typical opening through NLT deck (High Roof c.1951).

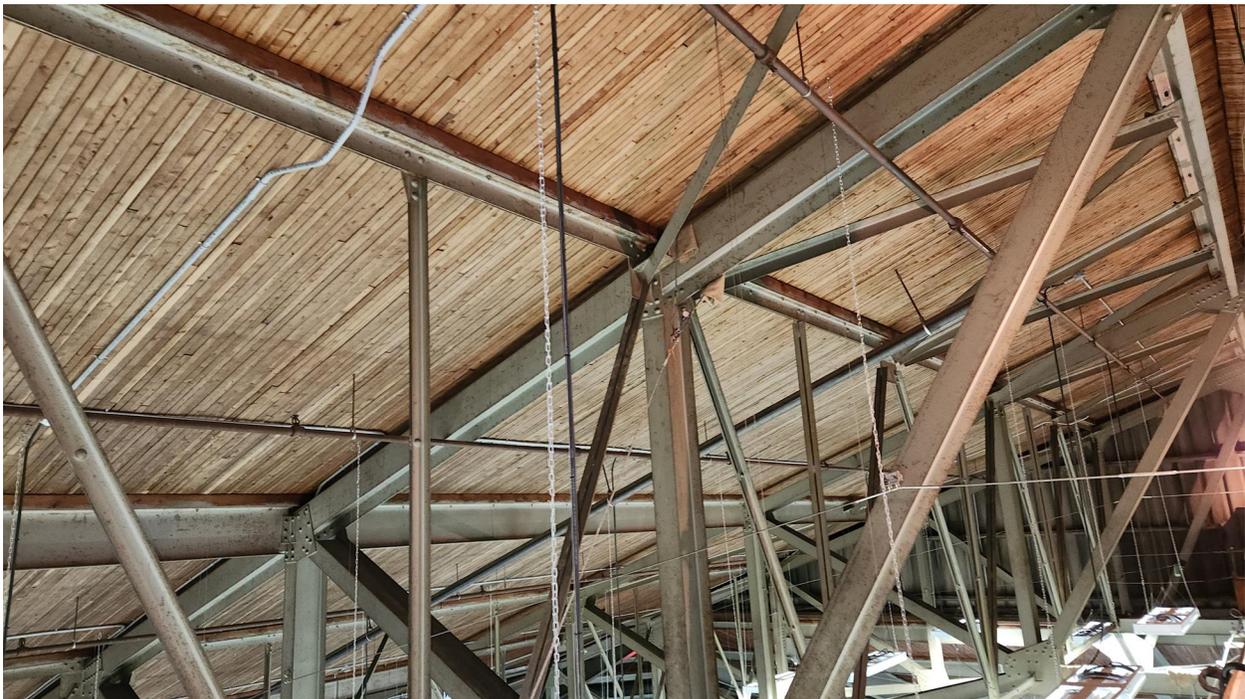
Photo 6: Typical High Roof structure exhibiting light surface corrosion (c.1951).

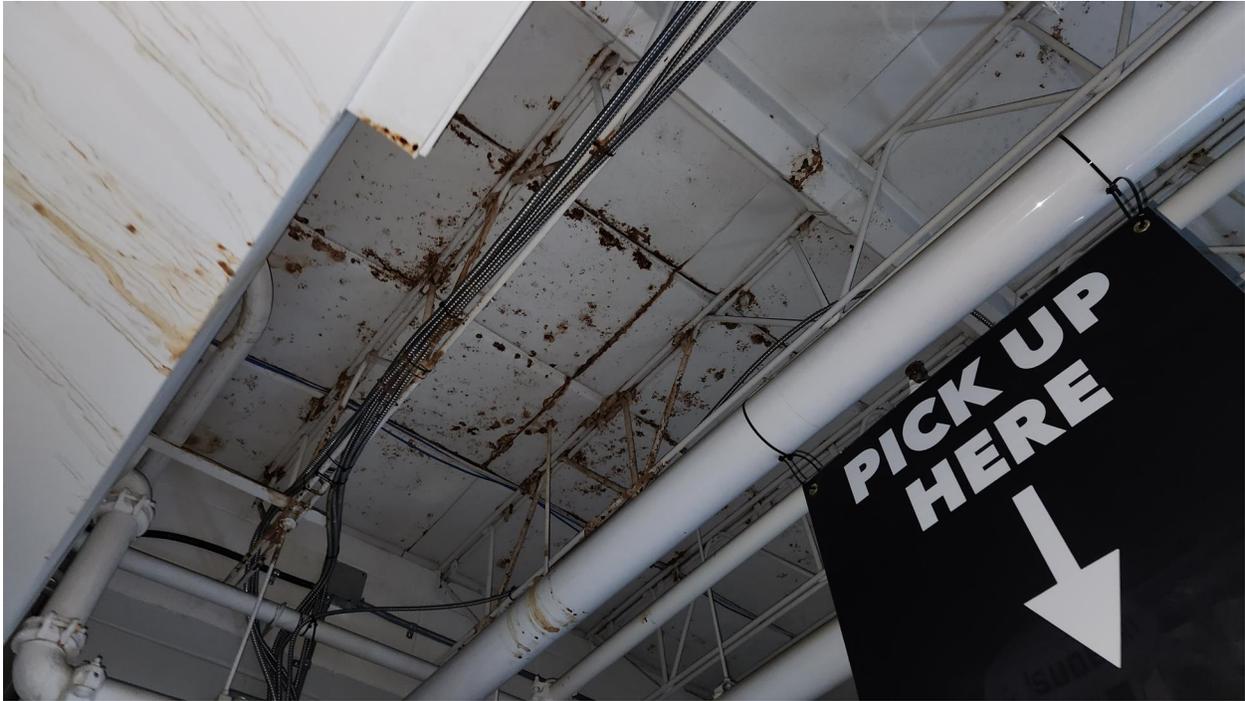
Building Staff have previously identified concerns regarding ongoing leakage in part of the 1951 Low Roof at the northwest corner of the arena, which does not yet appear to have been addressed. We noted evidence of excessive water infiltration and corrosion at the open-web steel joists and underside of the steel pan that appears to have worsened since our review in 2018 (refer to Appendix C). The continued and progressive deterioration of the structure is concerning but appears to be limited to a relatively small area nearest the northwest stair. Further review is recommended to confirm if the extent of deterioration observed is structurally significant and if it affects previously proposed reinforcing schemes to address snow loads as described in 4.2.3 below.

Photo 7: Deterioration of Low Roof structure at northwest corner (c.1951).

It is imperative that roof leaks be addressed in a timely manner to mitigate progressive deterioration of the structure. If left unaddressed, corrosion of the structural members could accelerate over time, eventually resulting in a reduction in the performance level requiring extensive compensating construction.

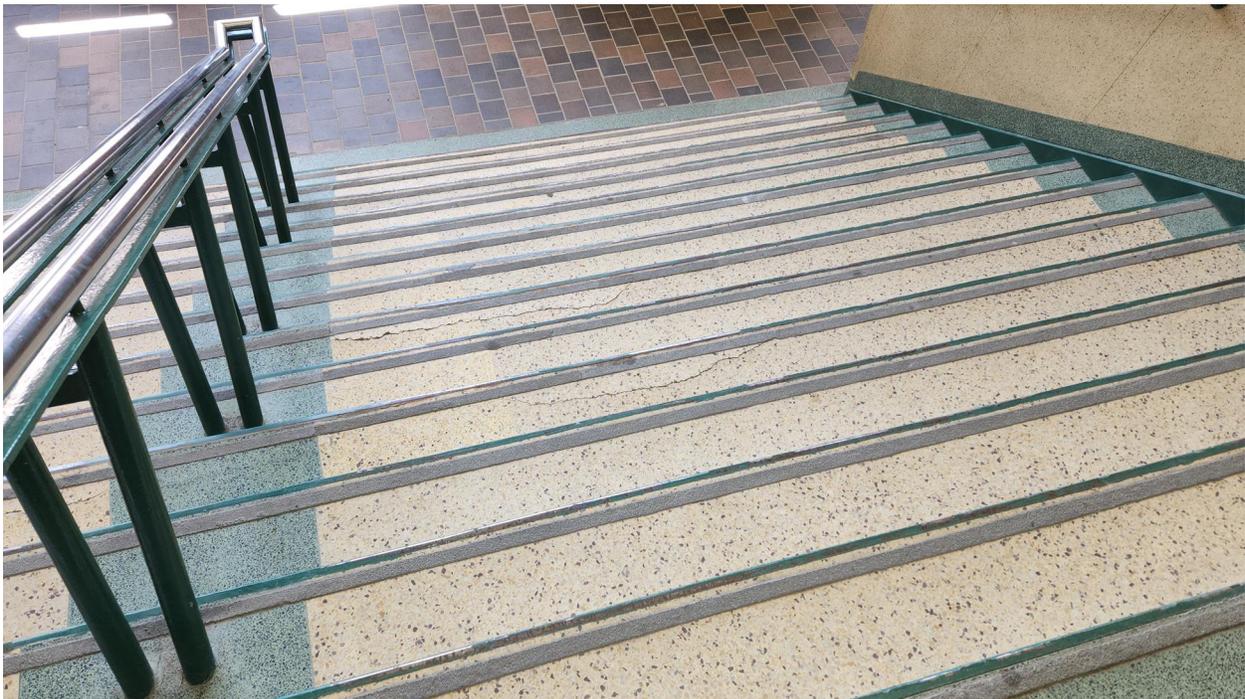
Building Staff noted that the stairs require regular maintenance to address concerns associated with tripping due to the stair tread nosing plates separating from the terrazzo infill. We did not identify any locations where the nosing plate was not reasonably tight to the terrazzo during our walkthrough but did note some cracking in the terrazzo at several treads.

It is reasonable to expect that the stair structure is similarly exposed to elevated levels of moisture and chlorides, like the Main Entrance slab. Corrosion of steel elements in the stair treads could manifest in the deformation of the nosing plate and/or cause cracking in the terrazzo finish. Review of the stair structure from below is highly recommended. Openings in the ceilings below will be required to sufficiently expose the structure to facilitate further review.

Photo 10: Main Entrance stairs (c.1951).

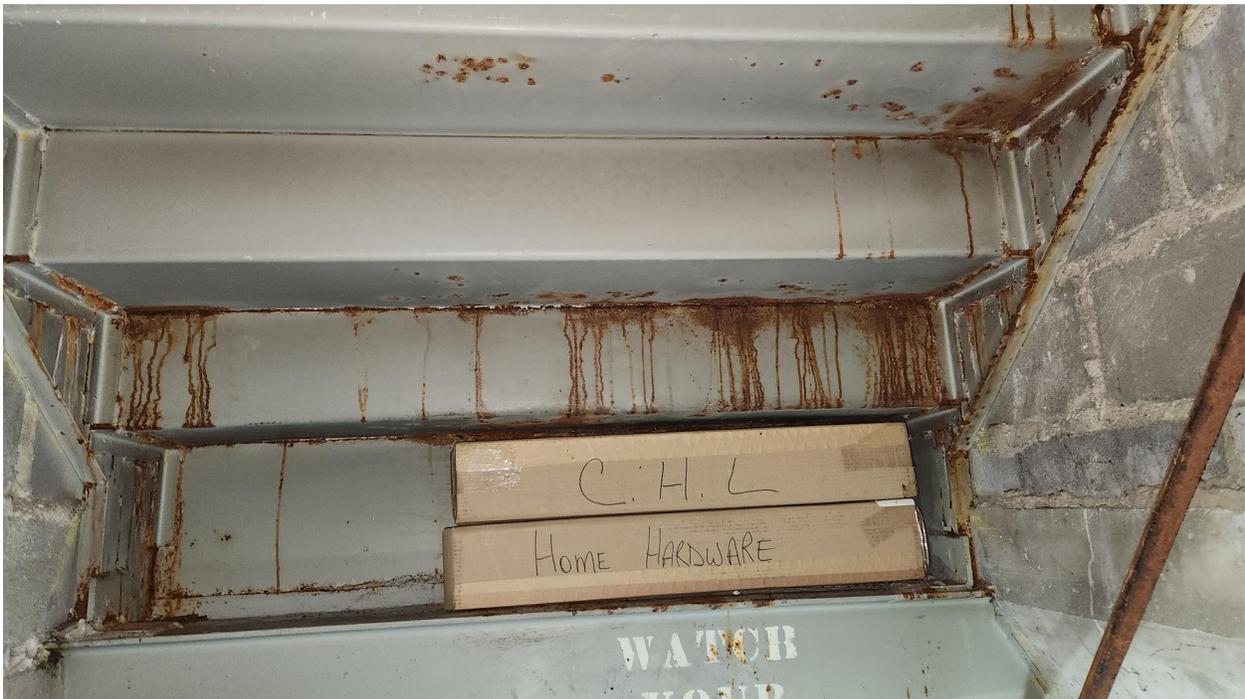
We noted evidence of excessive exposure to moisture and corrosion of the steel-framed stair members from below at this location. Exposed flanges of steel beams at the stair landing were showing signs of localized corrosion but we did not identify any obvious section loss that would constitute a reduction in the performance level of the structure.

The underside of the concrete landing slab showed signs of relatively minor water infiltration through small cracks but was not extensively cracked nor displaying surface delaminations that are often associated with accelerated deterioration of the reinforcing steel. Similar to the Main Entrance slab discussed above, we recommend a minimum of two (2) concrete samples for chloride ion testing at this location.

Photo 12: East Entrance (Minto Street) stairs from below (c.1951).

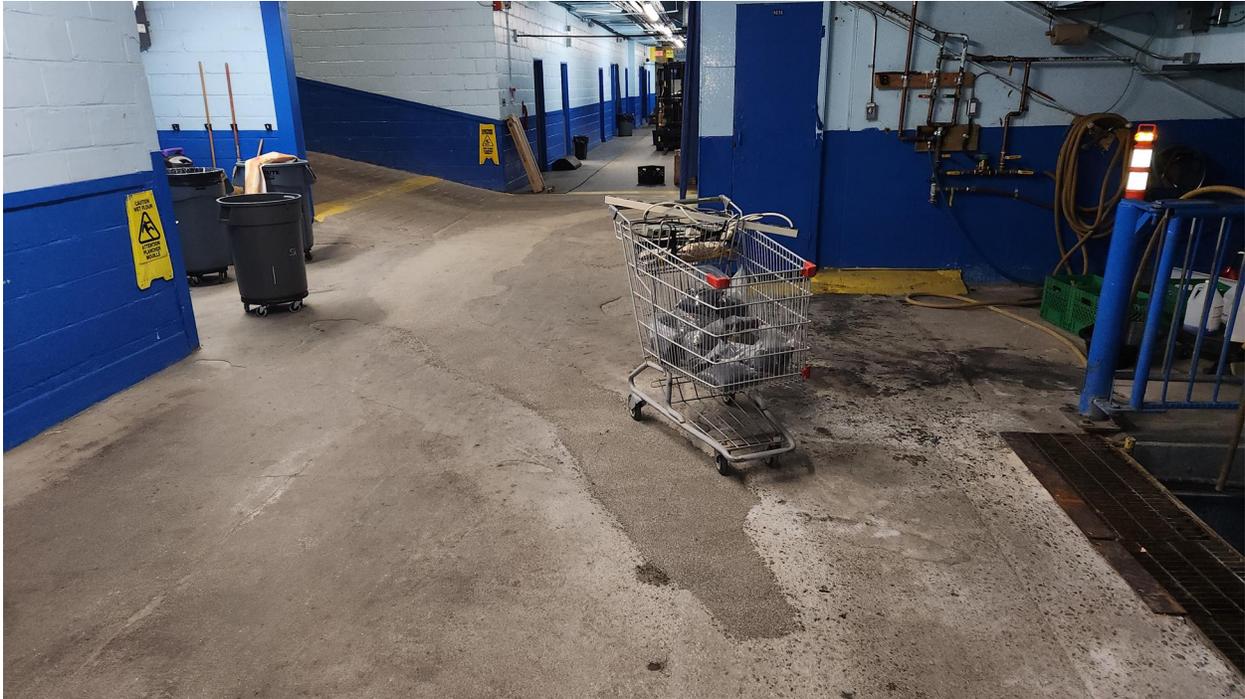
Deterioration of the slab-on-grade in the area adjacent to the snow melt pit and tunnel access to the ice surface (due to abrasion from the Zamboni tires) has been an issue since at least 2013 (refer also to our report of March 2016, attached in Appendix C). Building Staff confirmed that ongoing maintenance currently includes levelling the slab depressions with a pavement repair product (FastPatch DPR by WVCO), which is not an appropriate concrete repair material. Concrete deterioration will continue, and the base slab will progressively wear down, likely resulting in increased areas needing repair. Partial replacement is anticipated in this area to reinstate the concrete slab over the long term.

Photo 13: Area of ongoing slab-on-grade repairs (c.1951).

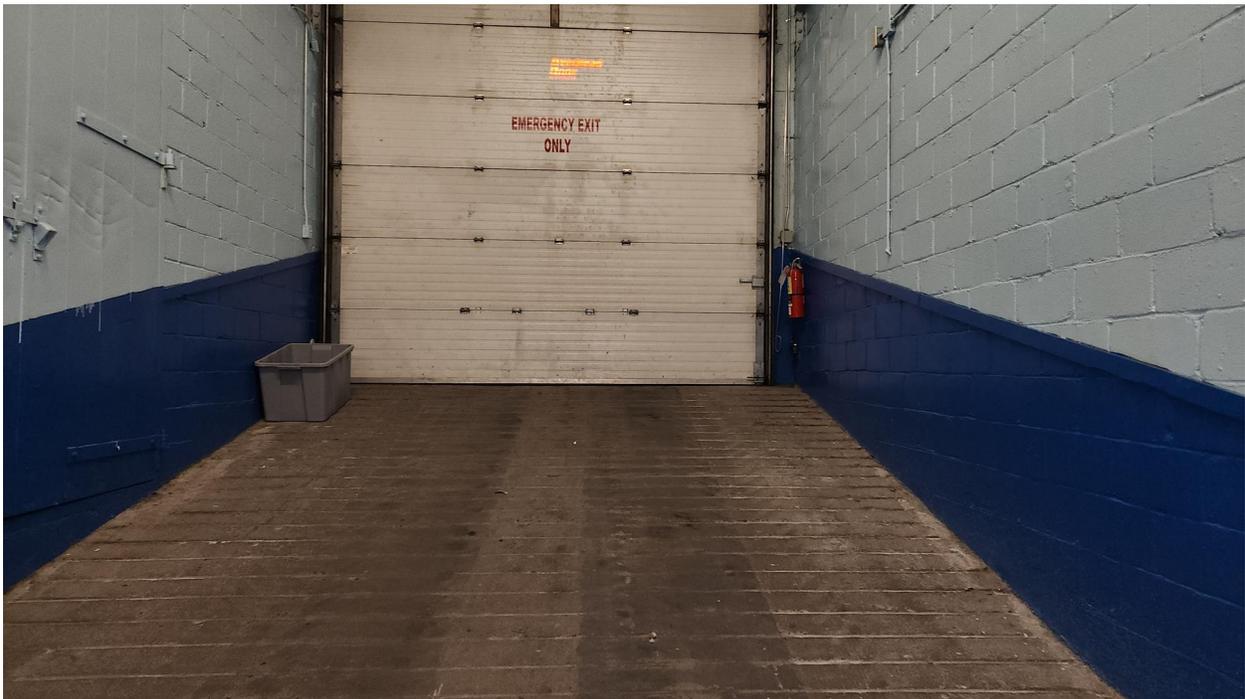
The slab that slopes from the Zamboni area up to the exterior of the building is not a slab-on-grade, but rather a reinforced concrete slab that spans over the Mechanical Room below. Topside deterioration of this slab is relatively minor in comparison to that observed at the adjacent floor at this time, but it is critical to note that all repairs to this slab must be completed under the supervision of a Professional Engineer. Inappropriate repair methods and/or materials may exacerbate damage to the slab, resulting in a reduction in the performance level of the structure and more invasive repairs or complete replacement.

Photo 14: Suspended concrete slab over mechanical room (c.1951).

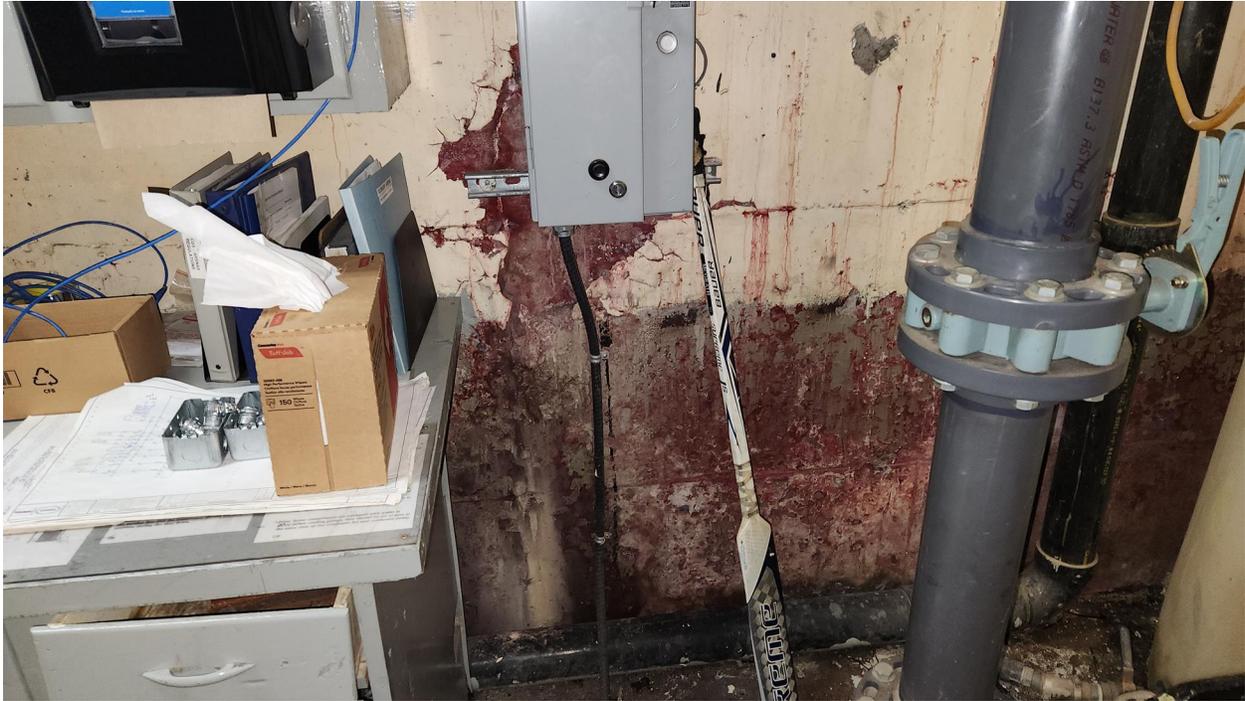
Photo 15: Evidence of leakage through concrete foundation wall in the Mechanical Room (c.1951).

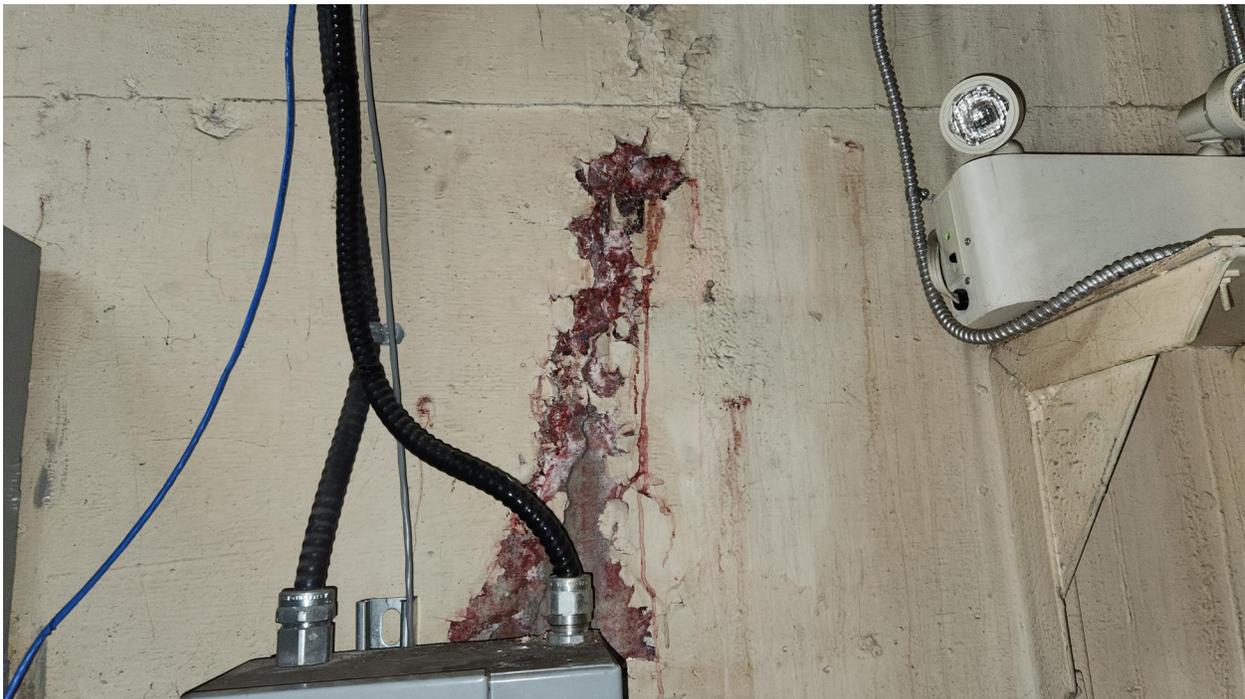
Photo 16: Evidence of leakage through concrete foundation wall in the Mechanical Room (c.1951).

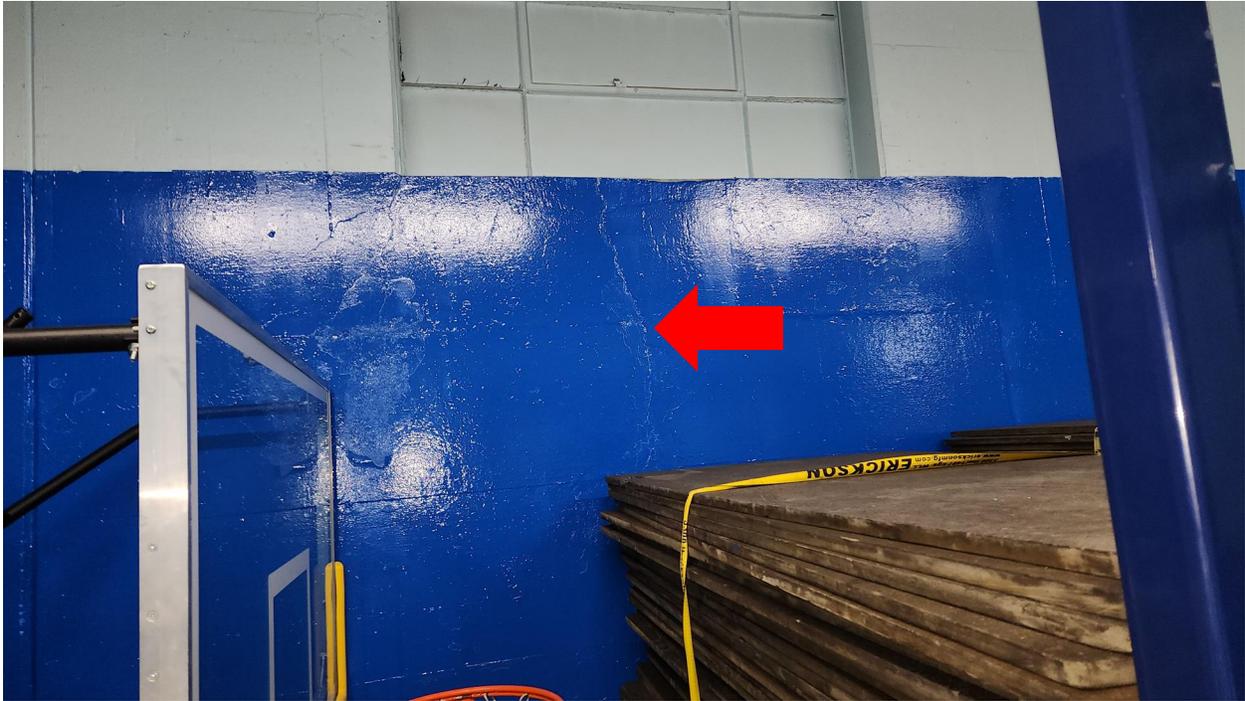
Photo 17: Typical crack in concrete foundation wall (c.1951).

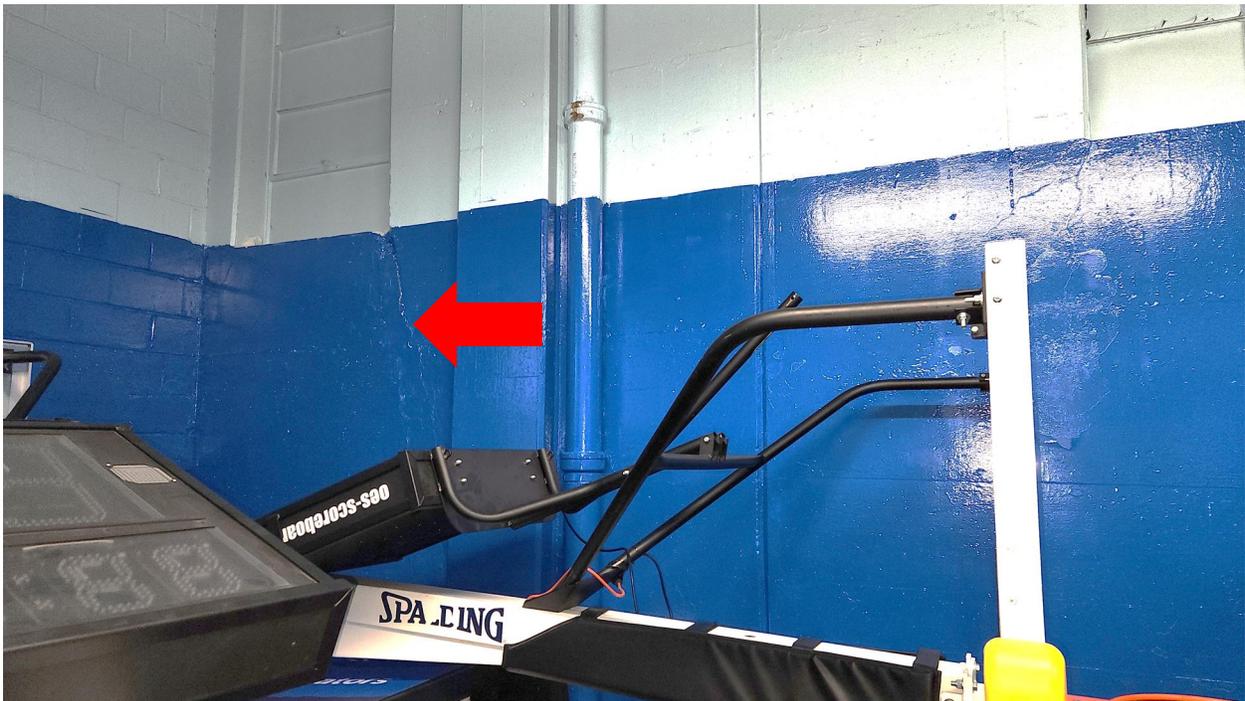
Photo 18: Typical crack in concrete foundation wall (c.1951).

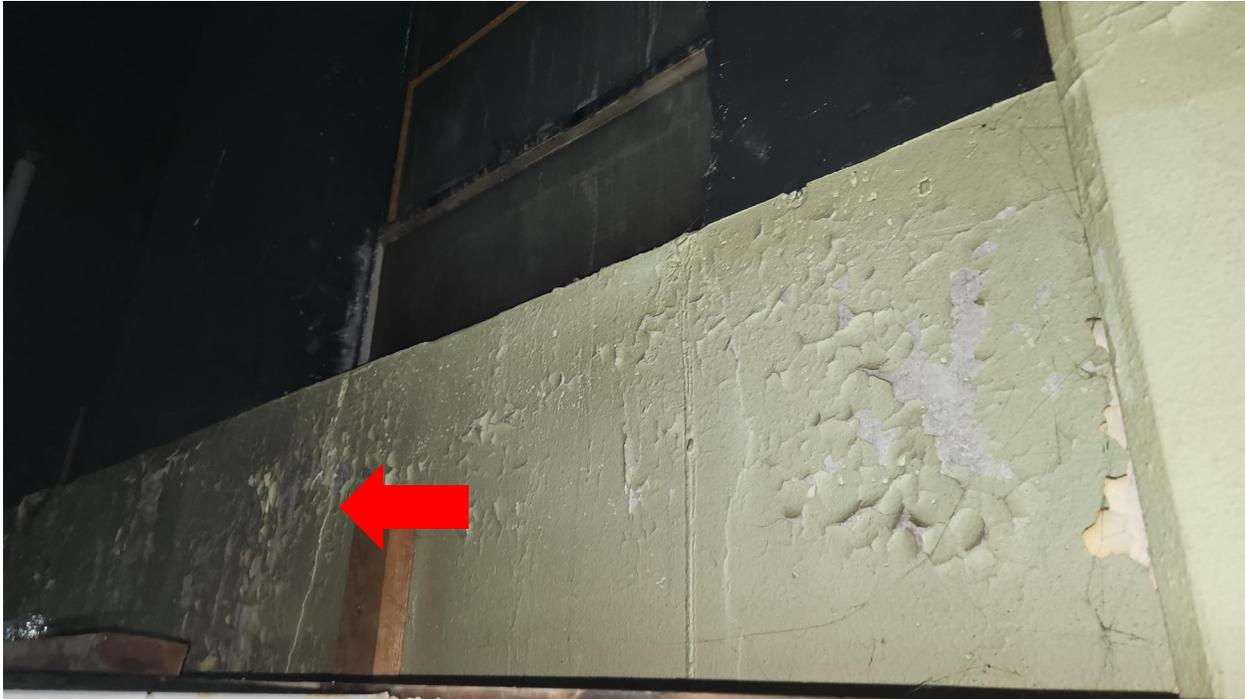
Photo 19: Typical crack in concrete foundation wall (c.1951).

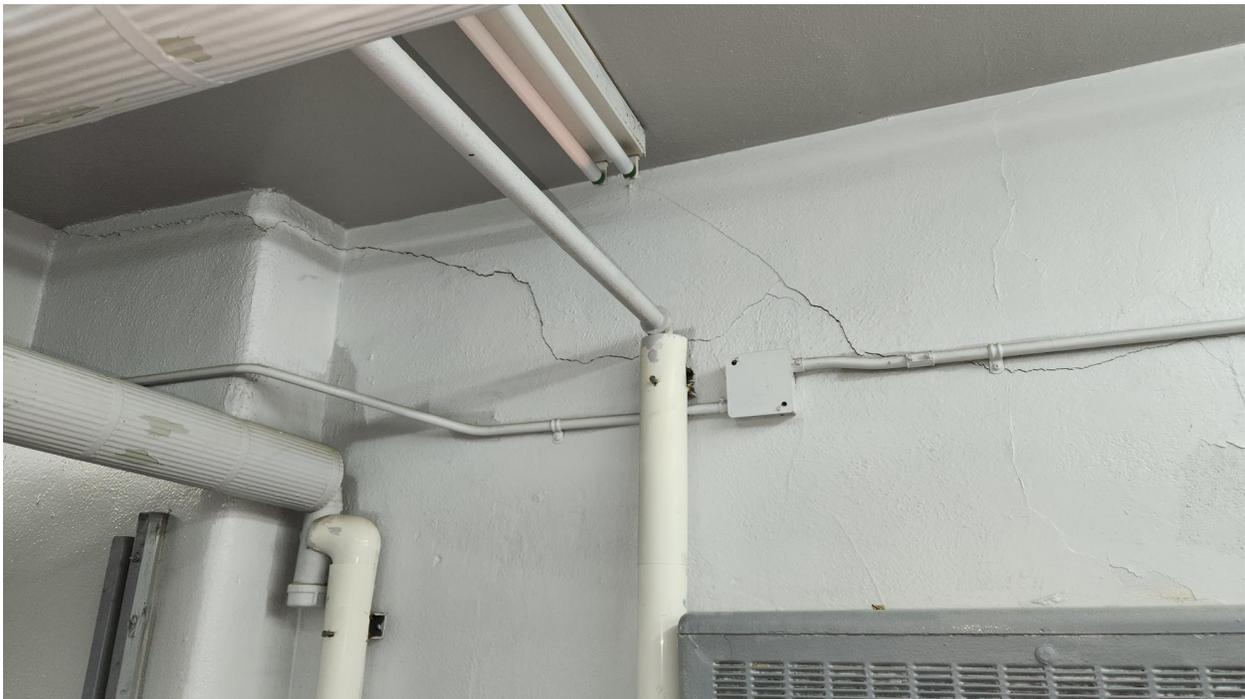
Photo 20: Cracked and spalling parging on the foundation walls at the south side of the building (c.1951).

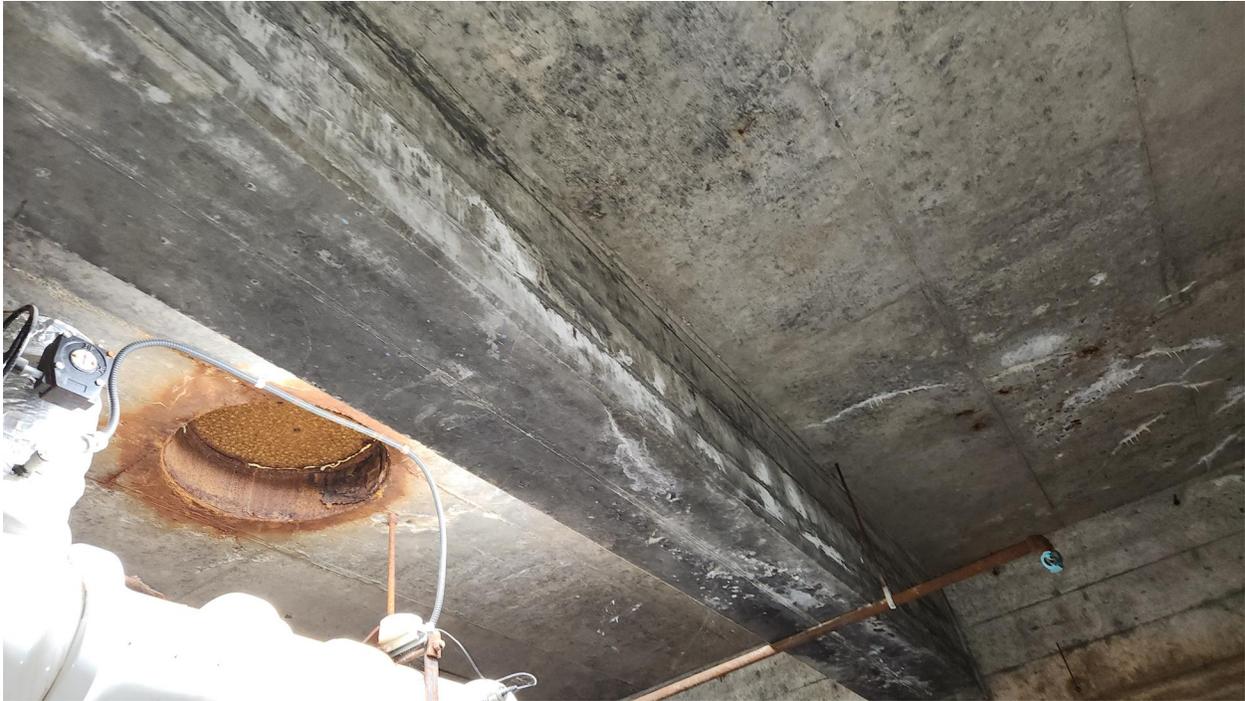
Photo 21: Evidence of water infiltration through roof slab in the old Coal Storage room (c.1951).

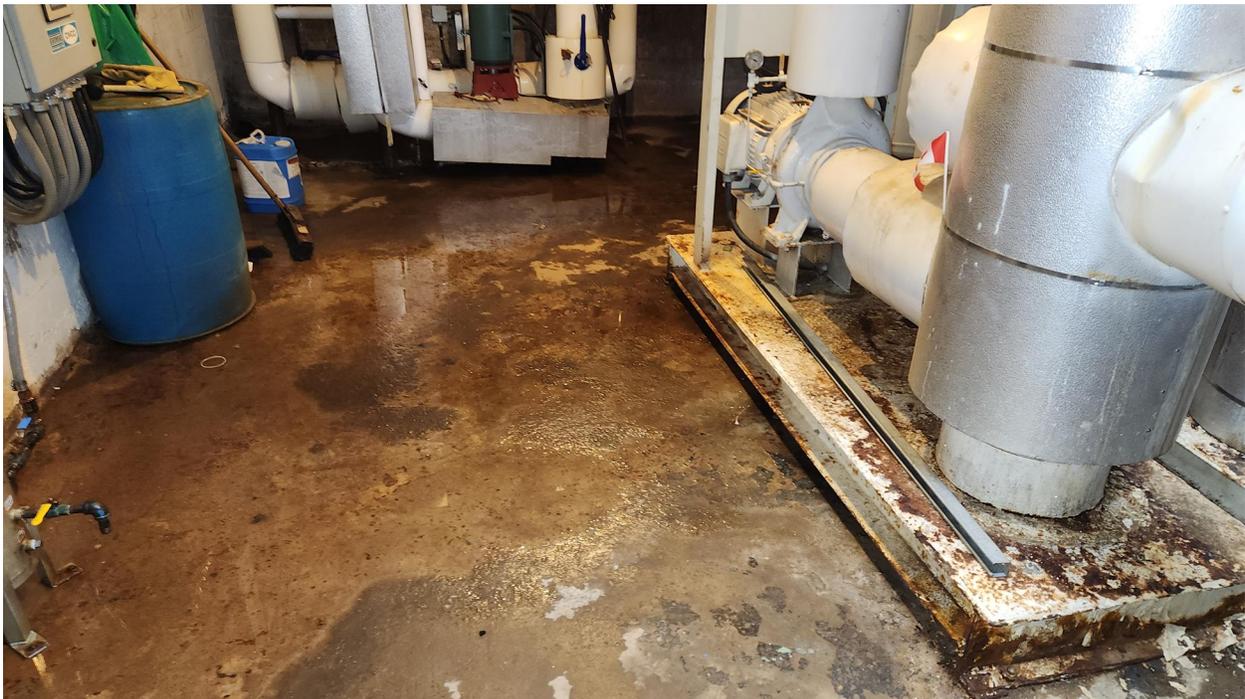
Photo 22: Water on the floor in old Coal Storage room (c.1951).

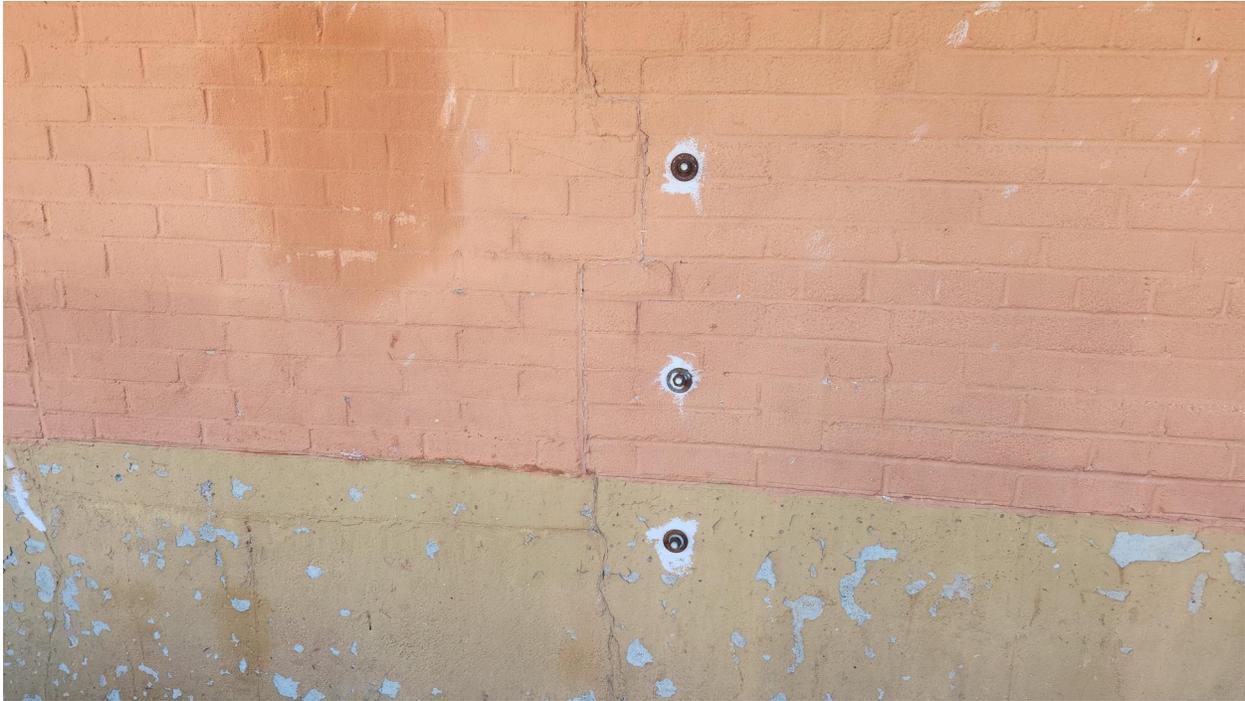
Photo 23: Crack in concrete foundation and masonry walls (c.1951).

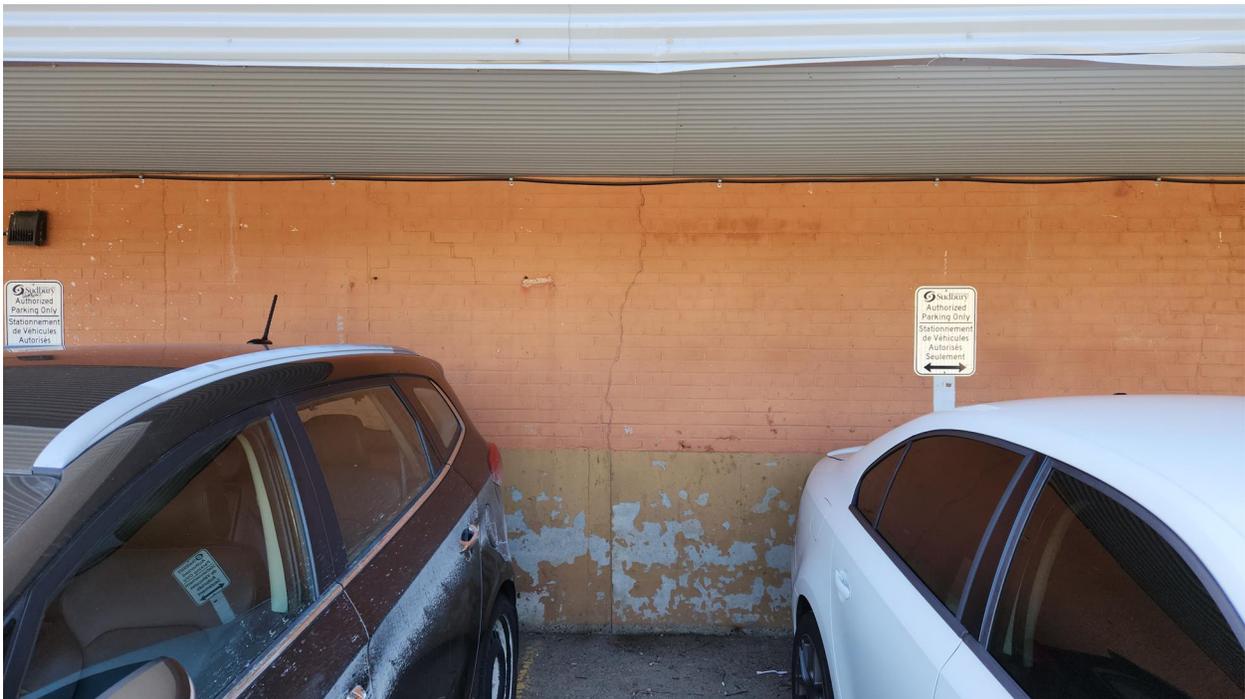
Photo 24: Cracks in concrete foundation and masonry walls (c.1951).

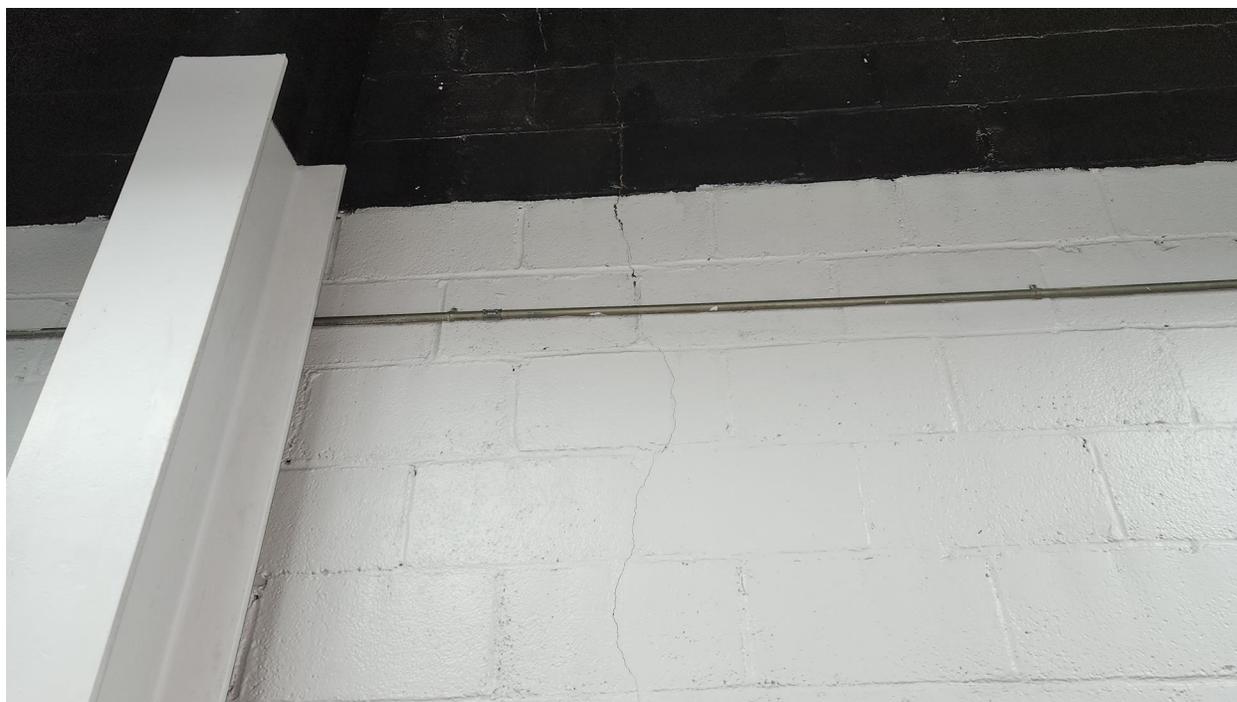
Photo 25: Crack in masonry wall (c.1951).

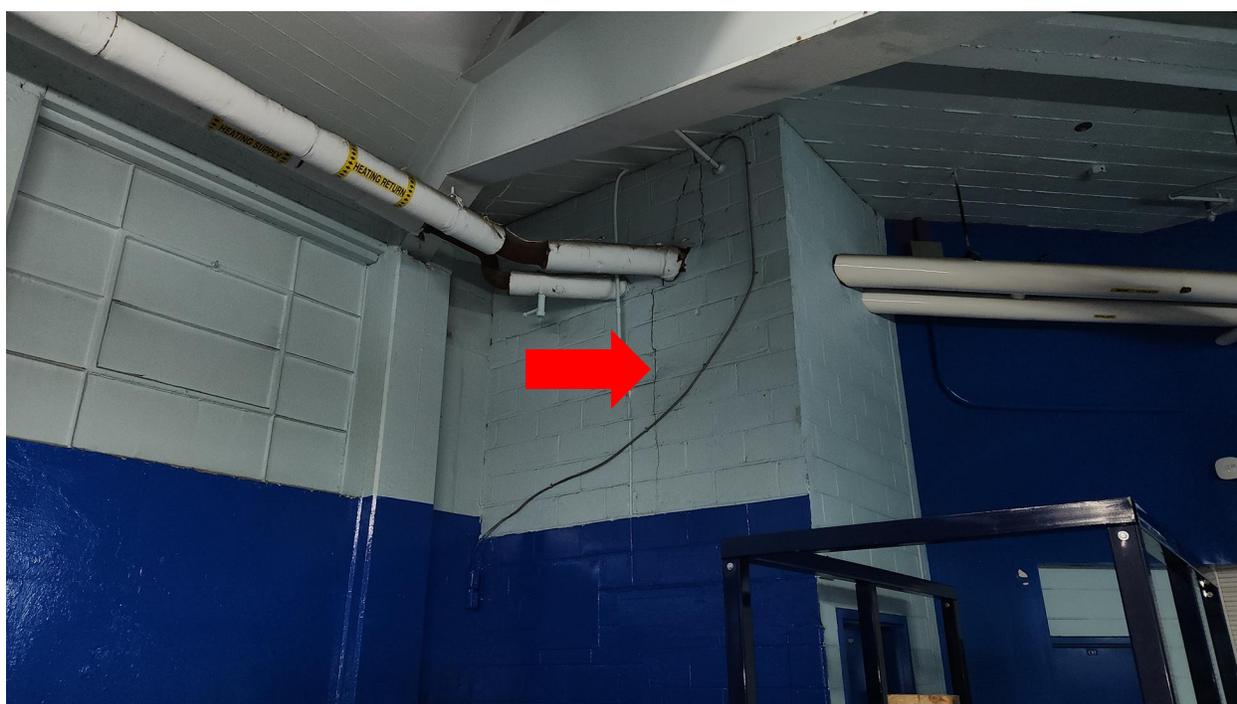
Photo 26: Crack in masonry wall (c.1951).

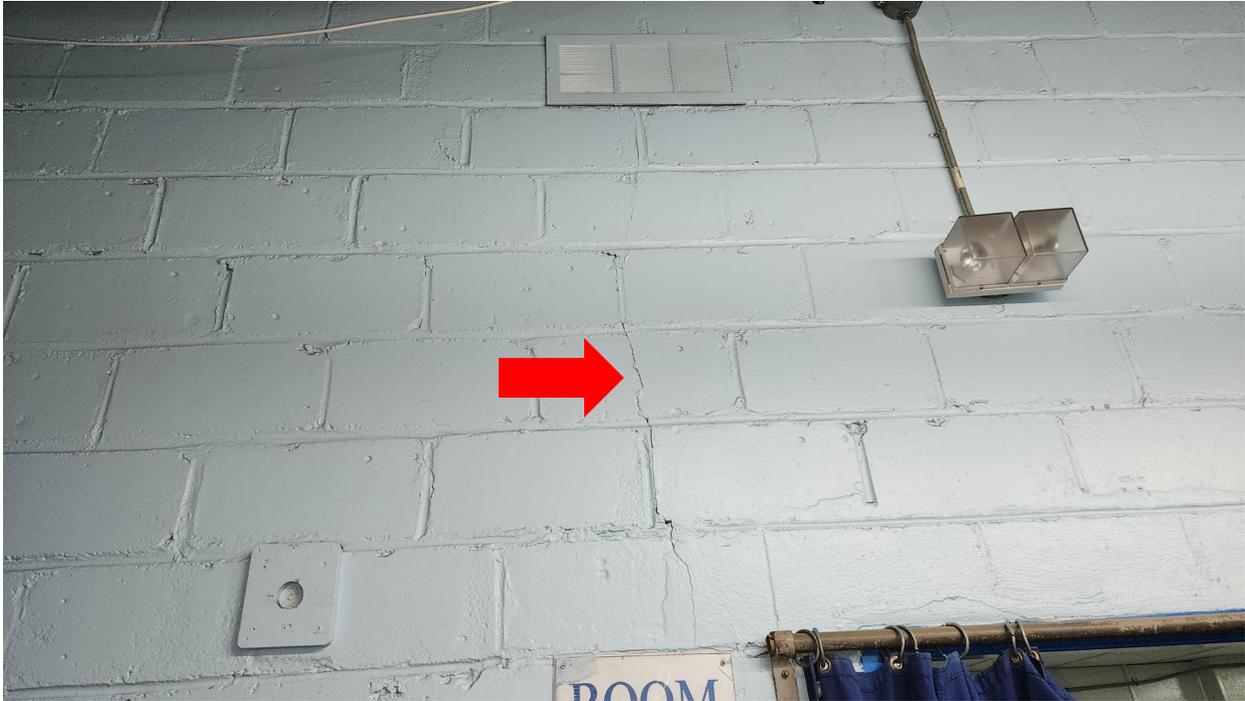
Photo 27: Crack in masonry wall (c.1951).

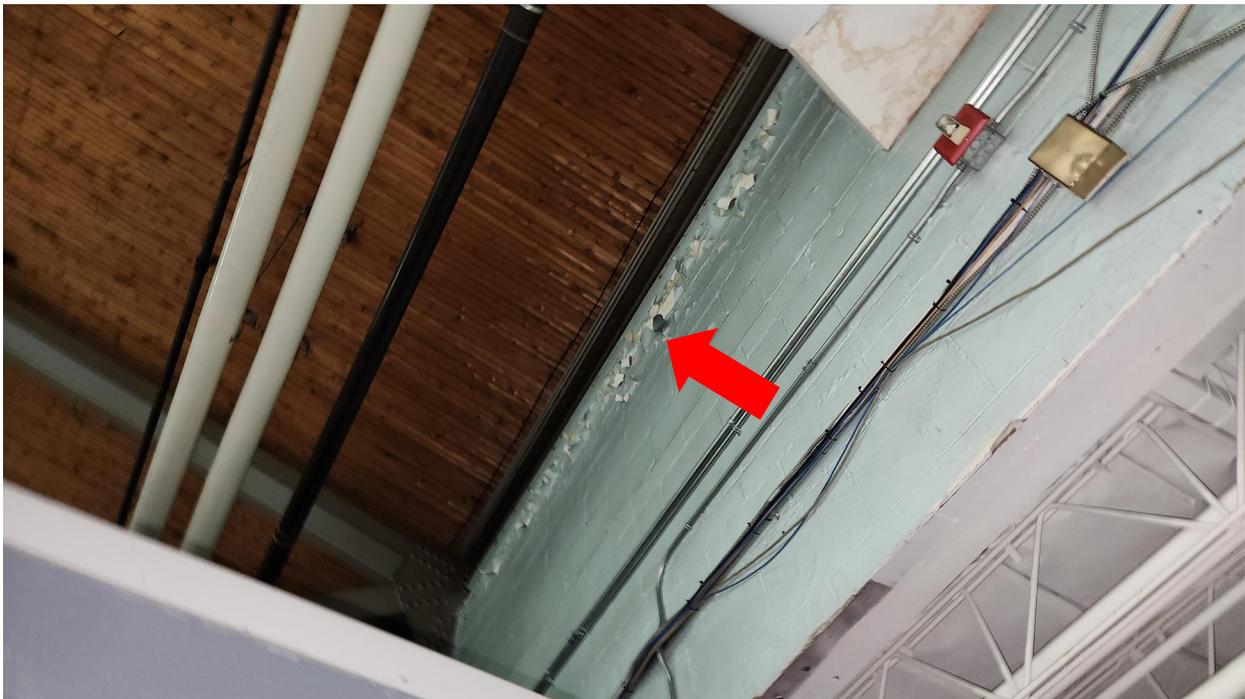
Photo 28: Peeling paint on masonry wall (c.1951).
