STRUCTURAL CONDITION ASSESSMENT

**SUDBURY COMMUNITY ARENA
240 ELGIN ST
SUDBURY, ONTARIO**

Our Project No.: 23131A

October 16, 2023

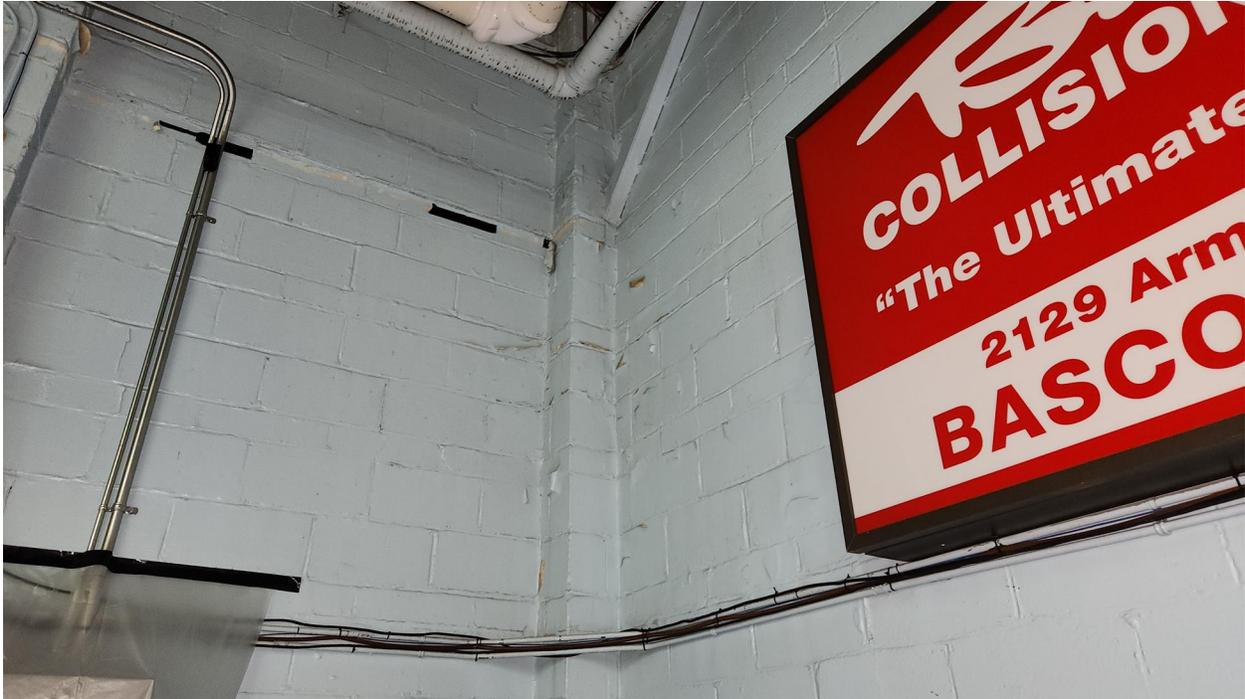
Photo 29: Peeling paint on masonry wall (c.1951).

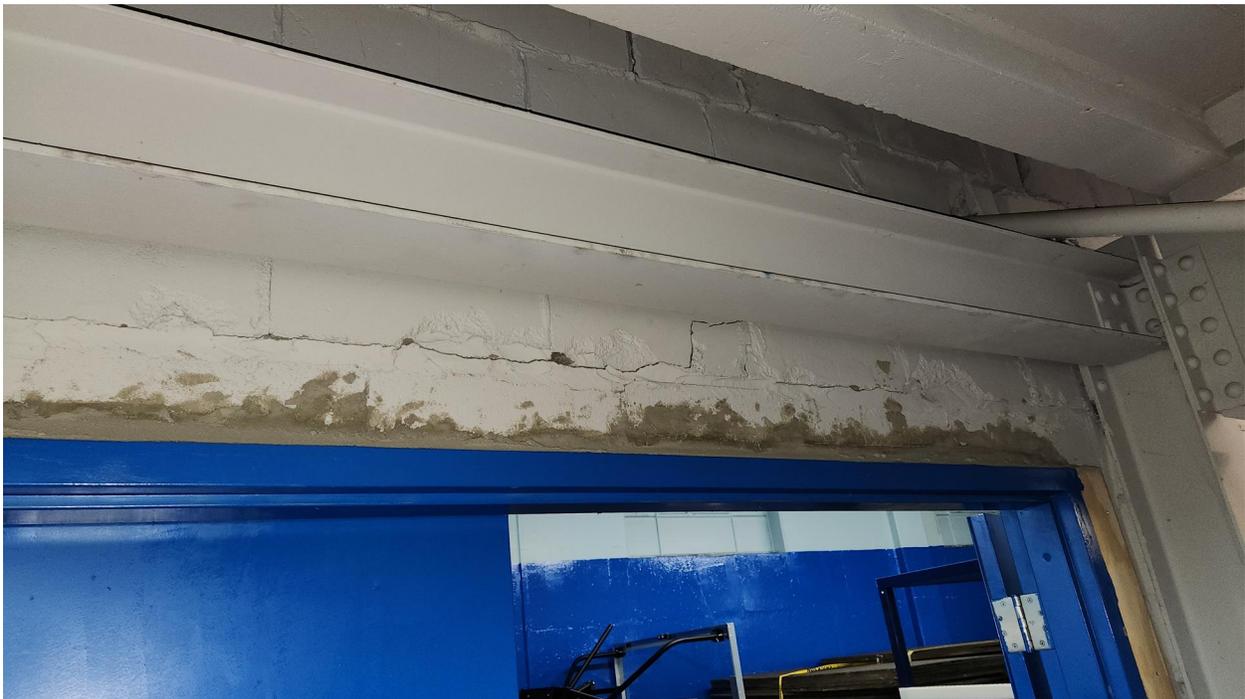
Photo 30: Missing lintel over Storage Room door (c.1951).

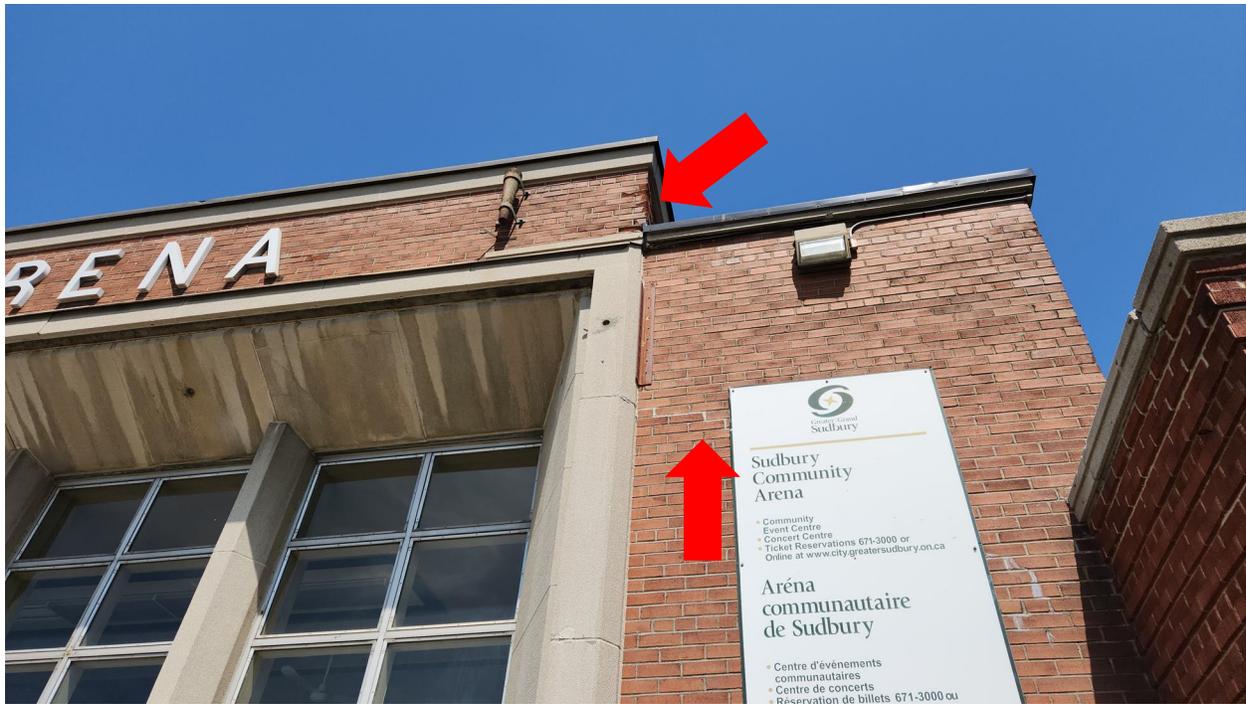
Photo 31: Damaged and cracked brick masonry (c.1951).

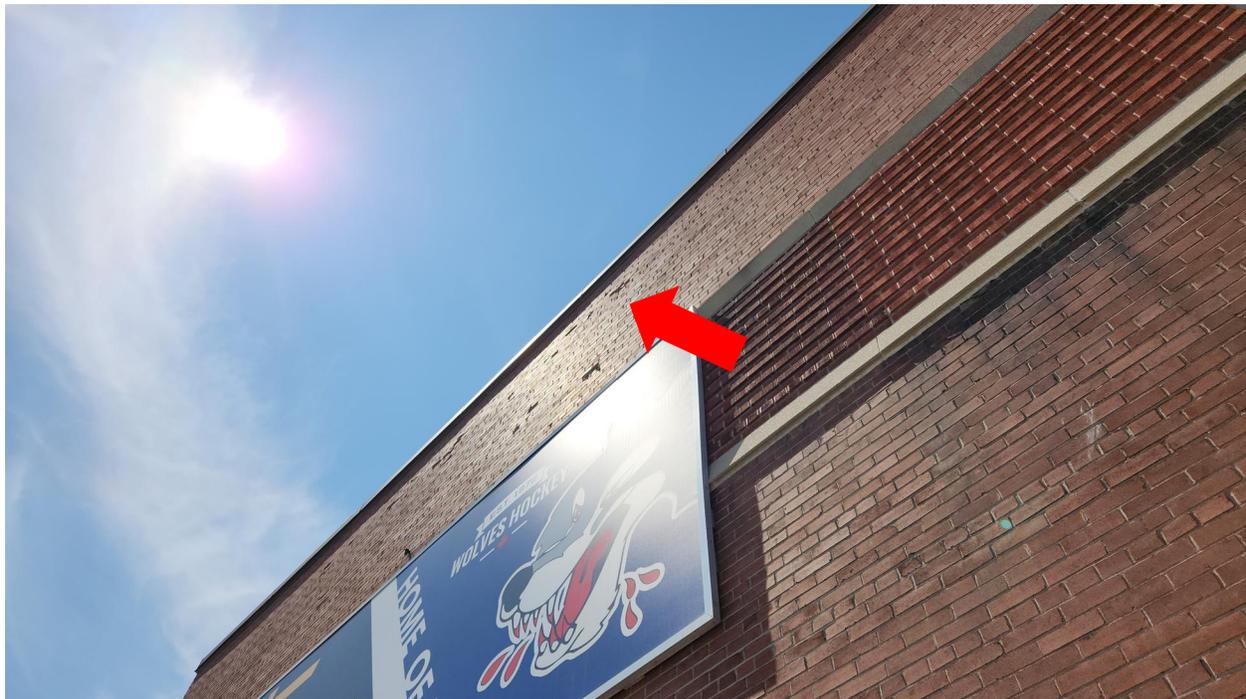
Photo 32: Damaged brick masonry (c.1951).

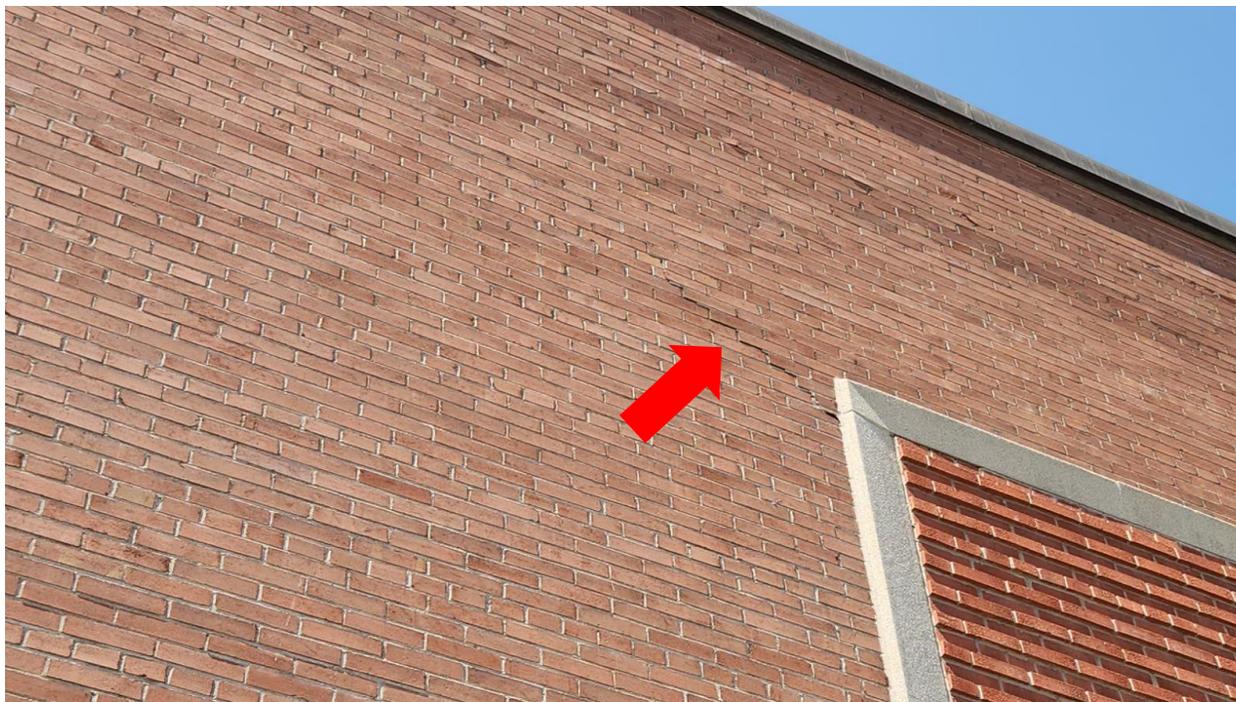
Photo 33: Cracked brick masonry (c.1951).

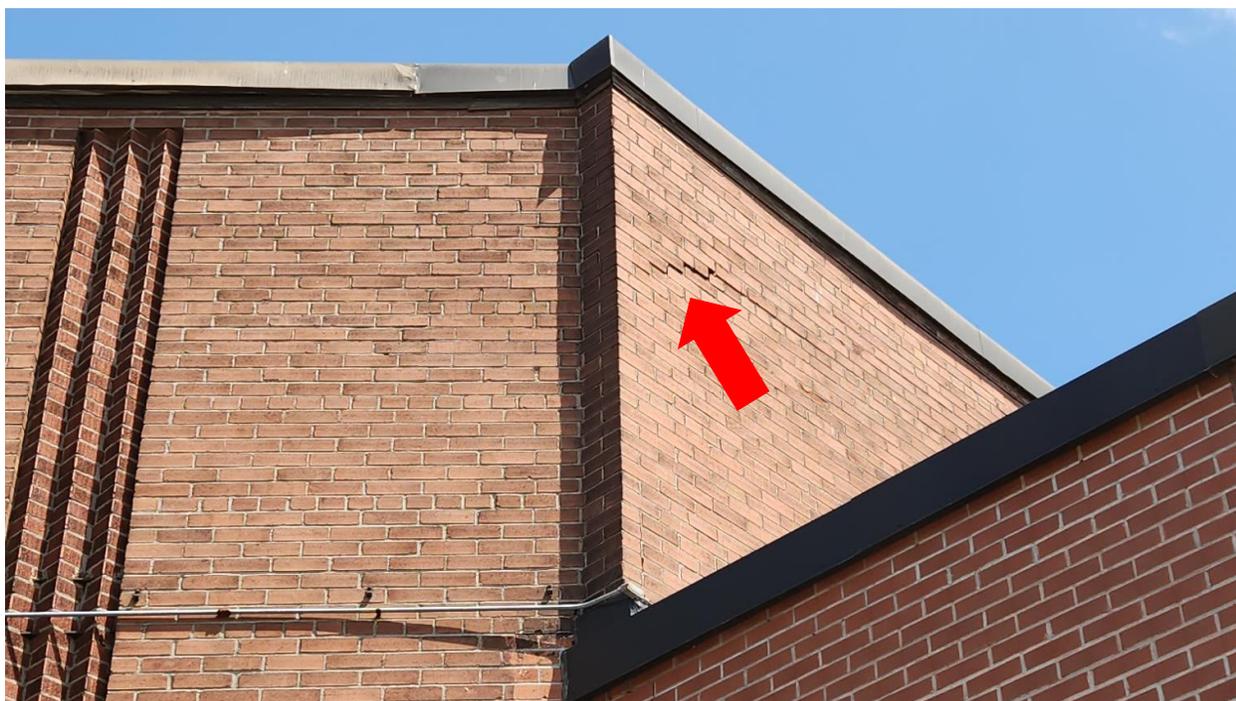
Photo 34: Cracked brick masonry (c.1951).

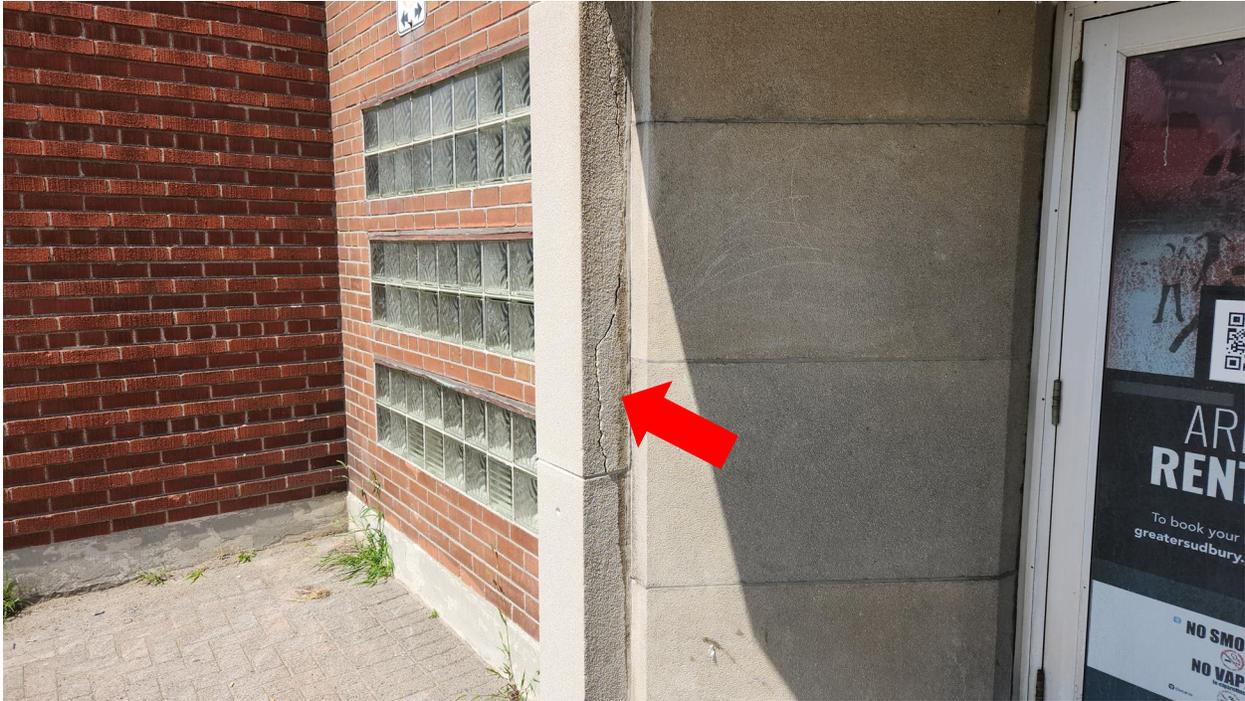
Photo 35: Cracked precast concrete at Main Entrance (c.1951).

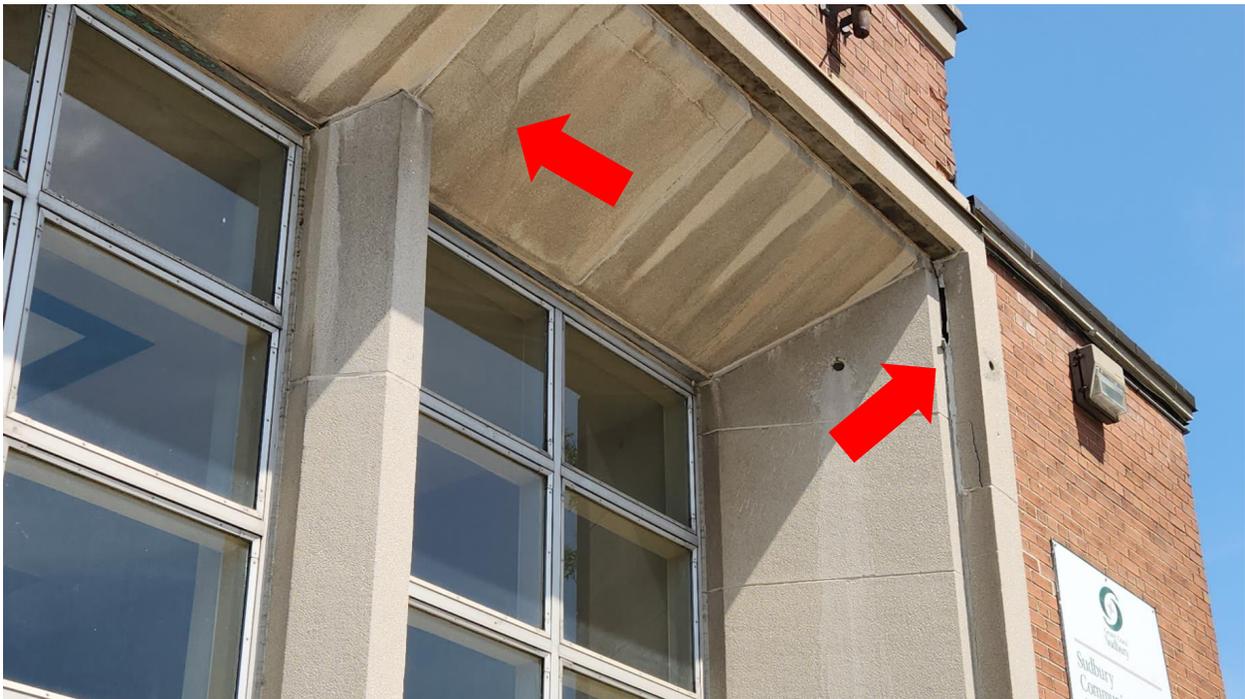
Photo 36: Cracked precast concrete at Main Entrance (c.1951).

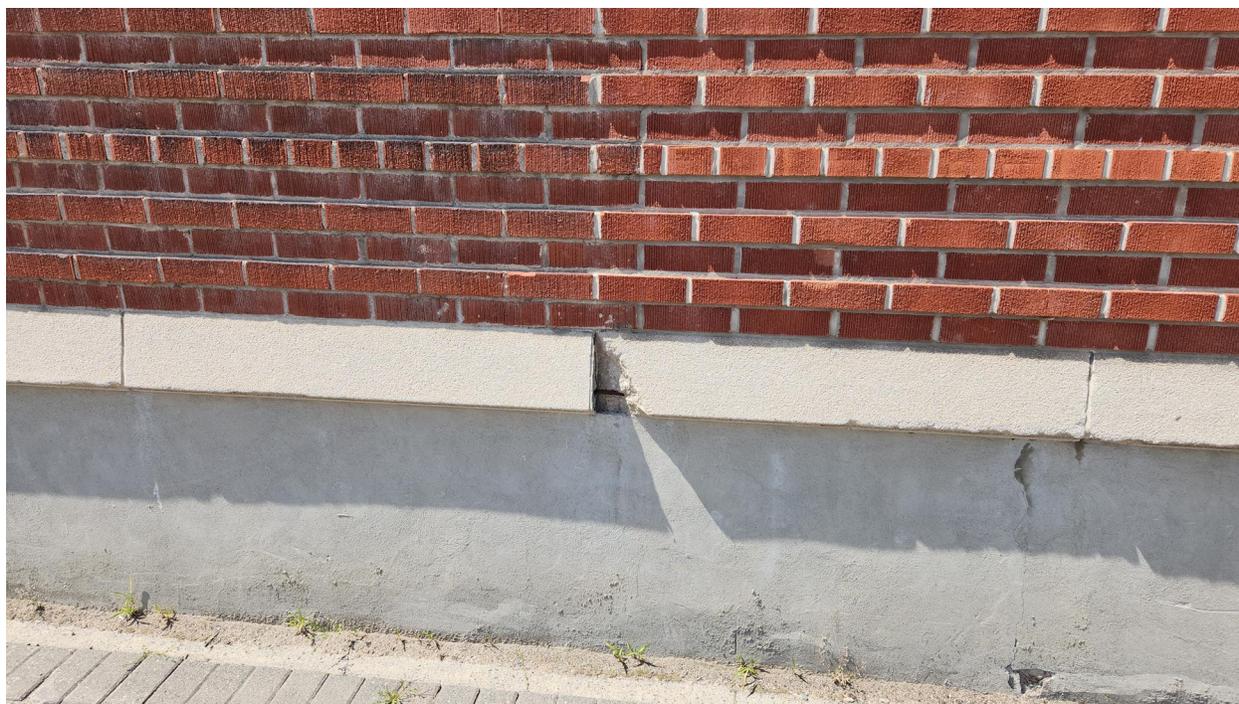
Photo 37: Damaged precast concrete sill (c.1951).

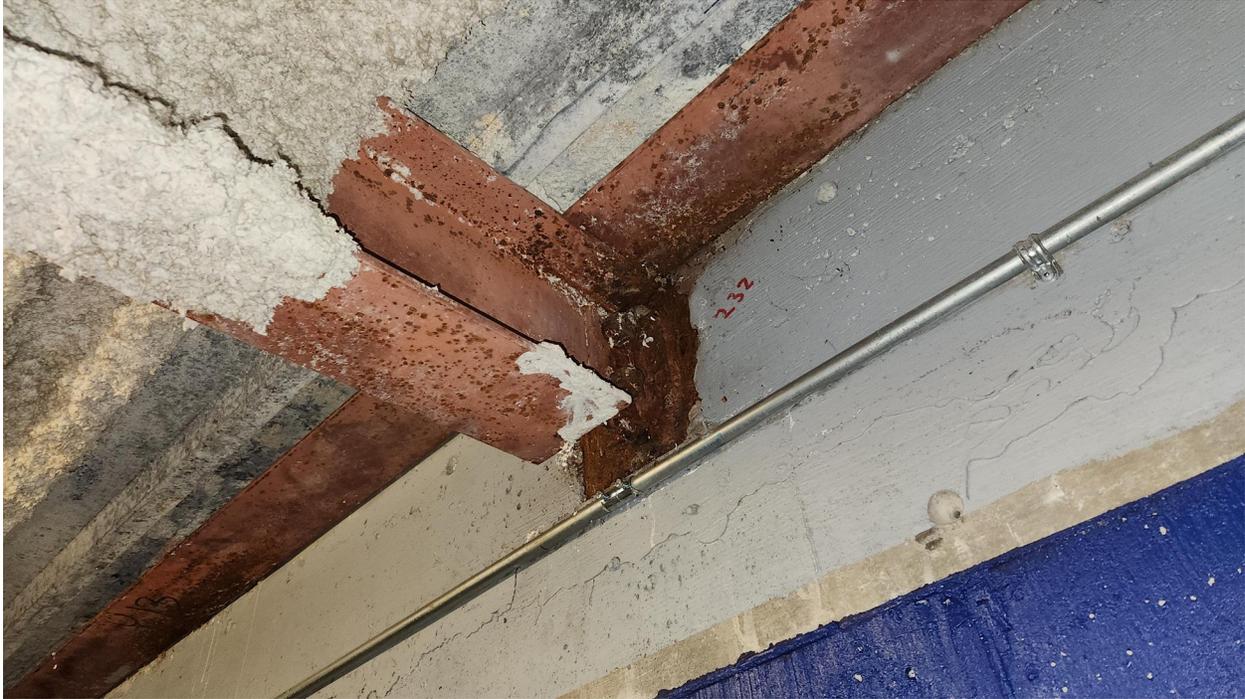
Photo 41: Corrosion of beam-to-column header connection at the southeast stair addition (c.2000).

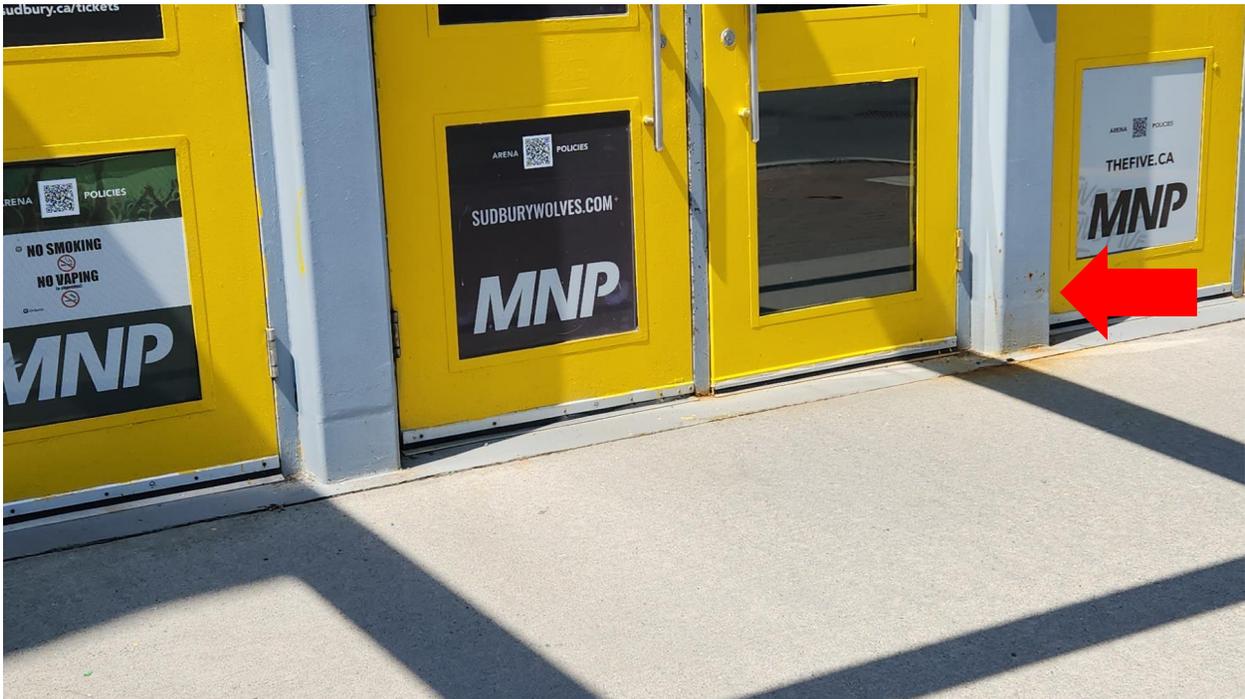
Photo 42: Evidence of continued corrosion to exposed steel columns at the northeast stair addition (c.2000).

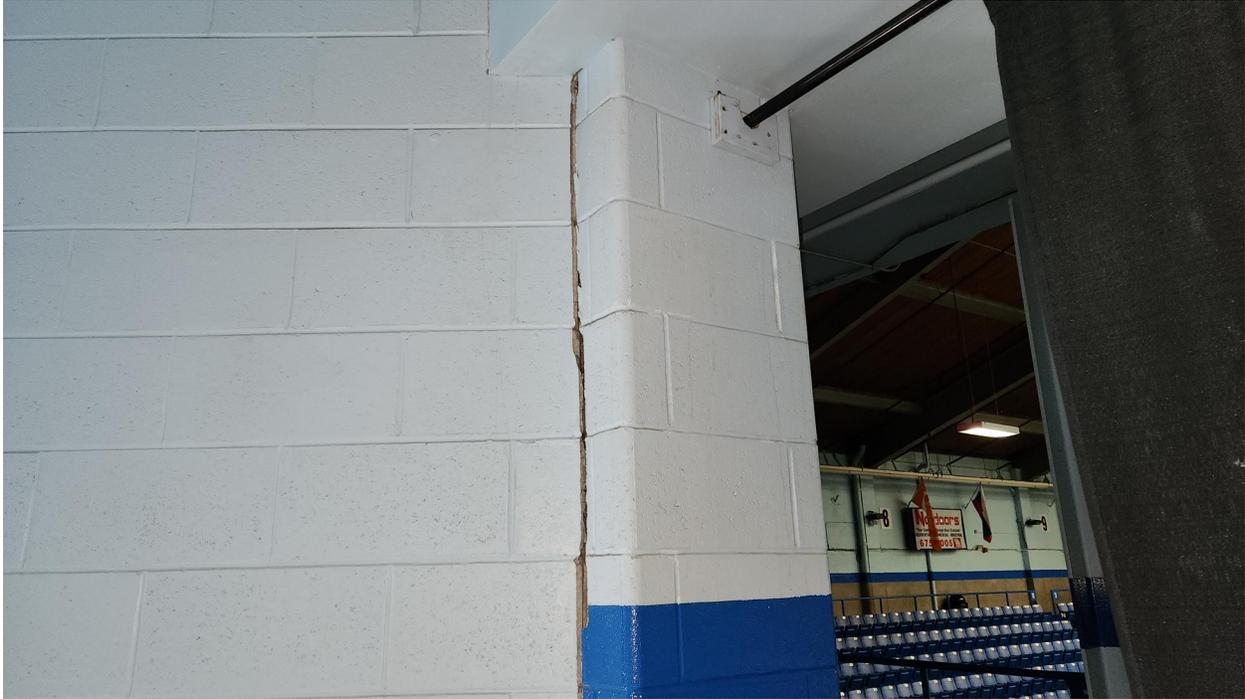
Photo 43: Masonry wall cracks at the southwest stair addition (c.2000).

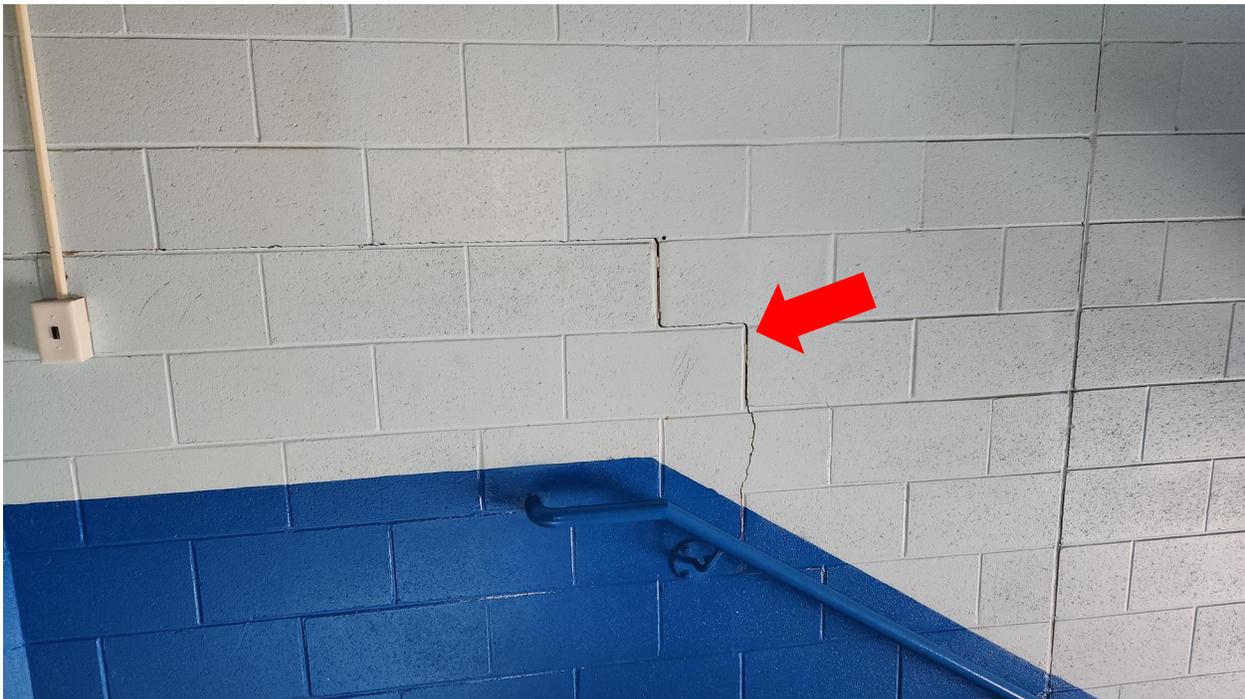
Photo 44: Masonry wall cracks at the southwest stair addition (c.2000).

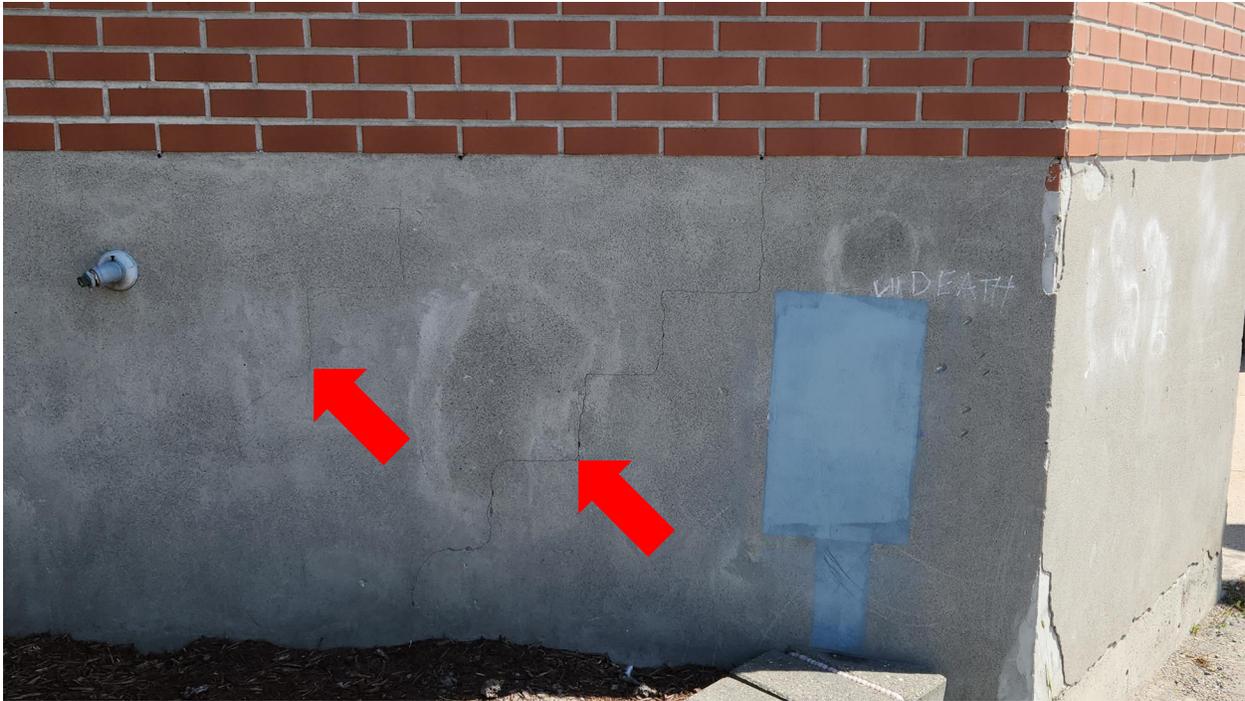
Photo 45: Step-cracking in masonry wall at the southwest stair addition (c.2000).

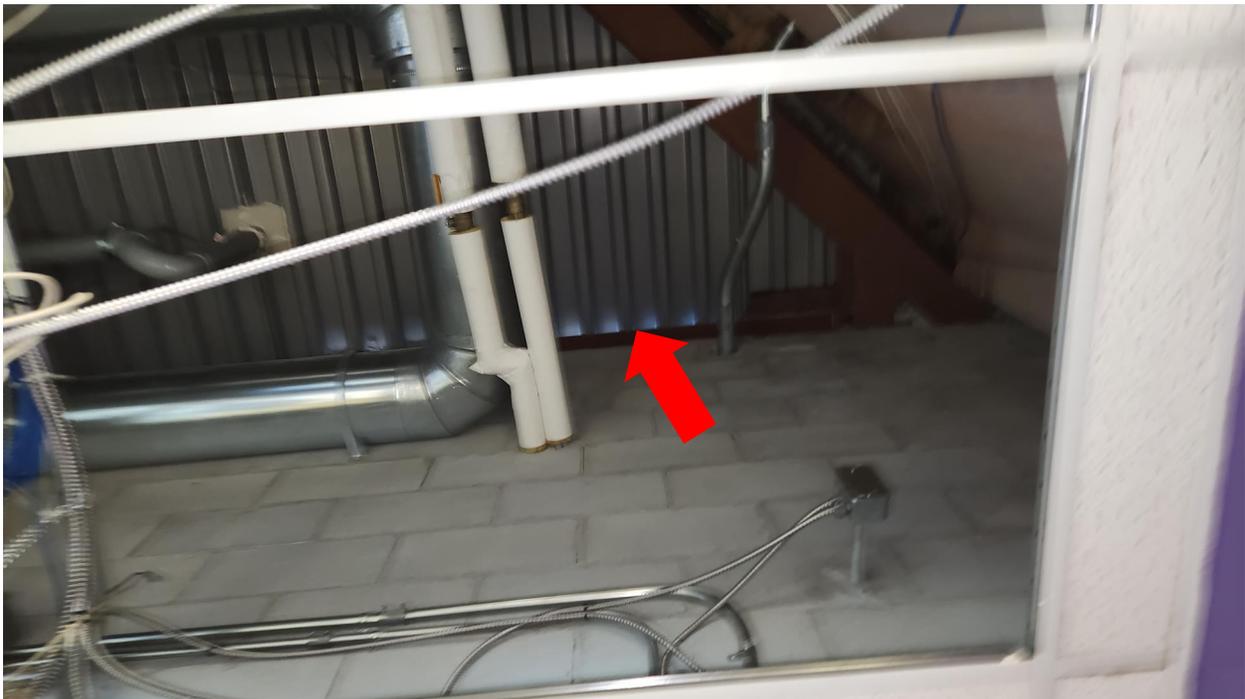
Photo 46: Gaps between the steel deck flutes and top of wall at the northwest stair addition (c.2000).

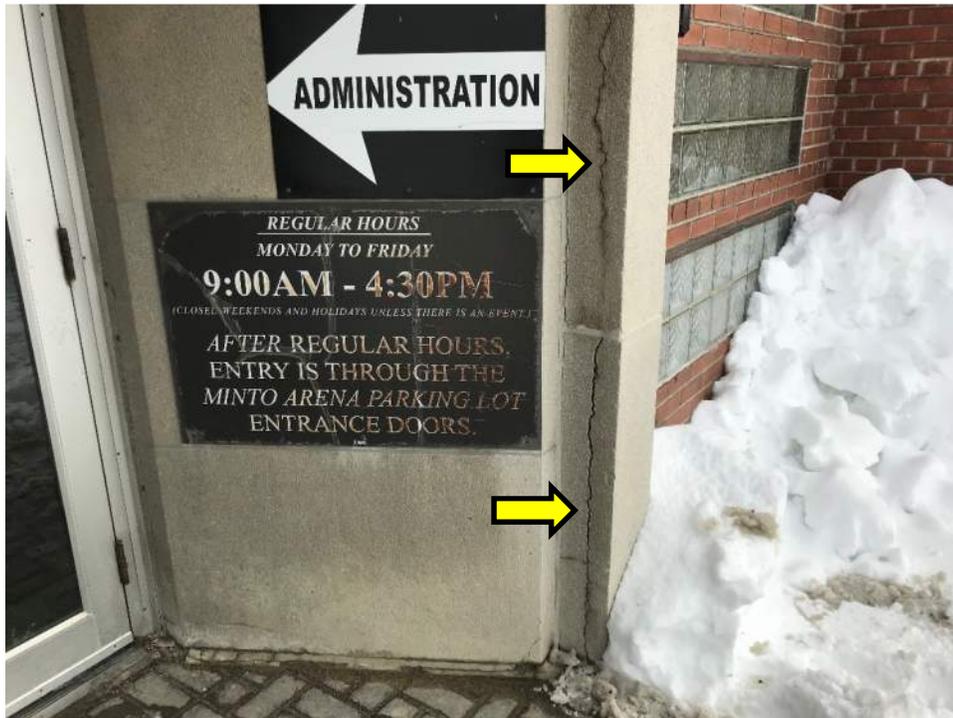
Figure 2: Typical vertical panel cracking.

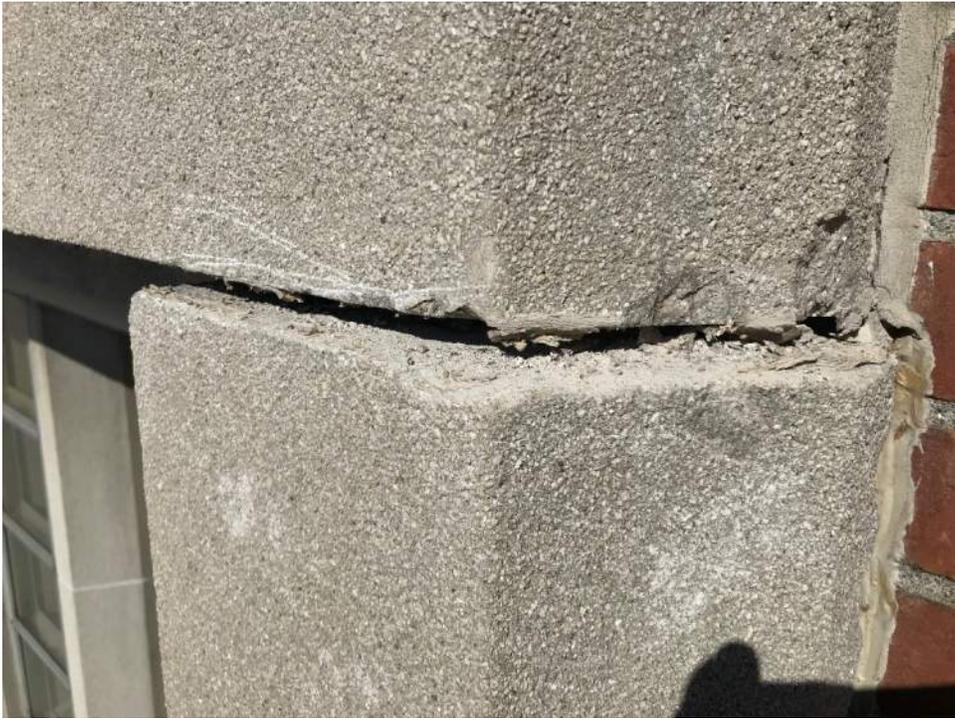
Figure 3: Typical displacement of topmost panel on outer column.

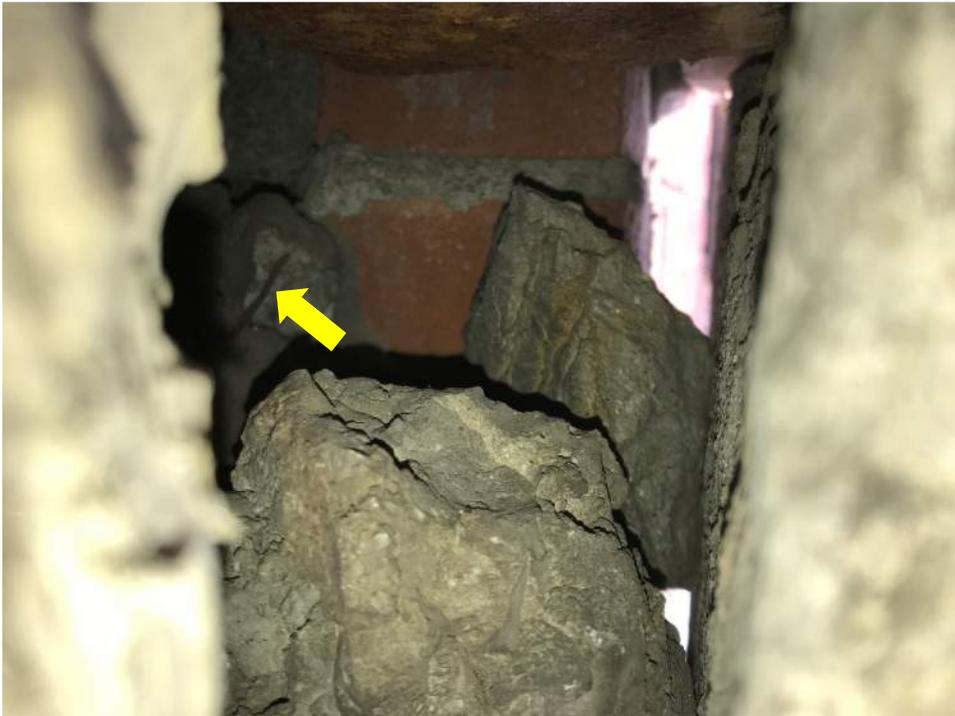
Figure 4: Typical snapped wire tie.

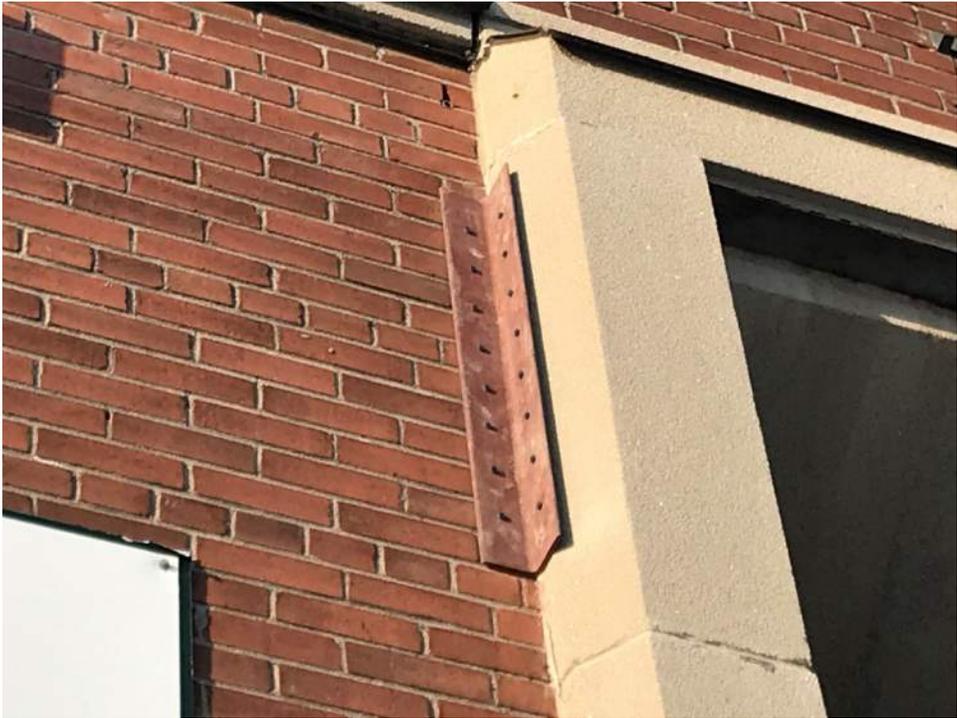
Figure 5: Immediate temporary panel support.

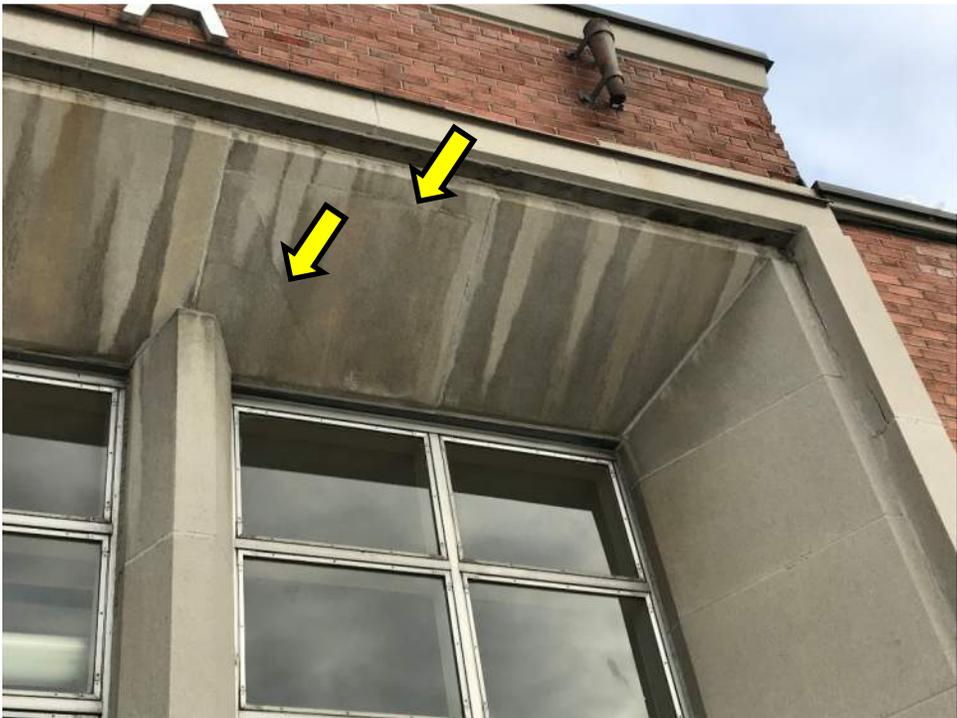
Figure 6: Soffit panel cracks and staining.

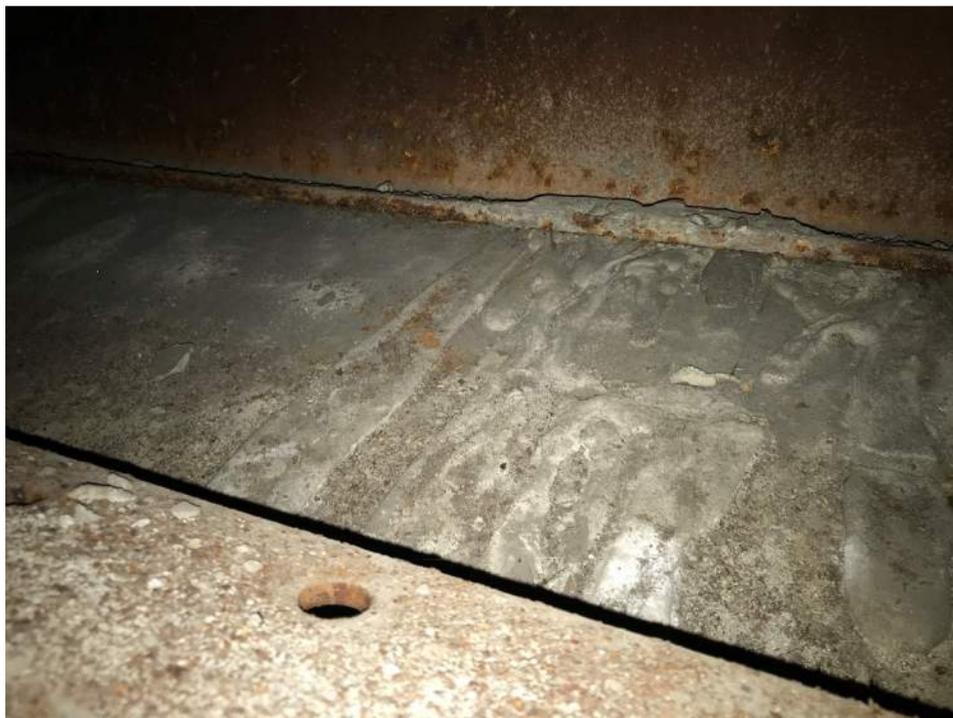
Figure 8: Surface corrosion and missing anchors at all pre-drilled holes.

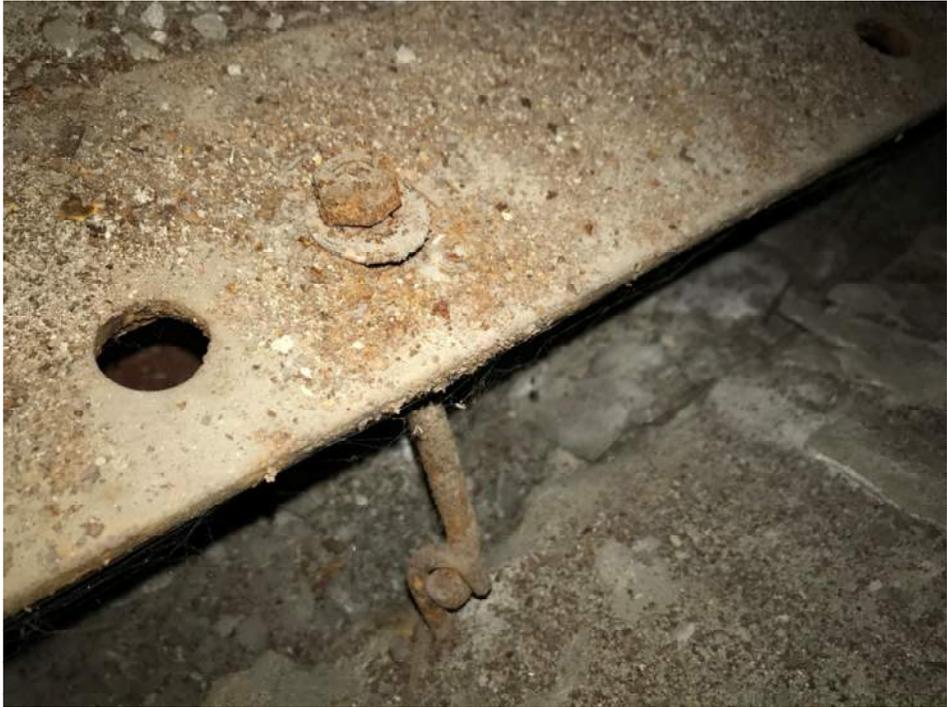
Figure 9: Typical soffit anchor j-bolt. Surface corrosion and nut not fully threaded.

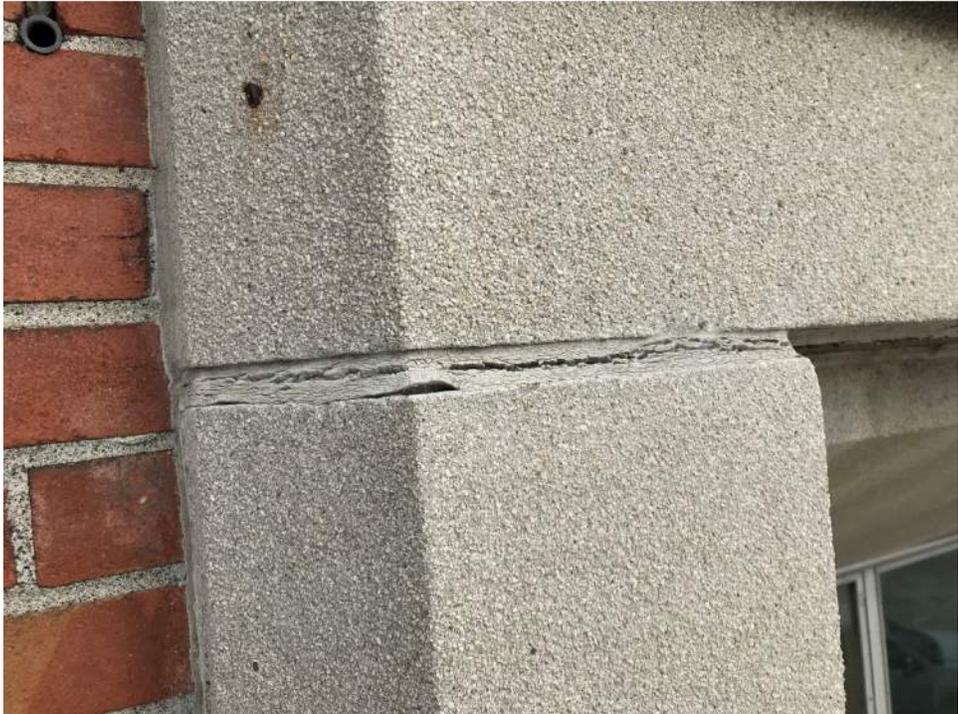
Figure 10: Typical sealant joint deterioration.
