Request for Decision

Lily Creek Boardwalk Options

**Re: *Structural Assessment of Lily Creek Boardwalk
Revised Final Report (DRAFT)***

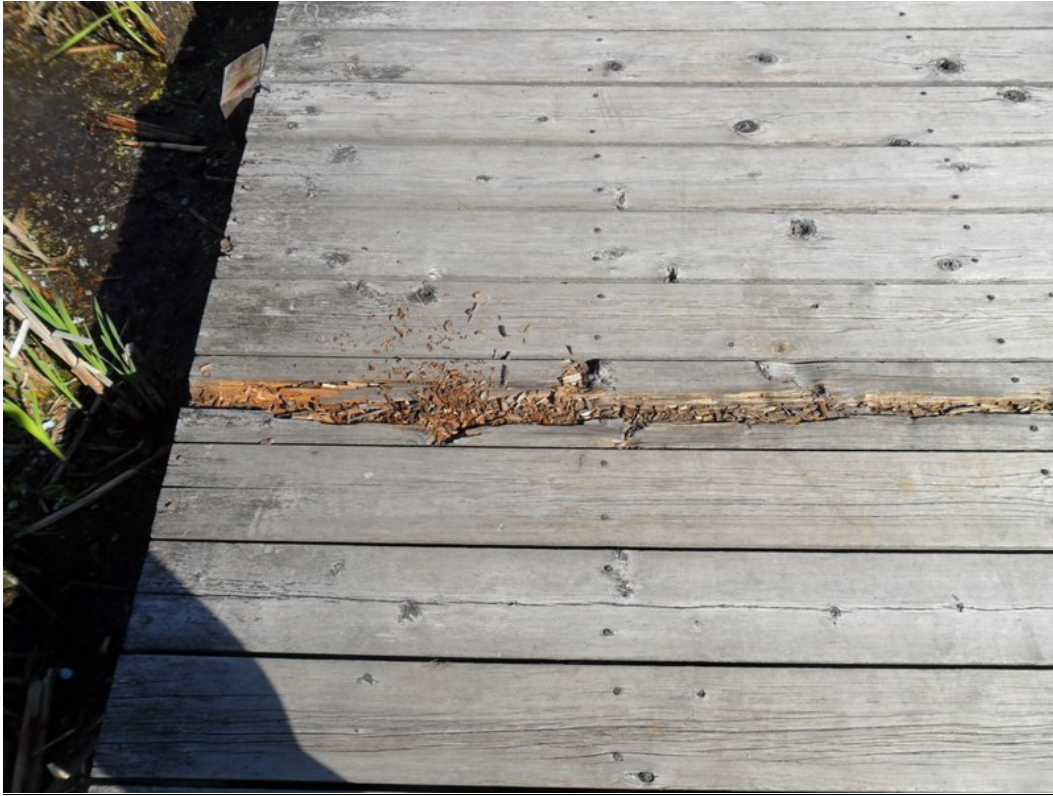
The boardwalk surface (decking) is generally in fair to poor condition. The cedar deck surface has weathered due to exposure to the elements. There is fungus/mould visible at the ends of the deck boards in some areas, which is indicative of rot occurring in the wood. We estimate 15 to 20% of the deck boards are showing signs of rot (see Photo 1) and are in need of replacement.

Photo 1 – Deck boards exhibiting rot.

- All deck boards that show significant signs of rot or deterioration be replaced;
- All protruding nail heads should be removed and replaced with deck screws;
- In areas where the boardwalk has shifted (i.e. sloped surface), it should be manoeuvred back into position to level the sloped surface; and
- During replacement of deck boards, the sub-structure (skirting, deck braces) should be inspected more thoroughly and replaced as required.

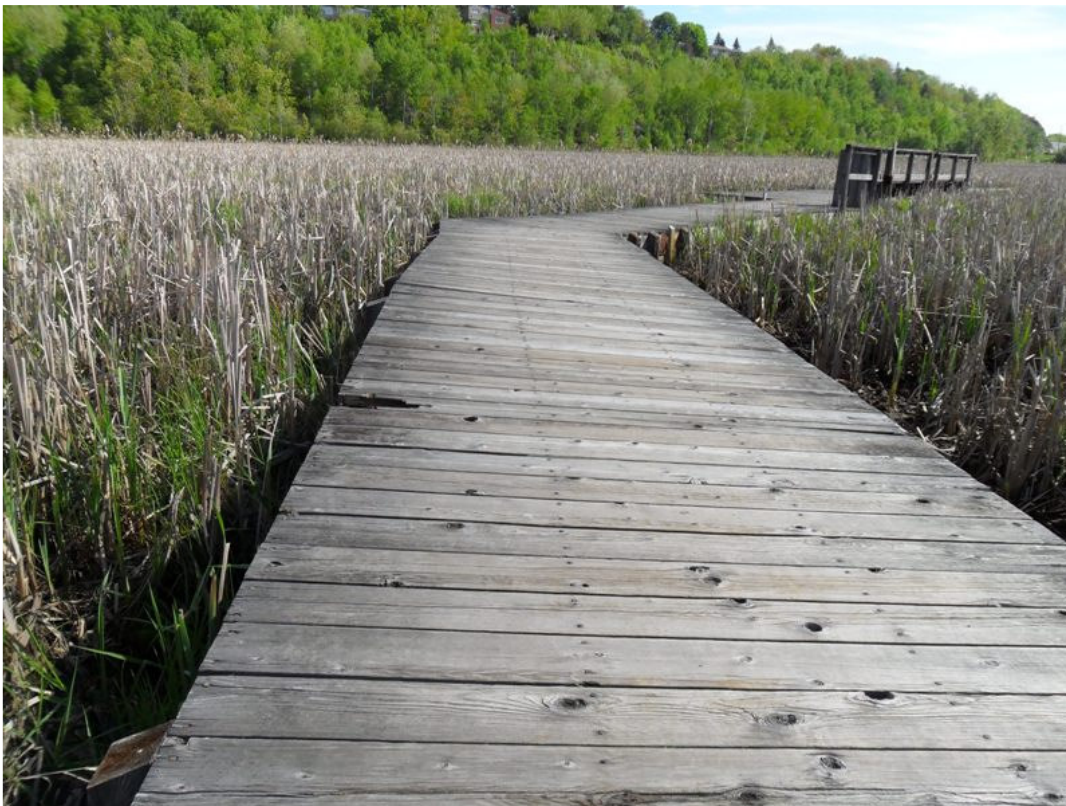
In some areas it was observed that the boardwalk surface slopes to one side (see Photo 2). In these areas this sloped surface appears to be the result of a portion of the boardwalk bearing on land, and a portion floating. This distortion of the boardwalk appears to be the result of a shift in the position of the boardwalk, possibly due to the action of the winter ice.

Photo 2 – Boardwalk sloping to side.

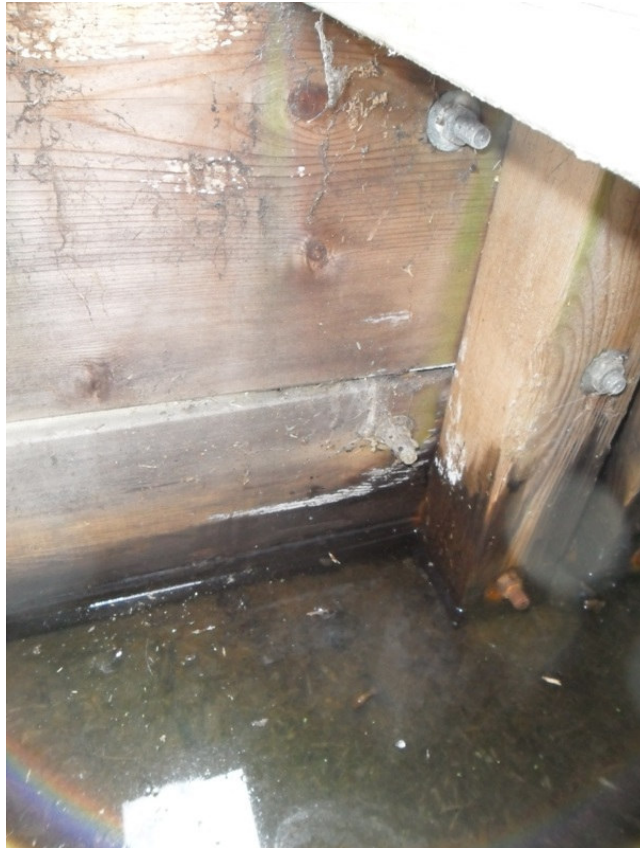
Below the water level the skirting boards and posts exhibit deterioration and rot (see Photo 3). These components are either completely immersed in water or are continually exposed to a cycle of wet/dry from the buoyant boardwalk structure. City staff were easily able to make indentations in the soft wood in these areas.

Photo 3 – Boardwalk sub-structure – rot and corrosion below water line.

The boardwalk sub-structure components (e.g. skirting, posts) are in poor condition and will continue to deteriorate over time. In order to extend the life of the boardwalk into the future, these components will all need to be totally replaced, including the foam billets. Replacing these sub-structure components can not be accomplished without disassembling the boardwalk decking. Therefore, we recommend the City implement a program to replace all 75 of the 2.43m x 3.66m (8-ft x 12-ft) panels with equivalent panels of a similar design.

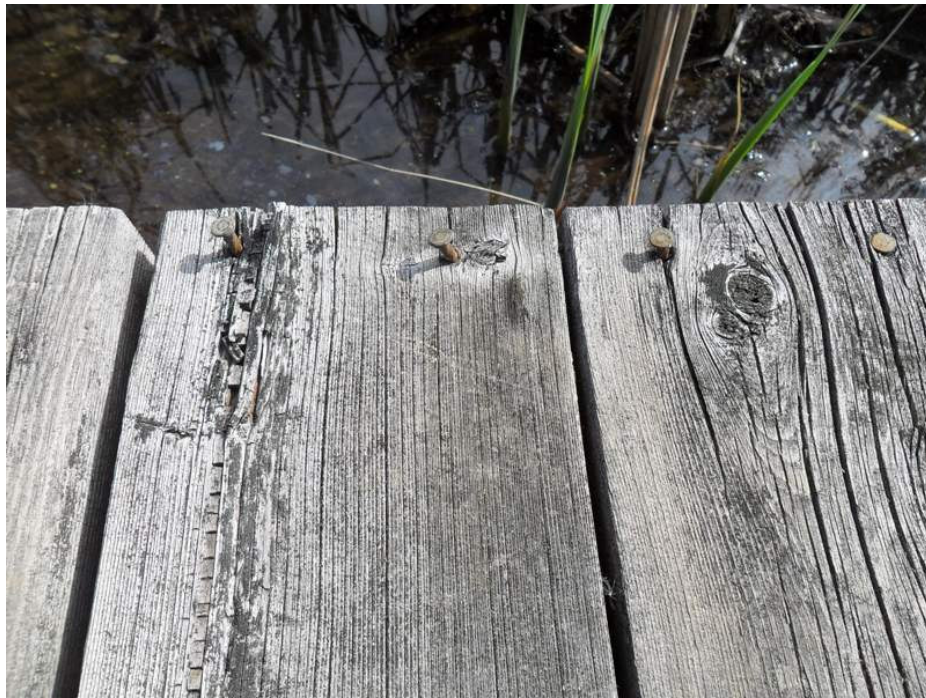
The spiral ardox nails used to fasten the deck boards to the sub-structure are exhibiting corrosion, but generally remain effective. There are a number of nail heads protruding along the sides of the walkway (see Photo 4).

Photo 4 – Nail heads protruding

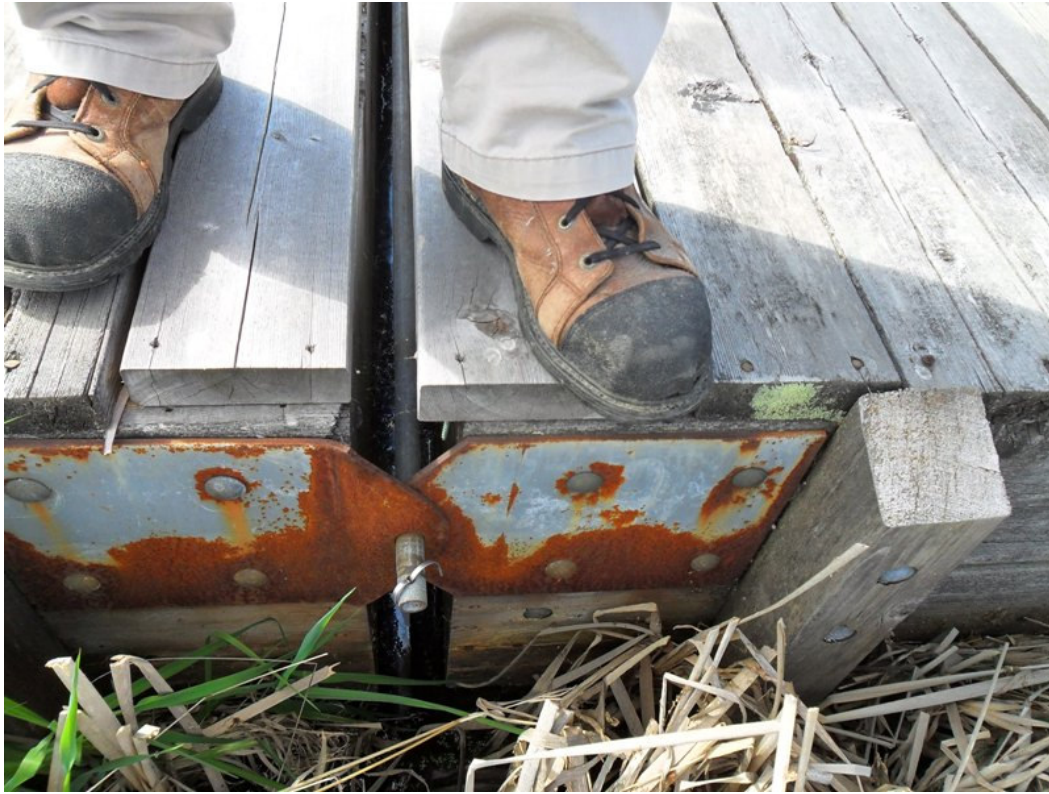
The connections (hinges) that fasten the boardwalk panels together are generally in good to fair condition, with most showing signs of surface corrosion only and the occasional connection showing more significant corrosion (see Photo 5). It is evident that some of the cotter pins have been replaced over the years as some appear to be relatively new.

Photo 5 – Panel connection showing mild corrosion.

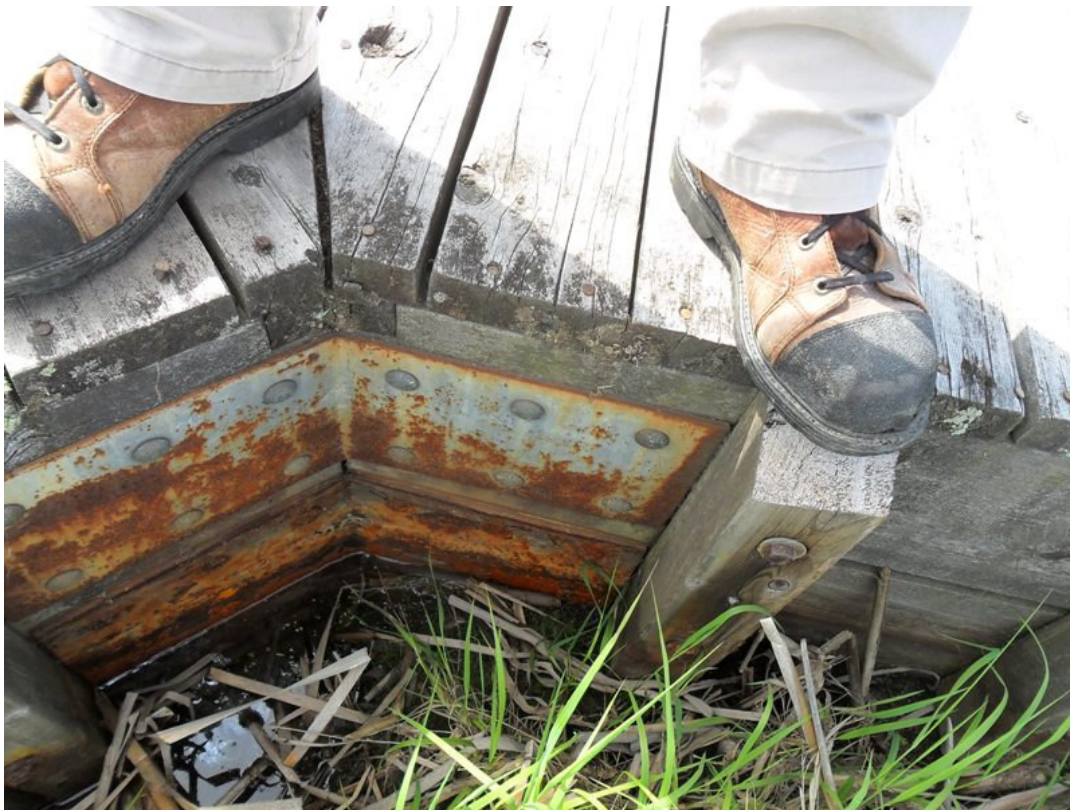
The other metal plates, connections and carriage bolts of the boardwalk above the water level are also in fair to good condition (i.e. surface corrosion only). However, those components below the water line exhibit more significant corrosion; including rust and delamination (see Photo 6).

Photo 6 – Metal connections corroded below water line.

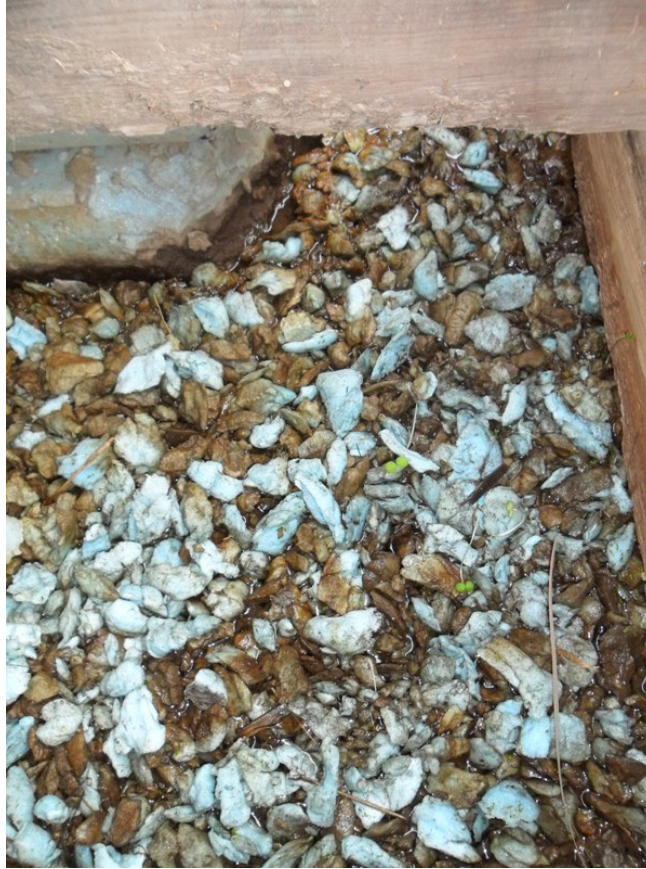
In some areas, however, the billets have been subjected to what appears to be gnawing (see Photo 7). We observed billets that have had a significant volume eaten away, and small pieces of foam were visible floating in the water below and adjacent to the boardwalk. We were informed by City Parks staff that this physical deterioration of the billets is the result of muskrats, which use the foam bits to construct nests.

The polystyrene billets appear to be functioning adequately; however they are subject to damage by animals, which will ultimately compromise their ability to provide flotation to the boardwalk. Further, the bits of foam that are chewed off create a mess in the wetland. Accordingly, over the long term the City should consider replacing the polystyrene billets with a different flotation system, such as high-density polyethylene (HDPE) barrels. We understand from speaking with City Parks staff that such a system was successfully implemented by the City for a new floating dock arrangement at the boat launch off Ramsey Lake Road.

Photo 7 – Chewed polystyrene billets.

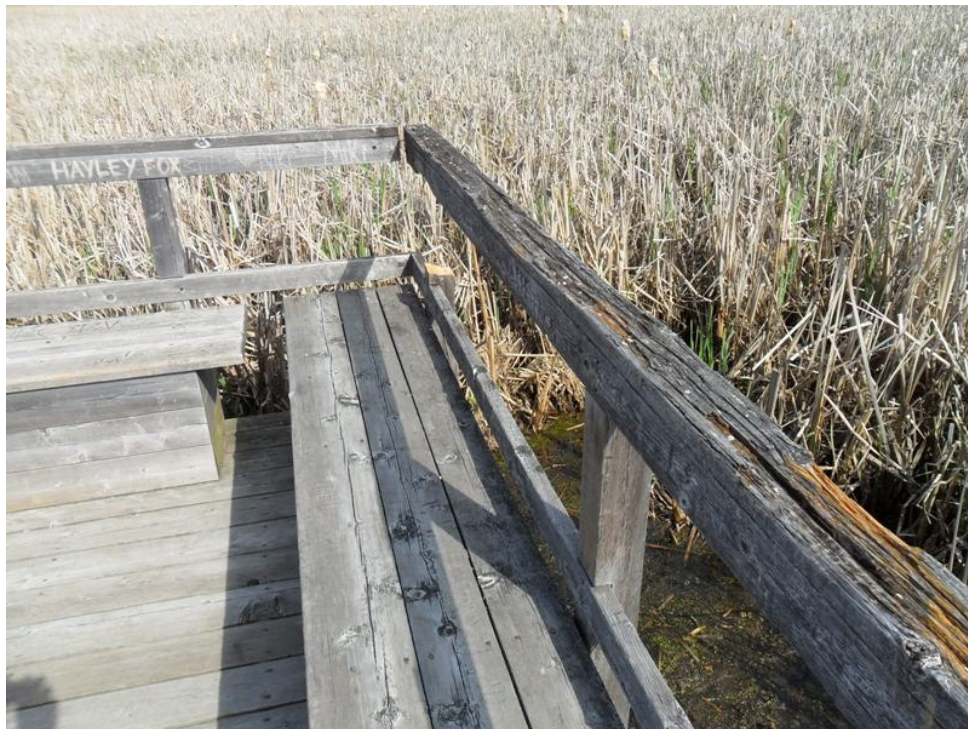
The handrails in the seating areas show some signs of deterioration, particularly the bases of the posts at the connection to the boardwalk skirt where the posts and anchors are below the water line. The handrails deflect relatively easily when force is applied, and the connections of one handrail to another (e.g. corners of observation platform) are generally not effective (see Photo 8).

Photo 8 – Observation deck and handrail.

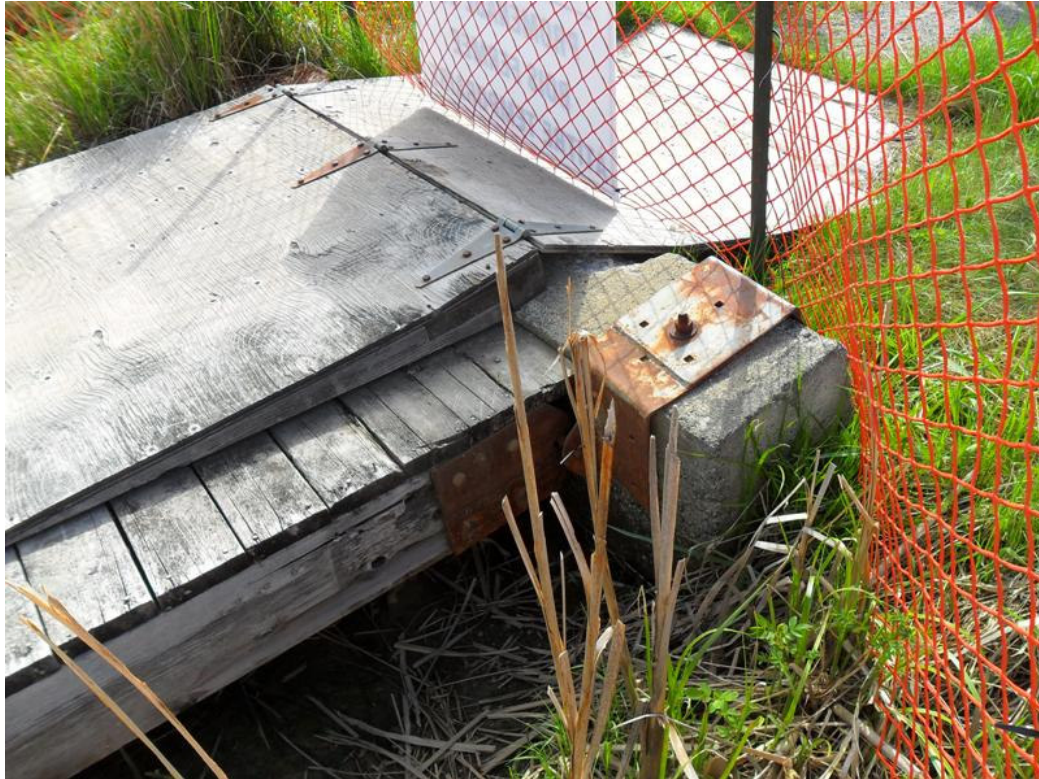
The City has previously placed a temporary ramp over the concrete abutment at the entrance to the boardwalk, presumably to mitigate a tripping hazard that has resulted from a step at the abutment. In spite of the temporary ramp, the tripping hazard remains. It appears the concrete abutment has shifted over the years such that it is tipping towards the wetland (see Photo 9).

Photo 9 – Start of boardwalk and connection to abutment.

In addition, the arrangement at the boardwalk entrance should be revised to eliminate the tripping hazard so as to safely accommodate pedestrian traffic. We recommend replacing the

wooden deck braces and metal connections on the wetland side of the concrete abutment. Also, the grading on the other side of the abutment should be raised with granular material and landscaped properly with topsoil and seed.

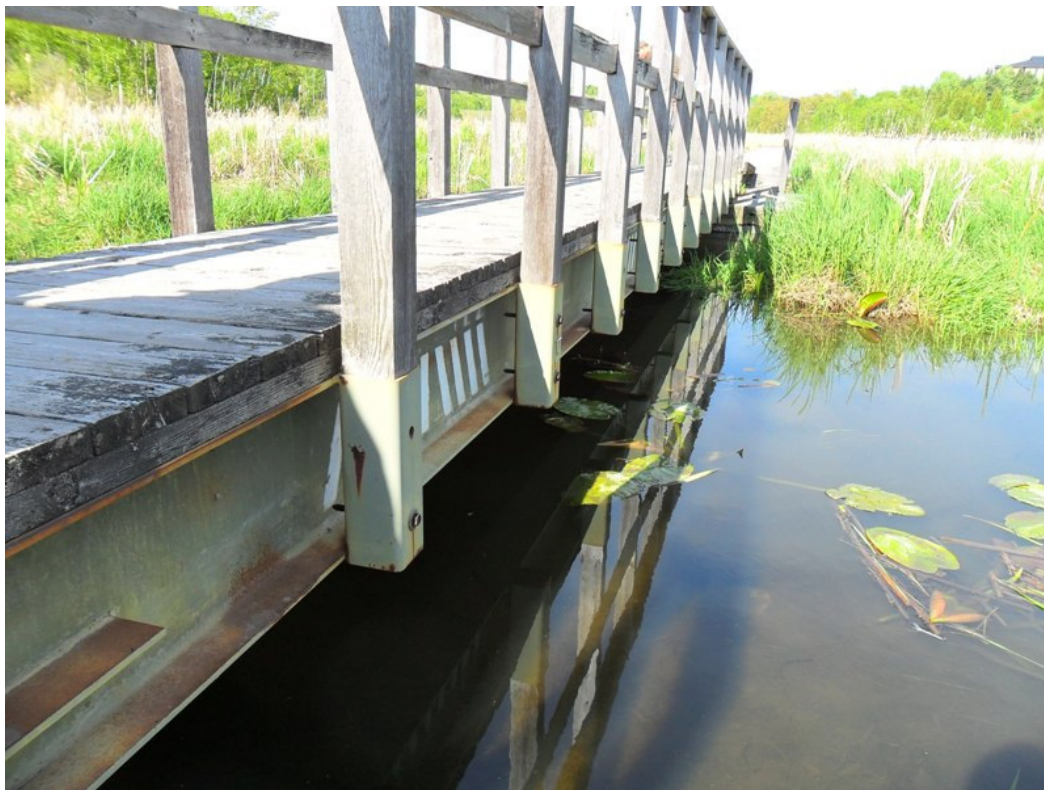
A structural steel pedestrian bridge spans over the principal creek channel, roughly mid-way along the boardwalk. The cedar decking and handrail of this bridge appeared to be in fair condition, and exhibited the same general weathering as was observed on the boardwalk surface elsewhere. We also observed mild corrosion of the structural steel components of the bridge that were visible from the side (see Photo 10).

Photo 10 – Pedestrian bridge.
