Operations Committee

Monday, March 5th, 2012

Pedestrian Crossing Policy and Recommendations

Pedestrian Traffic Study Crossing Review

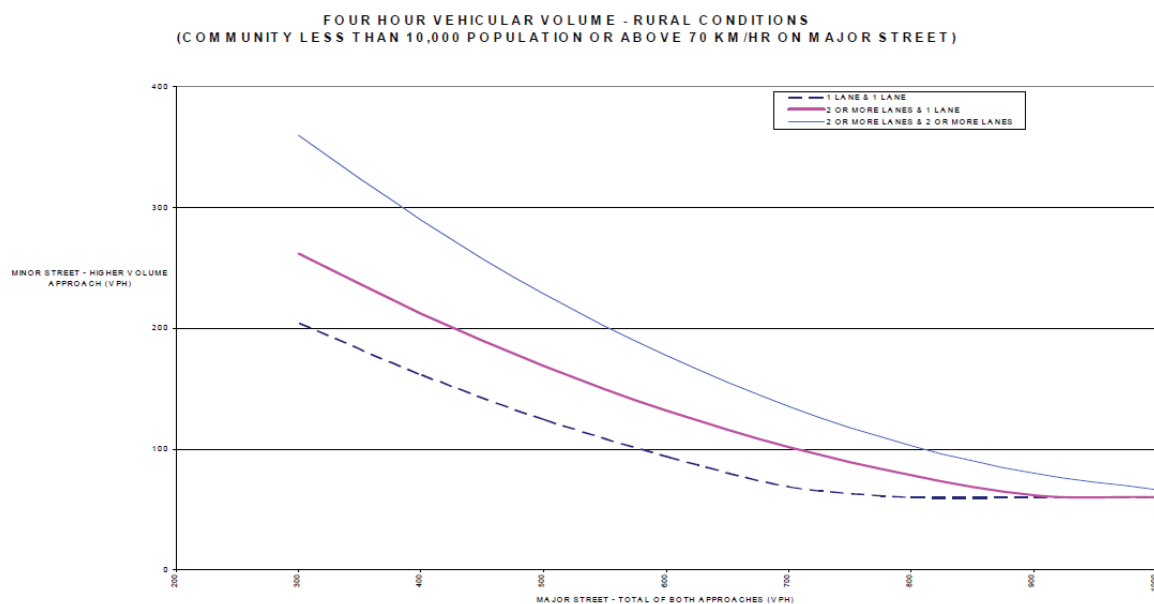
Figure 1: Justification 4 – Minimum Four Hour Justification, Unrestricted Flow

(Source: Figure 19, OTM Book 12, February 2007)

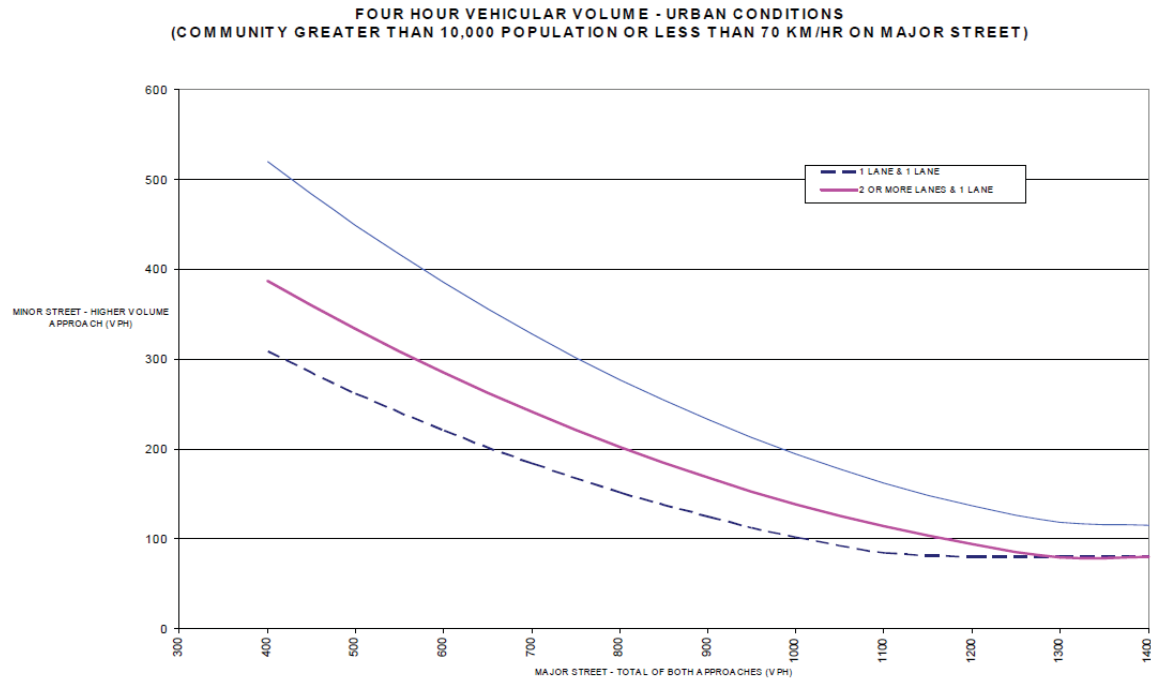
Figure 2: Justification 4 – Minimum Four Hour Justification, Restricted Flow
(Source: Figure 20, OTM Book 12, February 2007)

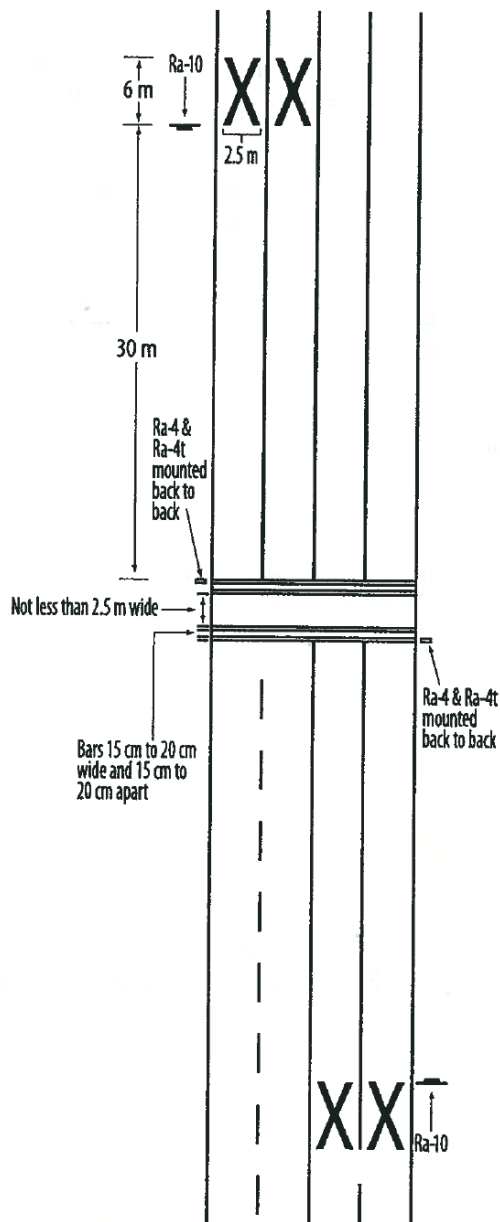
- Type 1 PXO is intended to serve pedestrian traffic crossing roadways with 60 km/h or less posted speed limits and AADT's less than 35,000
- The PXO is not within 200 metres of other signal-protected pedestrian crossings
- There are not more than four lanes of two-way traffic or three lanes of one-way traffic
- Parking and other sight obstructions are prohibited within at least 30 metres of the crossing, and
- If at an intersection, side street vehicular traffic does not meet one of the other justifications (1 through 5) under which full traffic control signals may be installed.

Figure 4: Type 1 Pedestrian Crossover

(Source: Figure 11 - OTM Book 15, December 2010)

A Type 1 Pedestrian Crossover is illustrated in **Figure 4**.

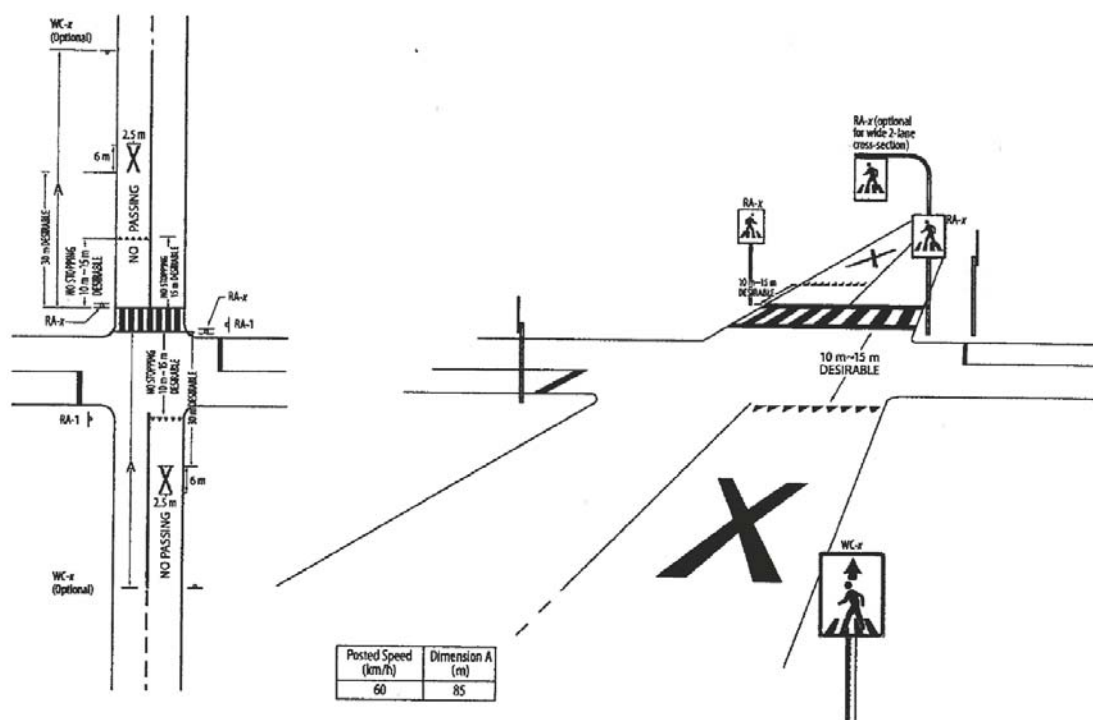
- Maximum of two lanes of traffic
- Sufficient stopping sight distance, 100 metres and 120 metres sight distance required for operating speeds of 50 km/h and 60 km/h respectively
- Sufficient distance to alternate crossings, offering equal or higher level of control (a minimum spacing of 200 metres from an adjacent traffic signal is recommended),
- Grades of less than eight percent, and
- Consistent level of pedestrian activity, typically greater than 10 to 20 pedestrians per hour.

Figure 5: Type 2 Pedestrian Crossover

(Source: Figure 13 – OTM Book 15, December 2010)

An example of a Type 2 Pedestrian Crossover and its supporting elements are illustrated in **Figure 5**.

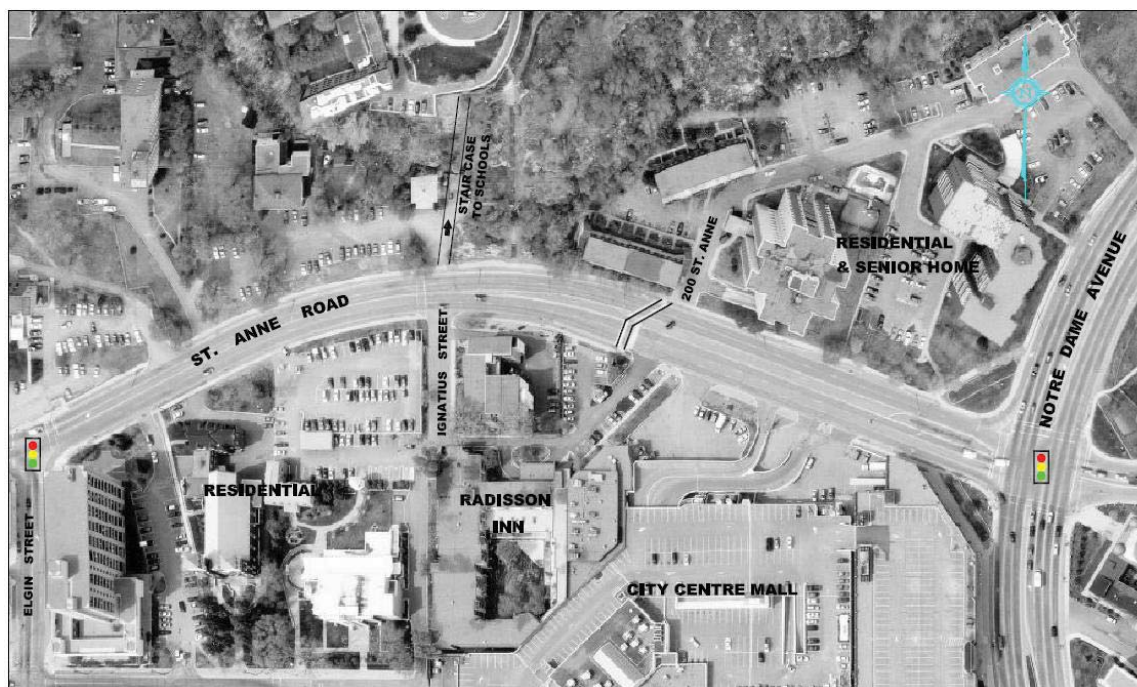
Exhibit 5: Ste. Anne Road Crossing

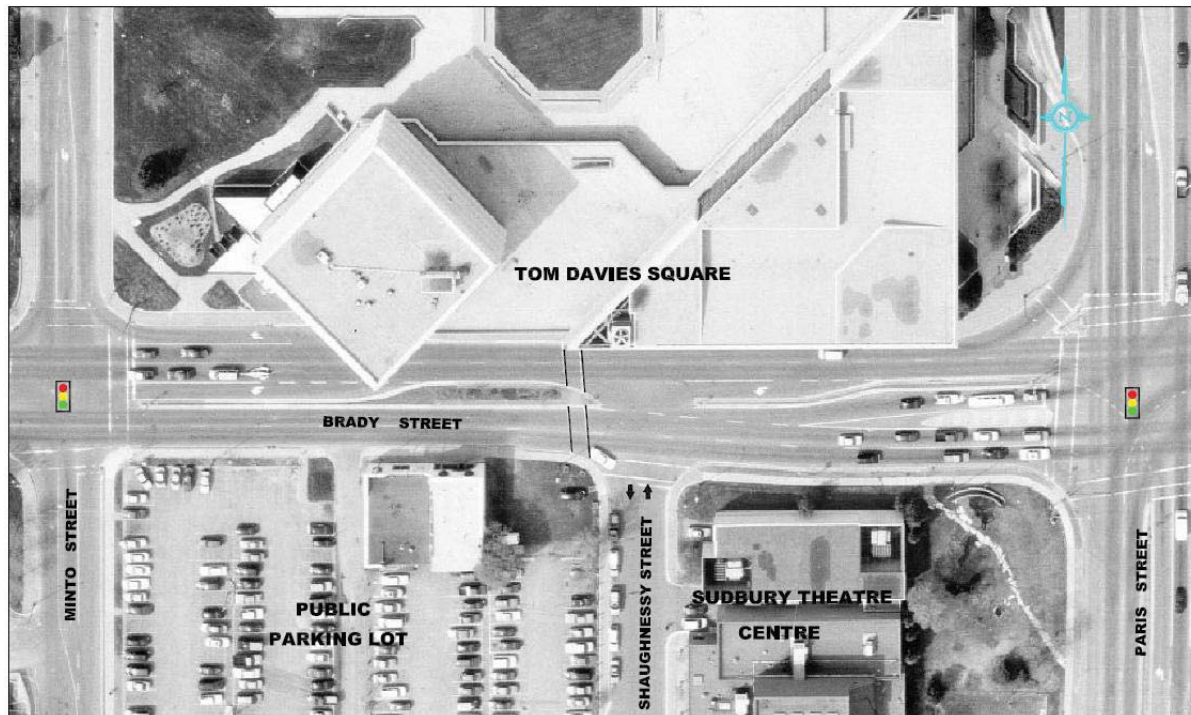
Exhibit 9: Brady Street Crossing
