## Pothole Study - Patching Methods and the All-In-One Pothole Patching Machine Update

Presented To:	Operations Committee
Meeting Date:	December 11, 2023
Type:	Correspondence for Information Only
Prepared by:	Tony De Silva Linear Infrastructure Services
Recommended by:	General Manager of Growth and Infrastructure

This report provides information regarding the final phase of the pothole study and the utilization of the All-In-One Pothole patching machine.

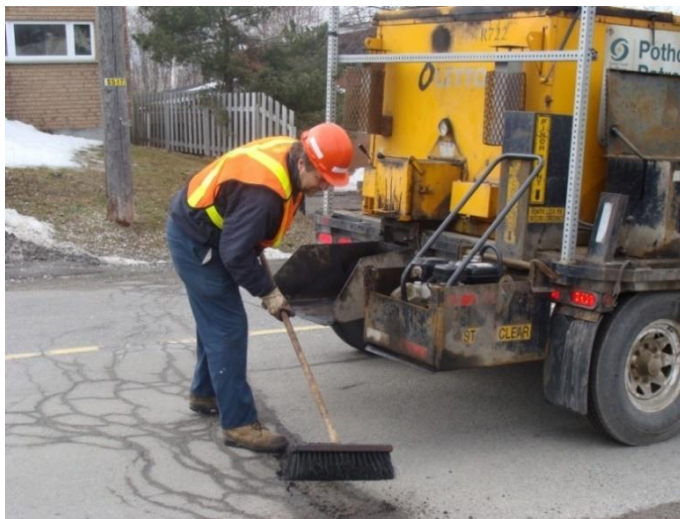
Figure 2a – Clean Pothole with Broom

The “Clean and Tamp” method typically involves a three to five-person crew using a heated material transportation device (more commonly known as a hot box) or flatbed truck to transport patching material from a maintenance depot to a road where potholes need patching. Using a broom, the crew will first sweep away loose particles then fill the pothole with patching material and compact it with either a plate tamper or hand tamper. Depending on the size of the pothole, it may take anywhere from one to five minutes to complete a patch using this method.

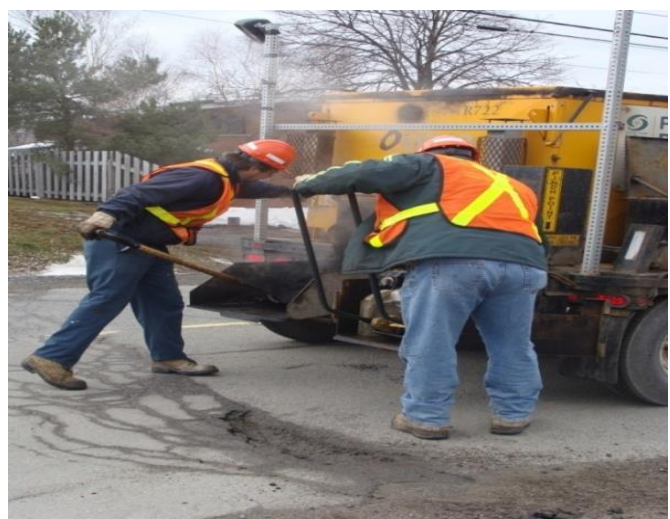
Figure 2b – Unload Patching Material from Hot Box

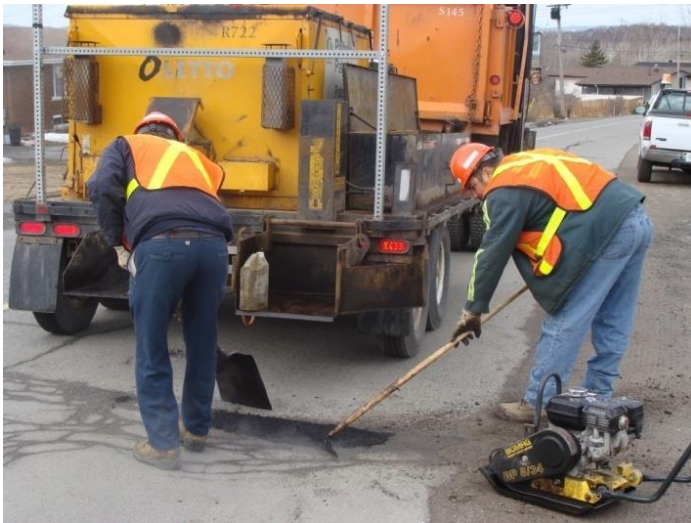
Figure 2c – Place and Shape Material

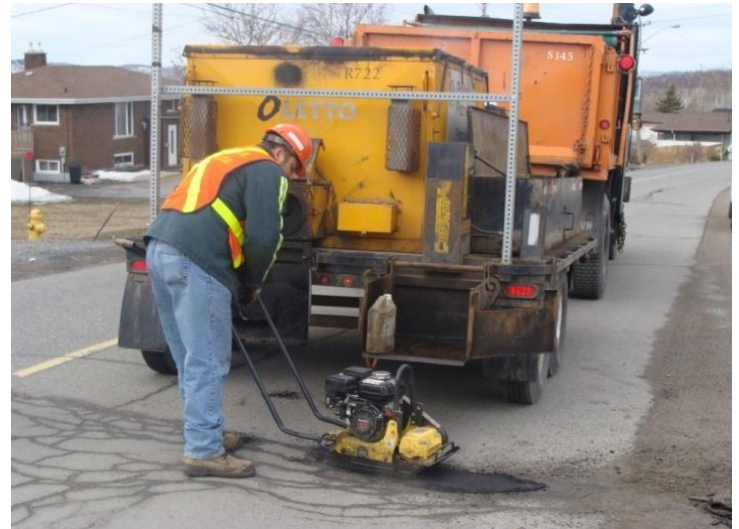
2d – Compact Material

This is the most common patching method utilized in Greater Sudbury. Cleaning the pothole prior to placing and compacting patching material maximizes the bond between the pothole and the patching material which leads to greater longevity of the patch. However, this technique is most suitable when conditions are dry.

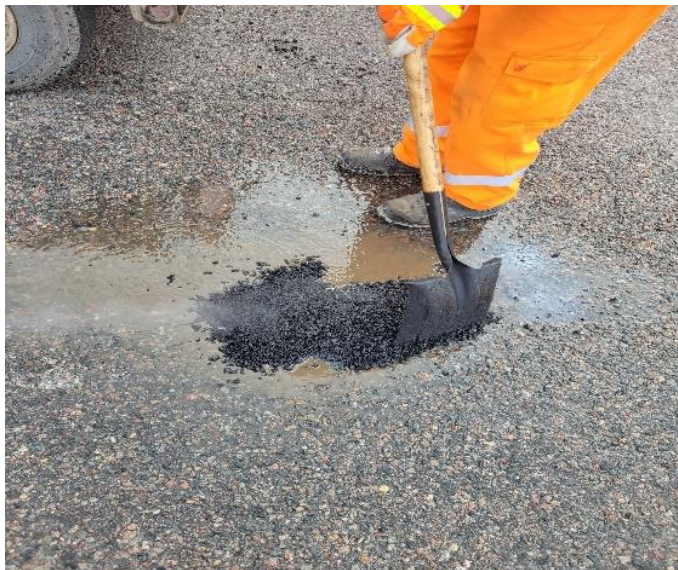
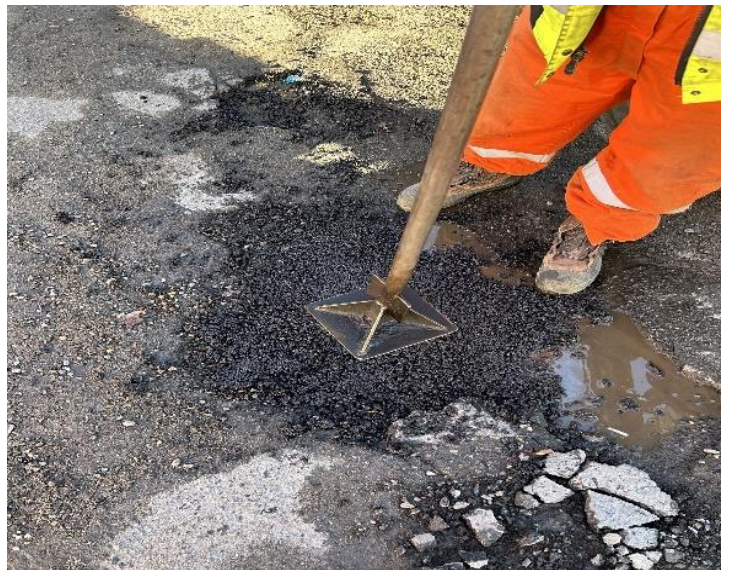
Figure 3a – Patching in a Wet Environments

Figure 3b – Patching in a Wet Environments

The “Throw and Tamp” method typically involves a three to five-person crew using a hot box or flatbed truck to transport patching material from a maintenance depot to a road where potholes need patching. The crew will fill the potholes with patching material and compact it with a plate tamper or hand tamper (used if plate tamper is not available or for small patches). Depending on the size of the pothole, it may take anywhere from one to five minutes to complete a patch using this method.

This method is typically utilized when the road is wet and where adequate cleaning of a pothole is not possible (ex. difficult to keep water and debris away from potholes). Rather, water is displaced by applying patching material to the pothole. Not cleaning a pothole reduces the bond between the pothole and patching material, which reduces the longevity of the patch. Although it is clearly less effective than the “Clean and Tamp” method, its utilization is sometimes necessary to meet the MMS and maintain safe motor vehicle passage during inclement weather conditions (ex. snow, rain and ponding).

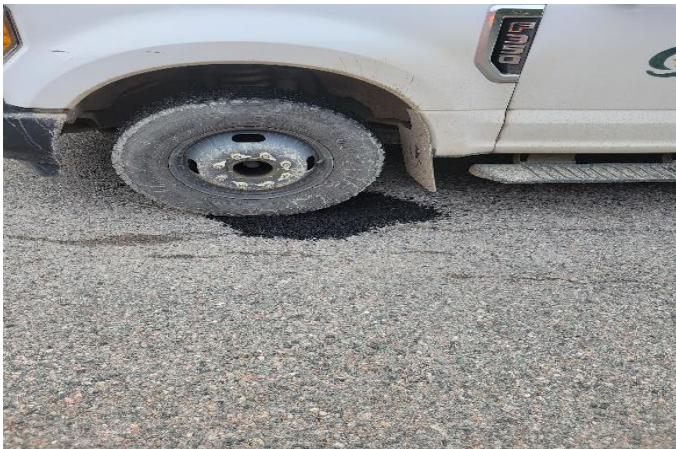
Figure 4a – Throw and Roll Patching

The “Throw and Roll” method (sometimes referred to as “Throw and Go”) typically involves a three to five-person crew using a hot box or flatbed truck to transport patching material from a maintenance depot to a road where potholes need patching. The crew will fill the potholes with patching material, level / shape it with a shovel and use the tires of the transport vehicle to compact the material rather than using a plate or hand tamping device. The method also partially relies on vehicular traffic to provide some of the compaction effort. Because truck tires do not apply adequate / uniform compaction to patches, partial failure of patches commence relatively quickly. Therefore, patch longevity is typically minimal with this method, especially in a wet environment with multiple freeze / thaw cycles. For these reasons, the City rarely utilizes this method for pothole patching. However, this method has been used with moderate success in areas where favourable weather conditions are common and when treating small potholes.

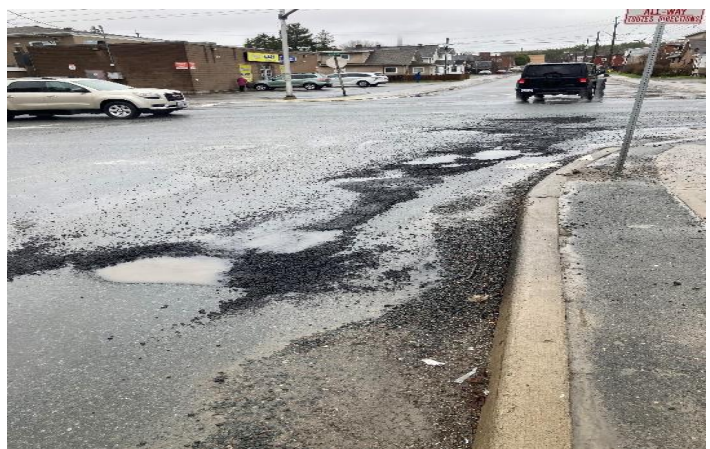
Figure 4b – Partial Failure of Patches

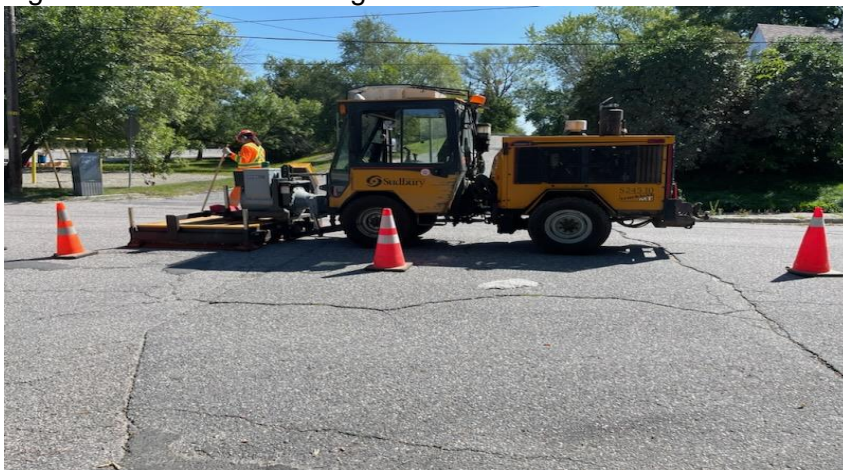
Figure 5 – Infrared Patching in Summer

Infrared Patching typically involves a three-person crew utilizing an infrared attachment on a municipal tractor to heat a small section (ex. 4 feet x 6 feet) of damaged pavement such that the pavement material becomes malleable. Additional material is added (as necessary) to the malleable pavement, spread and compacted with a plate tamper or asphalt roller to complete the patch. Although deemed to be effective for pothole patching, this method is extremely time and energy consuming. A typical patch requires more than 30 minutes depending on the size of pothole and ambient temperature. Therefore, the City does not utilize this method for winter pothole patching. Rather, this method is used in the summer months to repair pavement damage surrounding maintenance holes and catch basins.

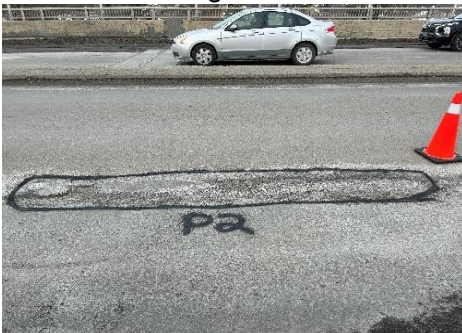
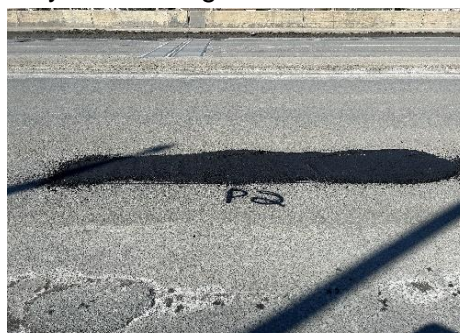
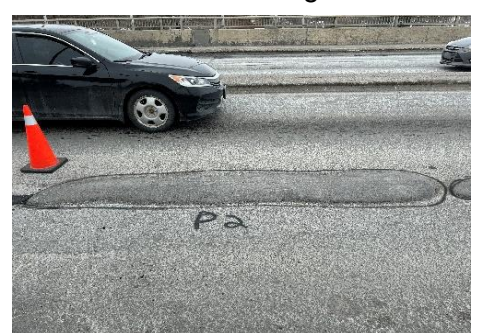
Figure 7 – Patching with the APPM

Prior to Patching

Day of Patching

2 Weeks after Patching

At the conclusion of the two-week observation period, all three patching techniques utilized resulted in less than 30% of the patching material being lost. The deterioration was largely found along the edges of the patches where bonding is expectedly minimal (difficult to compact new malleable material against existing hard pavement). As shown in Table 3 below, the APPM had the least amount of material loss with the manual labour crew using a plate tamper and hand tamper having increased amounts of material loss.

Patching Method	Performance Description	Percent of Material Loss
APPM	Very slight material loss at edges	10%
Manual Crew with Plate Tamper	Slight material loss at edges	15%
Manual Crew with Hand Tamper	Moderate material loss at edges	30%

Throughout the observation period, patch deterioration was deemed to be gradual. Assuming that patches have to be repaired once a material loss of 30% has been reached, through linear interpolation of the results, patch longevity the APPM, manual crew with a plate tamper and hand tamper would have lasted for six weeks, four weeks and two weeks respectively. Therefore, APPM patches were deemed to have a longevity of 1/3 (33%) more than the most effective manual patching methodology used in the study.

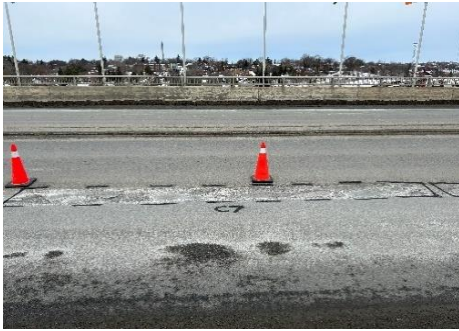
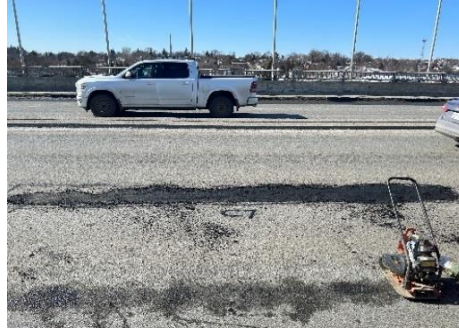
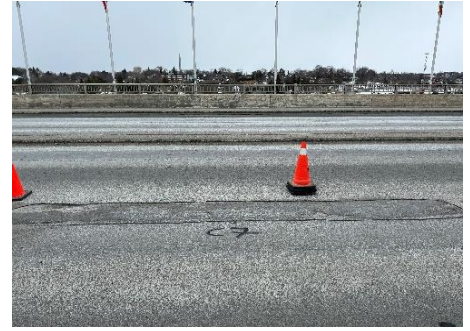
Figure 8 – Manual Labour Crew Patching with Plate Tamper

Prior to Patching

Day of Patching

2 Weeks after Patching

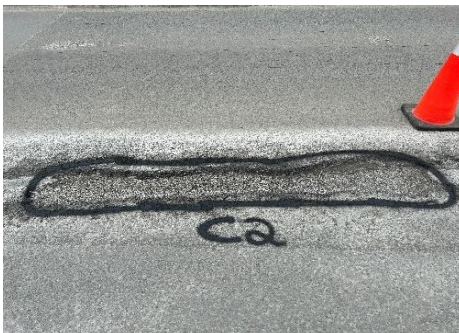
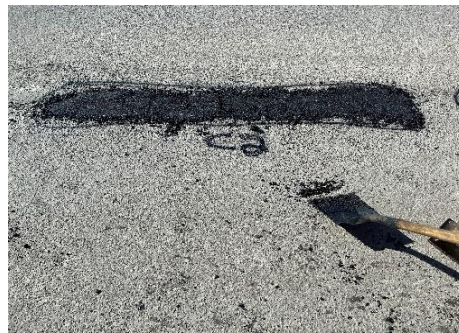
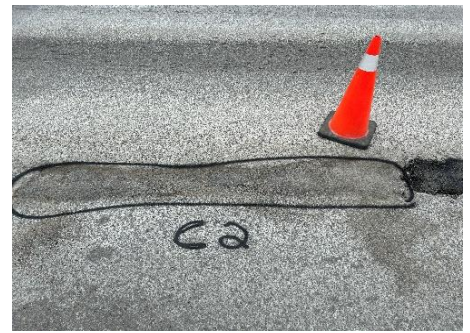
Figure 9 – Manual Labour Crew Patching with Hand Tamper

Prior to Patching

Day of Patching

2 Weeks after Patching

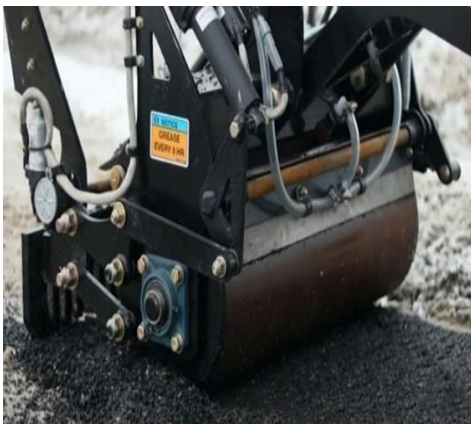
Figure 10a – APPM Roller

Given that all patches within the test strip were subject to the same general conditions (ex. same patching material used under the same weather and traffic conditions), it is concluded that the only variable with the application of patching material was the compaction effort. Greater compaction resulted in greater longevity of patches. The APPM provided the greatest compaction (weight of the machine's frontend applied to patch), followed by the manual crew using a plate tamper (approx. weight of 120 pounds / 55 Kg applied to patch) and hand tamper (approx. weight of 16 pounds / 7 Kg applied to patch), respectively. The compaction methods used are depicted in Figure 10.

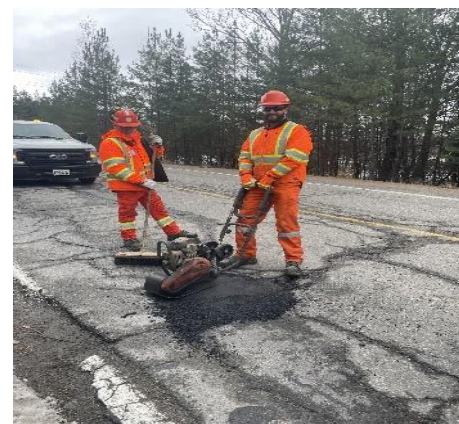
Figure 10b – Plate Tamper

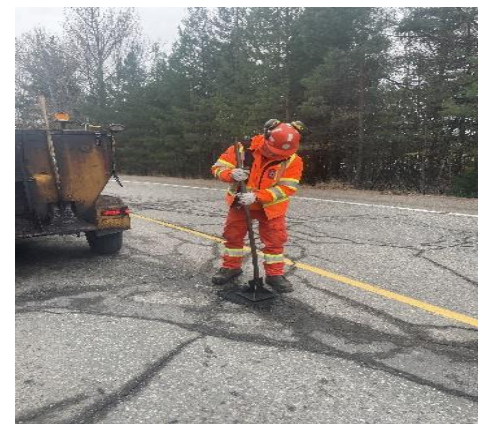
Figure 10c – Hand Tamper

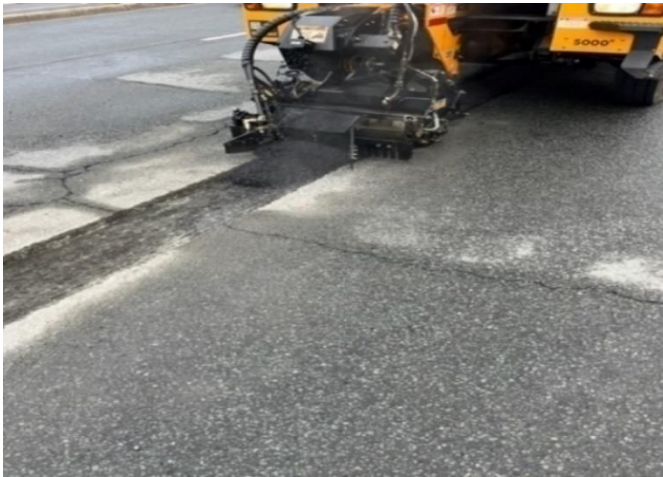
Figure 11a – Paving behind “Small Grinder” Crew

The APPM was utilized on all maintenance road classifications throughout the summer months. An objective of summer operations was to determine how to maximize the units' utilization. In addition to its standard pothole patching operation, trials were conducted to use the APPM with a small grinder crew, conduct shoulder edging and asphalt overlays. Some of these alternate applications are depicted below.

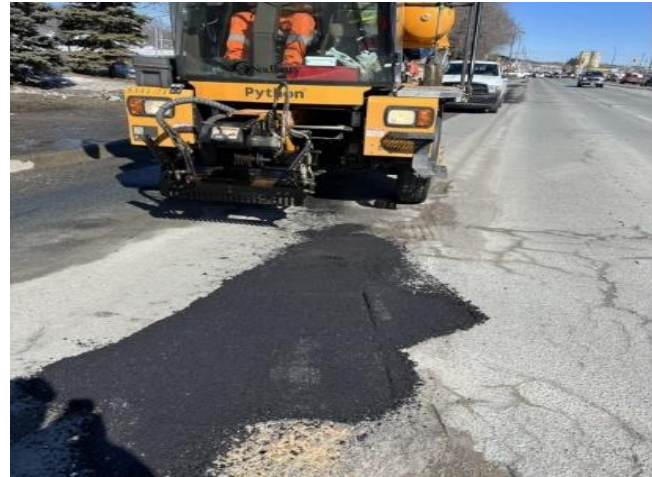
Figure 11b – Asphalt Overlay
