## Geotechnical Investigation and Design Report

Proposed Re-Zoning of 1876 and 1890 Bancroft Drive  
Sudbury, Ontario

SUD-21017389-A0

2021-09-28

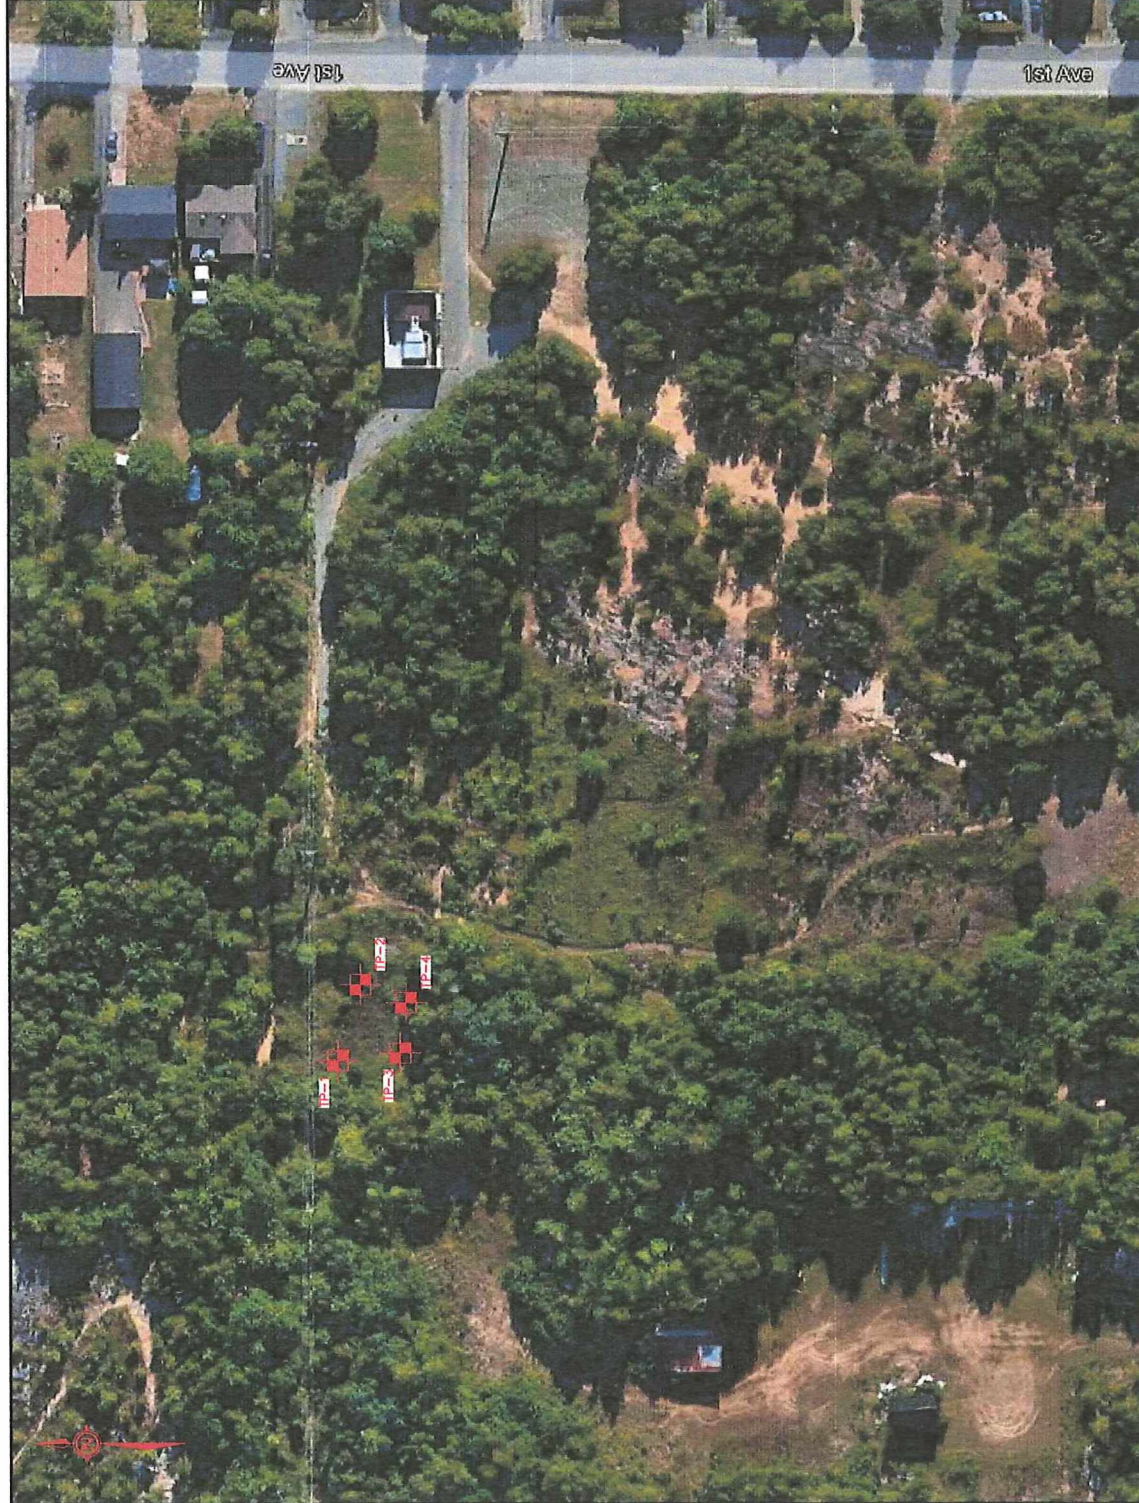
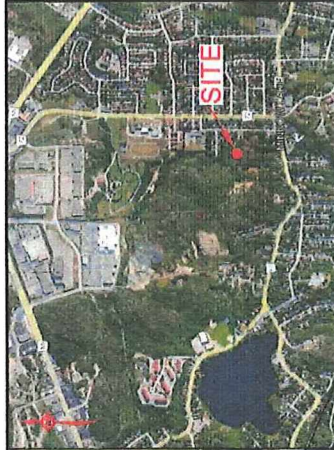
TITLE		TEST PIT LOCATION PLAN	
DATE	SCALE	DATE	DWG. NO.
SEPT 2021	NTS		A-1

The field investigation for this project consisted of the advancement of four (4) sampled test pits at the sites, at accessible locations within the areas identified as potential wetland. The test pits were completed on September 15, 2021 at the locations shown on Dwg. No. A-1 included in Appendix A.

The test pit locations and elevations were surveyed in the field using a handheld GPS. The locations and elevations should be considered accurate only to the degree implied by the method used.

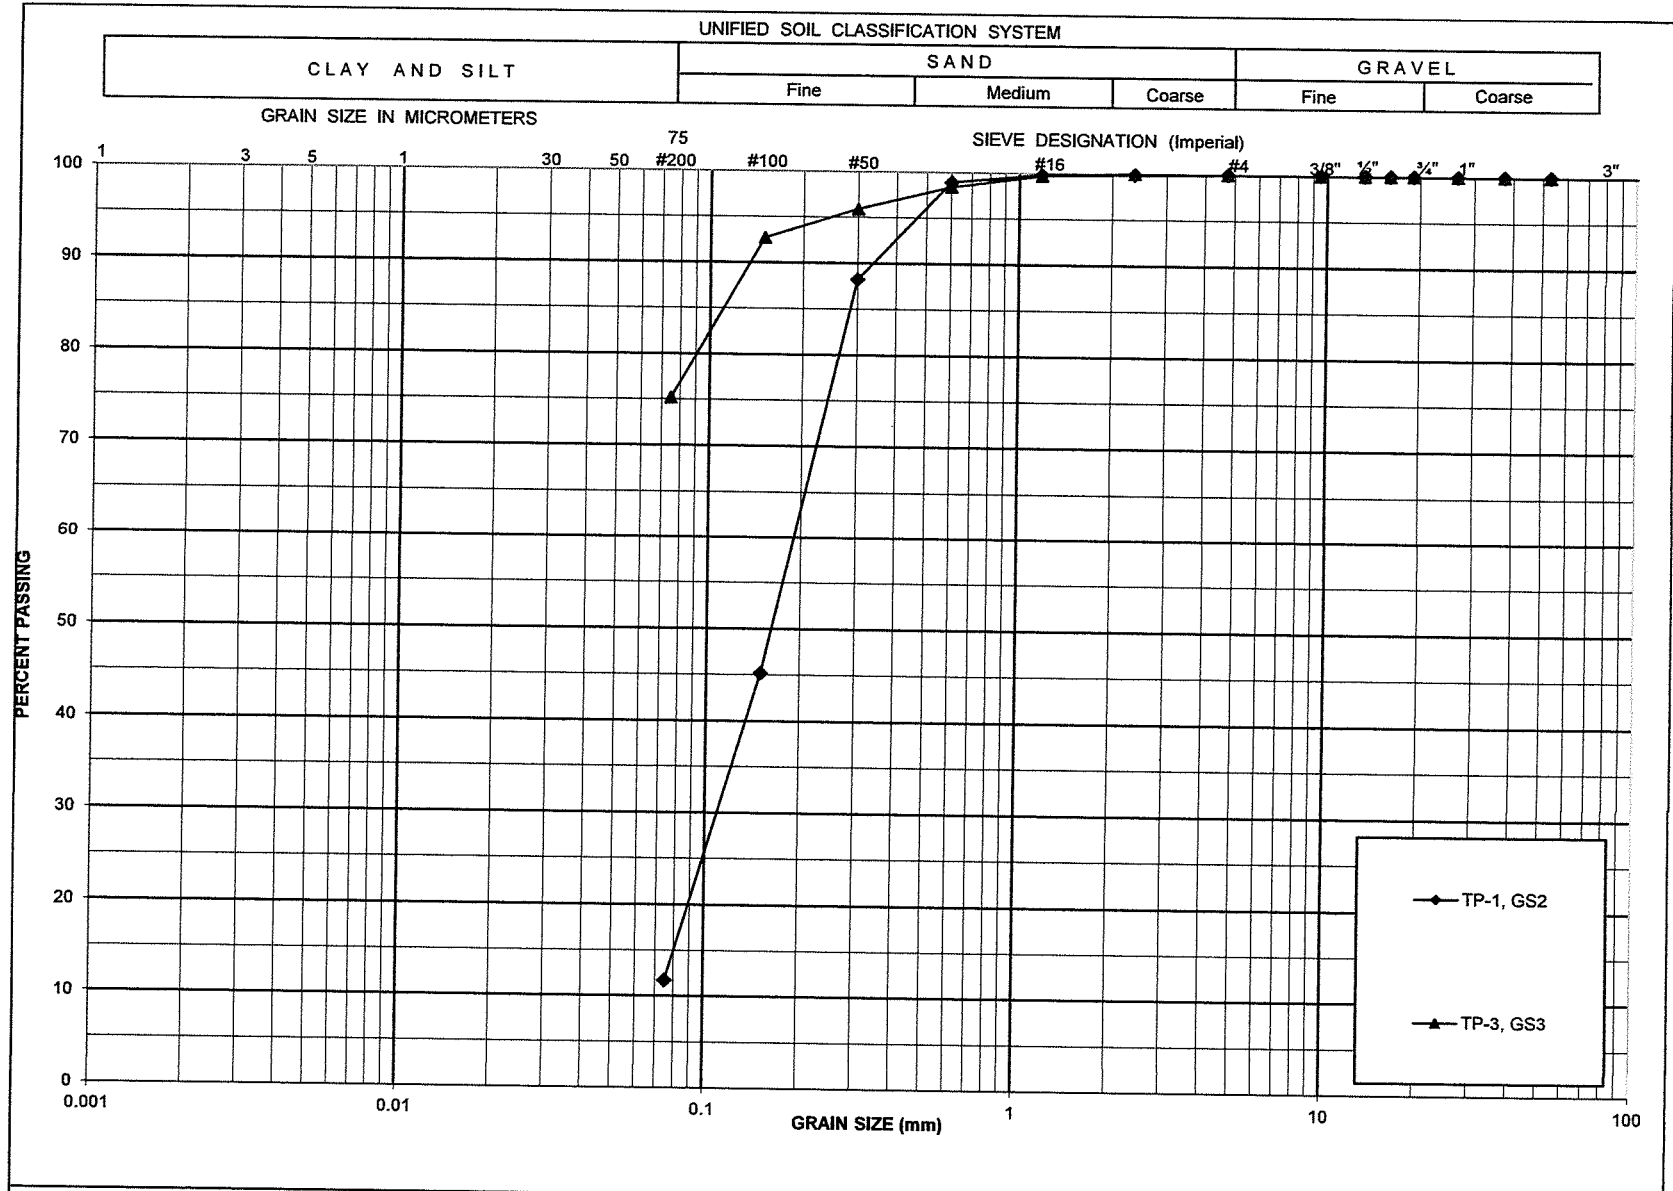
FIGURE: C-1  
 PROJECT No.: SUD-21017389-A0  
 DATE: September 2021

A geotechnical laboratory testing program was performed on representative soil samples and consisted of moisture content tests and grain size analyses. The laboratory test results are summarized on the test pit logs in Appendix B, with detailed results included in Appendix C.

**GRAIN SIZE DISTRIBUTION**  
*Proposed Re-Zoning of 1876 and 1890 Bancroft Dr.*  
*Sudbury, Ontario*

Underlying the topsoil/organics was native sand. The sand extended to 0.6 to 2.0 m depth. At Test Pit TP-2, the sand extended to the test pit termination depth of 2.0 m. The sand was brown to grey in colour, moist, and contained trace to some silt and trace to some organics. Measured moisture contents within the sand ranged from 17.5 to 69.9%.

Underlying the sand at TP-1, TP-3, and TP-4 was native sandy silt that extended to the test pit termination depths of 1.5 to 3.0 m. The sandy silt was brown to grey in colour, and moist to wet. Measured moisture contents within the sandy silt ranged from 27.1 to 36.0%.
