Traffic Study – Intersection of Second Avenue and Concession Street

Presented To:	Operations Committee
Meeting Date:	August 12, 2024
Type:	Correspondence for Information Only
Prepared by:	Mofor Augustine Linear Infrastructure Services
Recommended by:	General Manager of Growth and Infrastructure

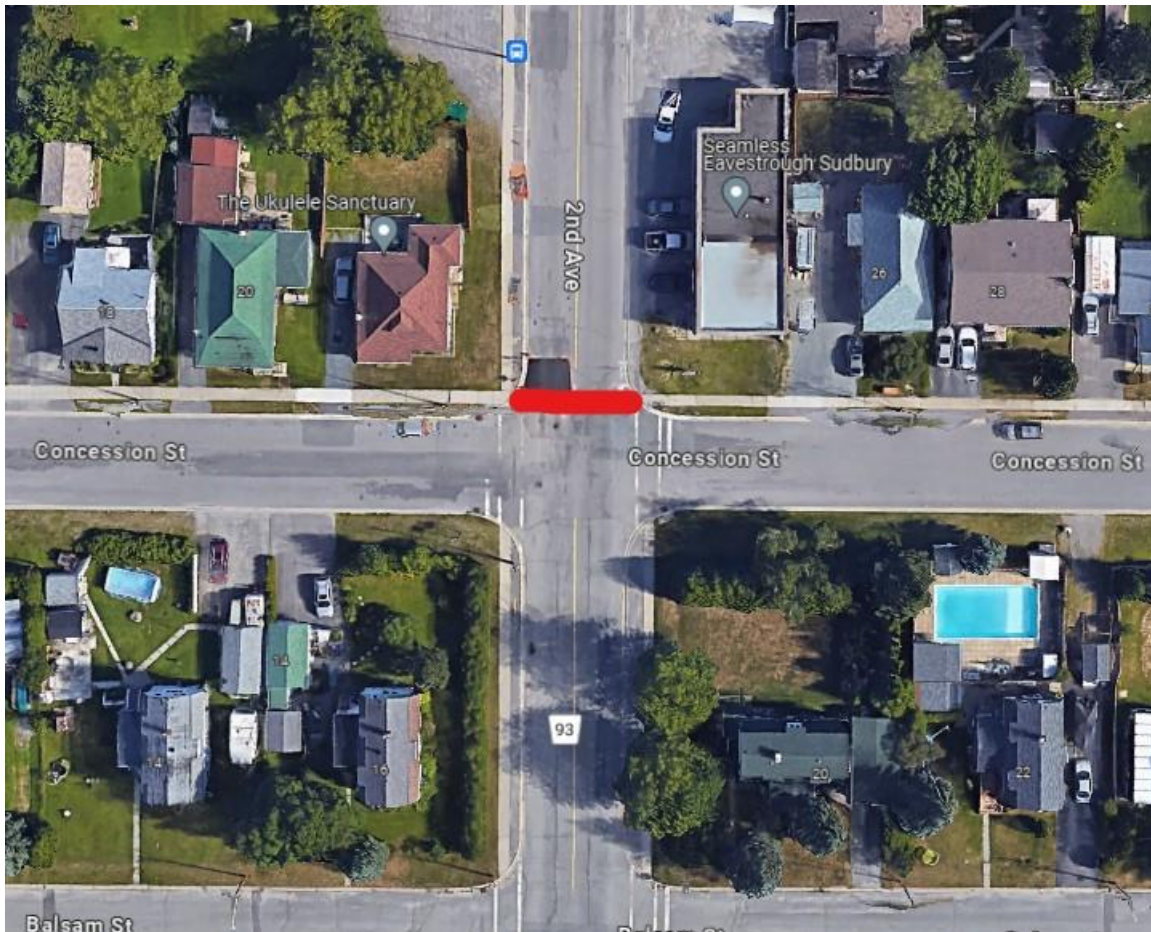
Figure 1 – Satellite View

intersection which makes Concession Street a popular walking route for school aged children. Currently a school crossing guard connects the north side sidewalk on Concession Street across Second Avenue. Figure 1 & 2 show the intersection and school crossing guard location in satellite view and street view, respectively.
