Request for Decision

Pedestrian Crossing Policy and Recommendations

Pedestrian Traffic Study Crossing Review

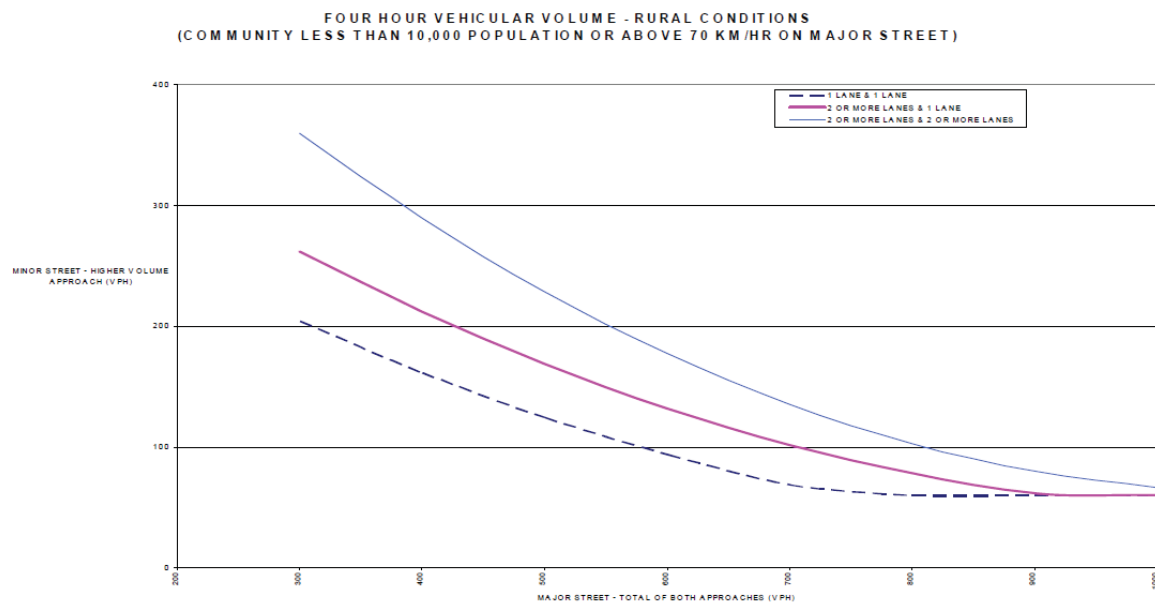
Figure 1: Justification 4 – Minimum Four Hour Justification, Unrestricted Flow

(Source: Figure 19, OTM Book 12, February 2007)

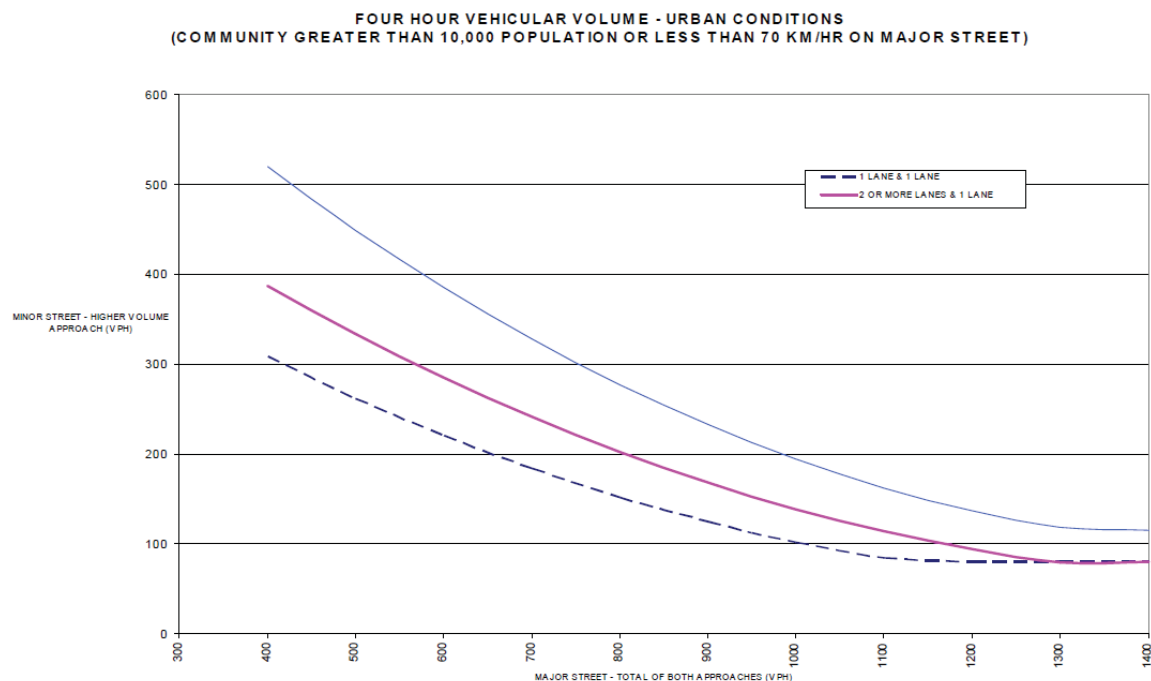
Figure 2: Justification 4 – Minimum Four Hour Justification, Restricted Flow
(Source: Figure 20, OTM Book 12, February 2007)

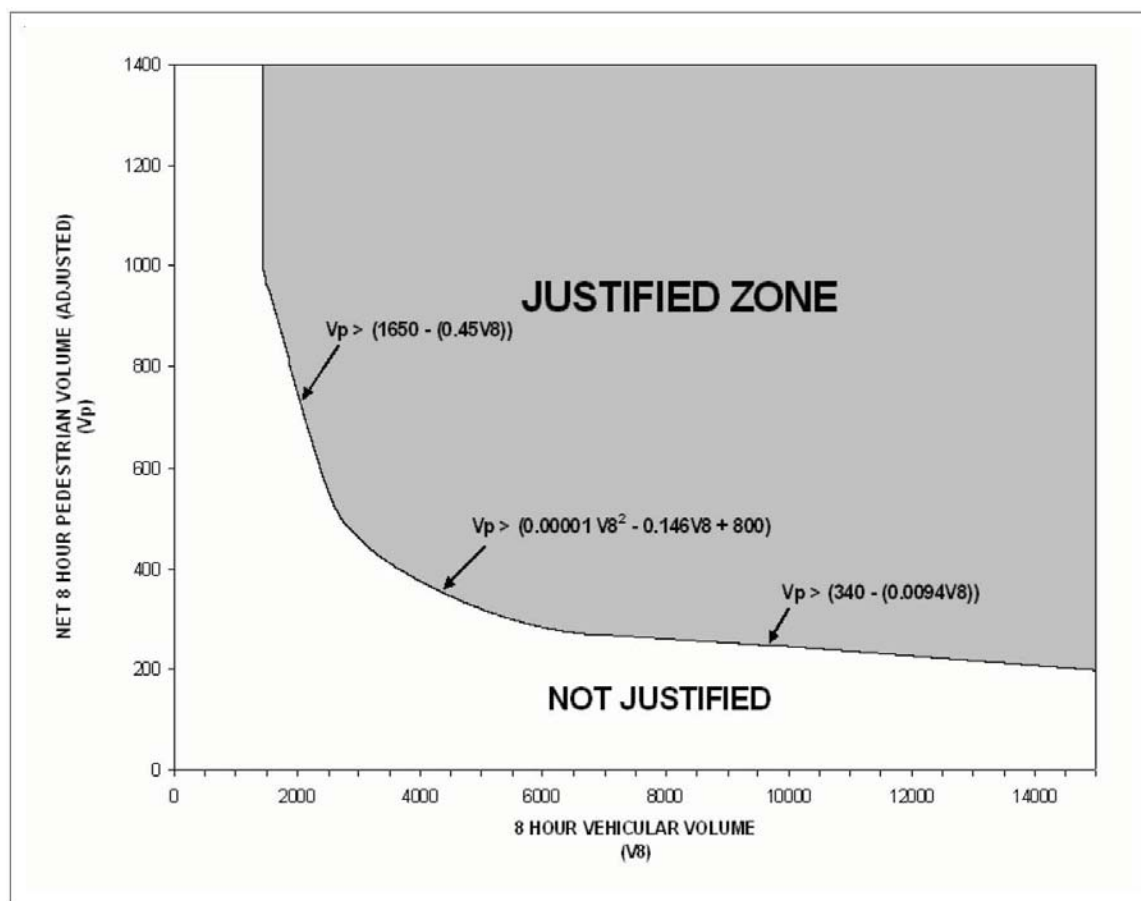
Figure 3: 8 Hour Pedestrian Crossing Warrants

(Source: OTM Book 12, Figure 21 – Justification 6 – Pedestrian Volume)

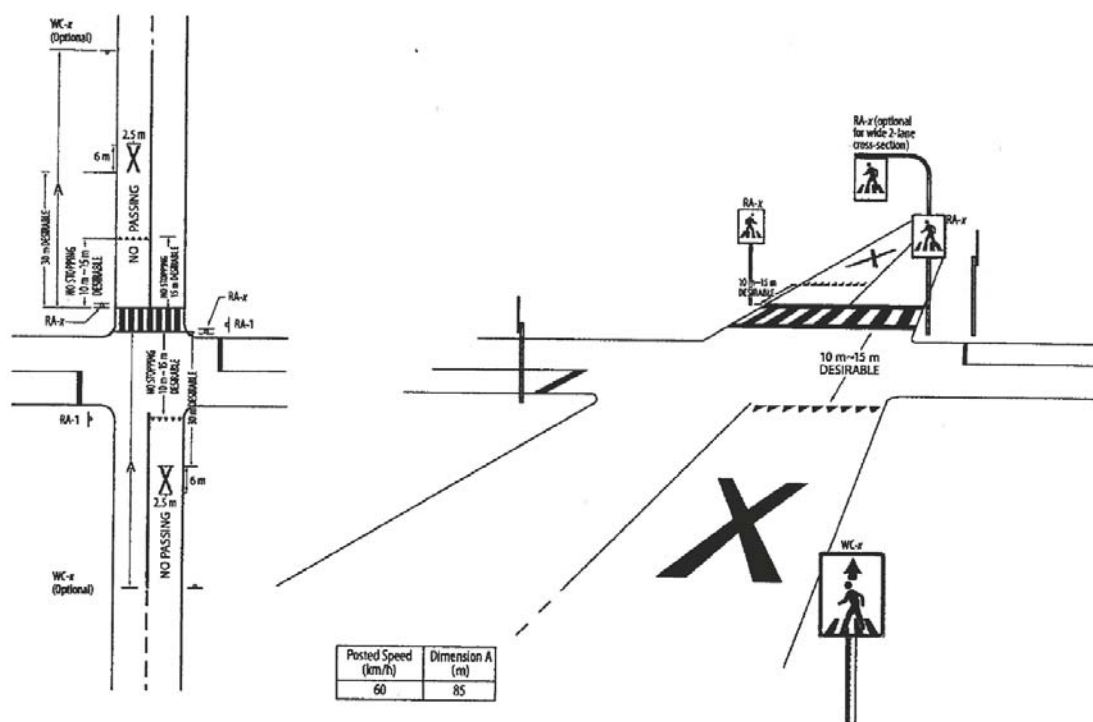
An example of a Type 2 Pedestrian Crossover and its supporting elements are illustrated in **Figure 5**.

Figure 5: Type 2 Pedestrian Crossover

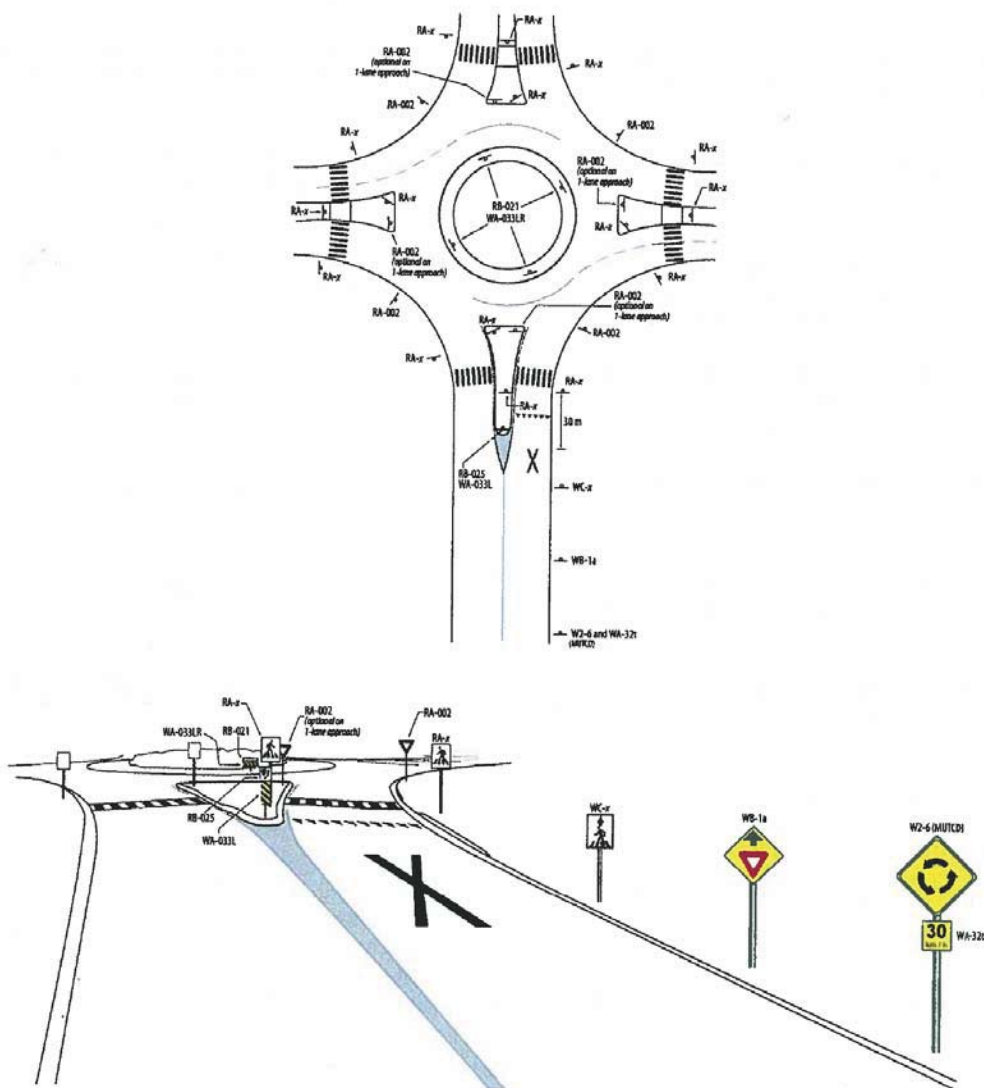
An example of a roundabout with a pedestrian crossing the recommended signage, as per OTM Book 15, is illustrated in **Figure 6**.

Figure 6: Example of a Roundabout with a Pedestrian Crossing and Recommended Signage

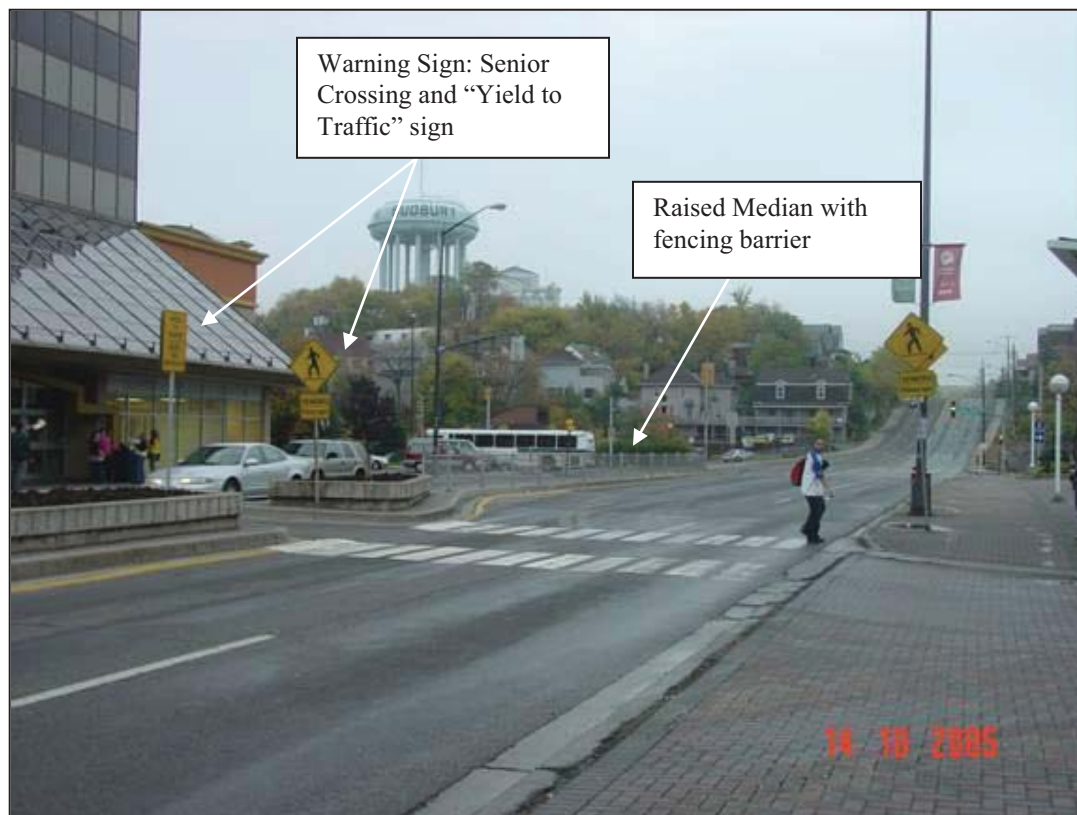
A raised median extends approximately 90 metres westerly from Notre Dame Avenue-Paris Street to the Mall entrance driveway with a 3-metre cut-out for the mid-block crossing. Fencing barrier is installed on portion of the median close to the Elm Street / Notre Dame Avenue – Paris Street intersection and the remaining portion has planters constructed. See **Exhibit 3**.

Exhibit 3: Raised Median Extending from Elm Street / Notre Dame Avenue – Paris Street Intersection

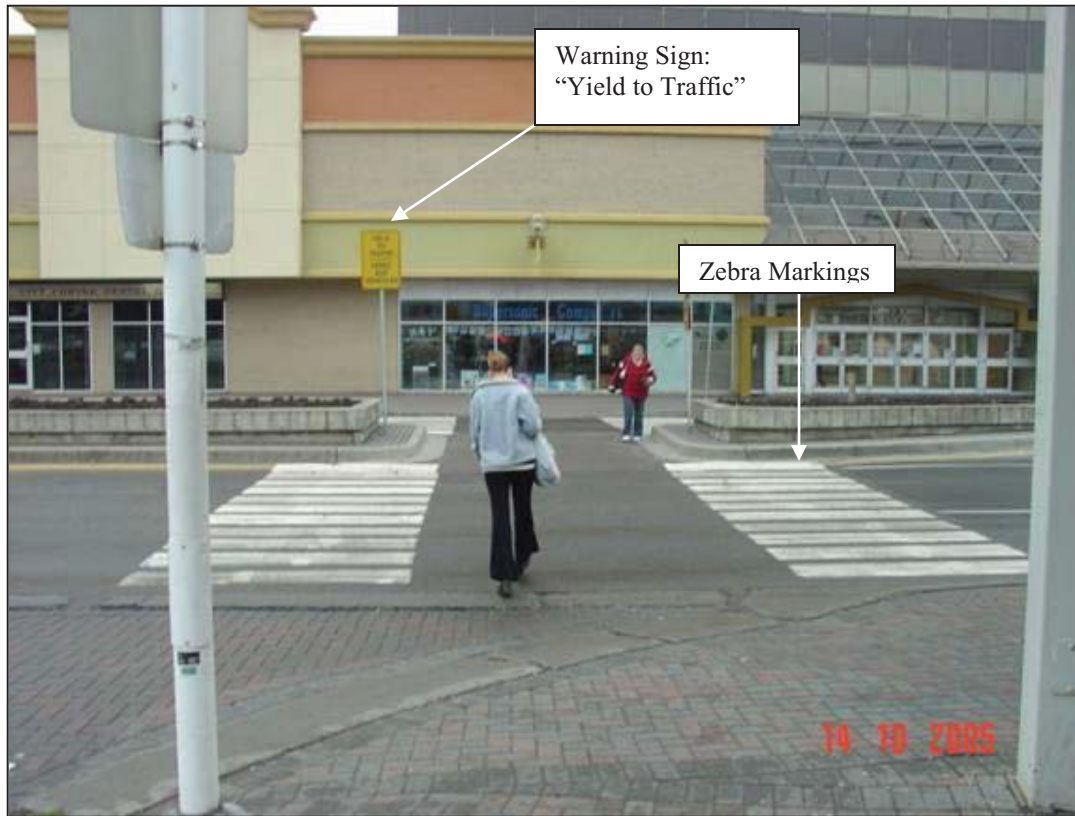
There are curb depressions at both ends of the crosswalk. The crosswalk lines are identified through zebra markings. The crossing is signed with “Seniors Crossing” warning signs. There are two signs facing each direction of traffic. There are also “Yield to Traffic” warning signs facing each curb side directed at pedestrians. See **Exhibit 3** and **Exhibit 4**.

Exhibit 4: Elm Street Crossing

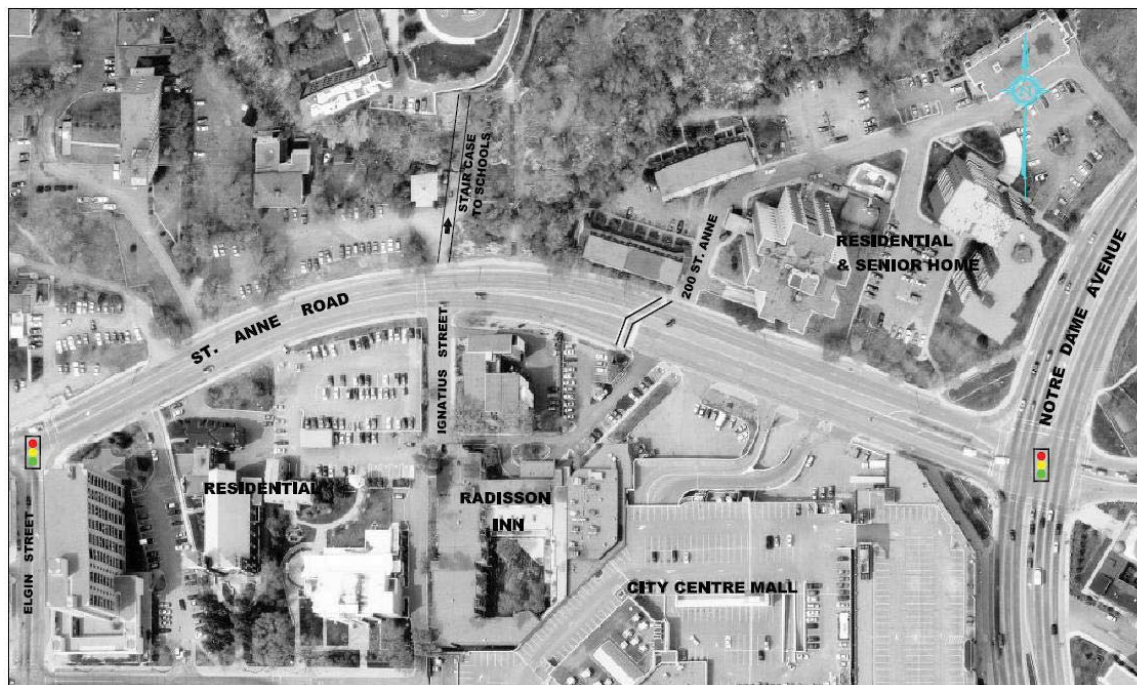
Exhibit 5: Ste. Anne Road Crossing

The original scope of this study included an assessment of the formerly unprotected pedestrian crossing across Ste. Anne Road at 200 Ste. Anne Street, between Notre Dame Avenue and Ignatius Street. This crossing has since been converted into a signalized intersection on Ste. Anne Road at 200 Ste. Anne and the access to the Radisson Inn, as per the recommendation in this report. The following subsections provide a description of the former crossing and issues, which led to the recommendation to signalize the intersection.

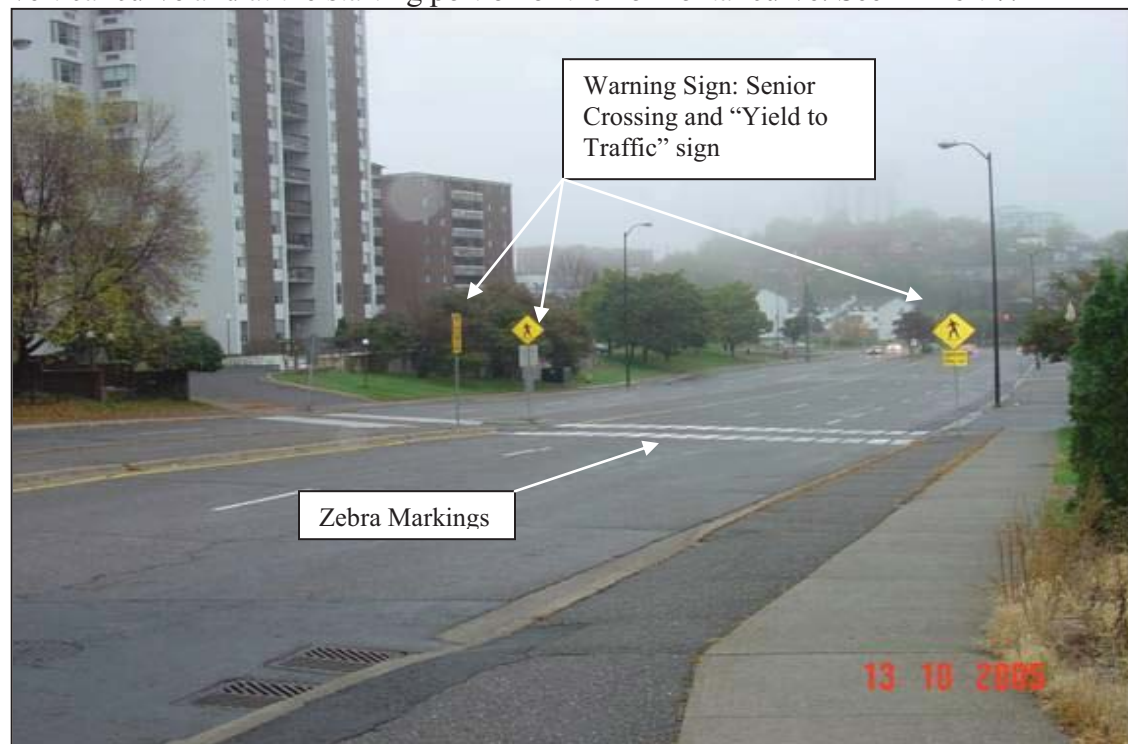
Exhibit 6: Former Ste. Anne Road Crossing Facing East

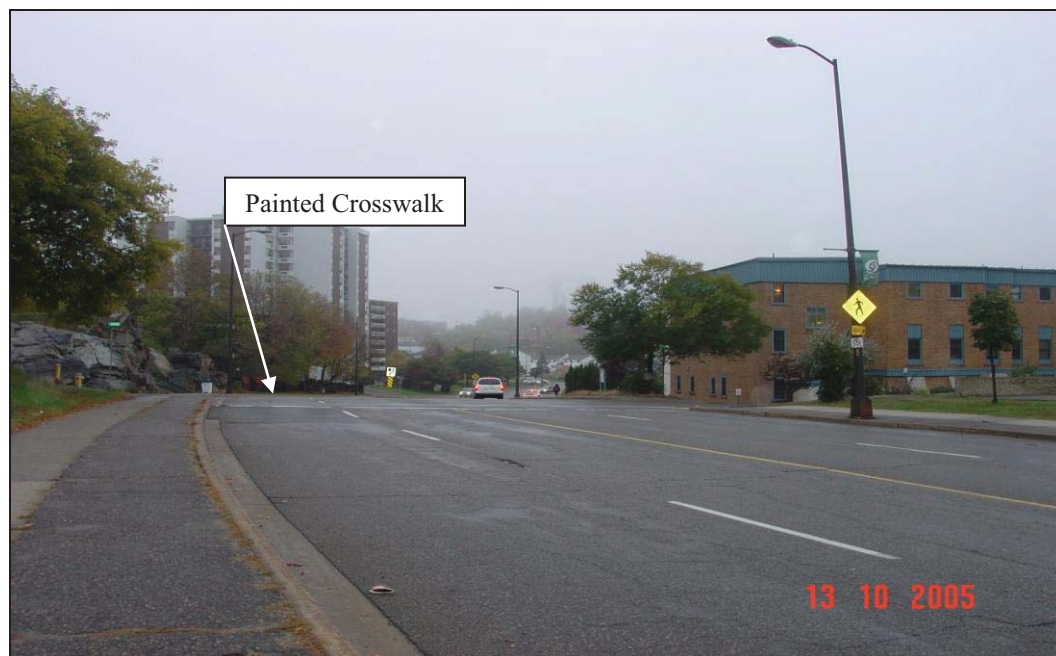
There was a painted, but unsigned crosswalk at the west leg of the Ste. Anne Road / Ignatius Street intersection approximately 45 metres west of the subject crossing at the crest of the vertical curve and at the starting portion of the horizontal curve. See Exhibit 7.

Exhibit 7: Former Ste. Anne Road / Ignatius Street Crossing (West of Subject Crossing)

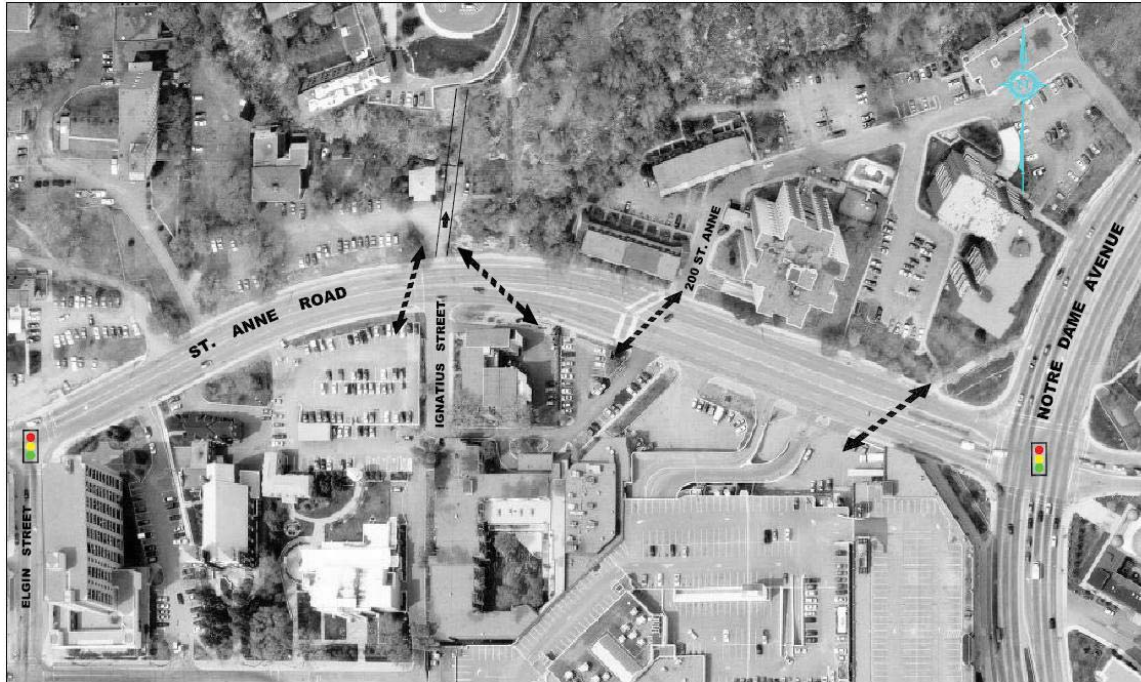
The interaction between the residential area/schools to the north and the Elm Street downtown area to the south results in several pedestrian desire lines along Ste. Anne Road as illustrated in **Exhibit 8**.

Exhibit 8: Pedestrian Desire Lines
