# Pedestrian Traffic Study Crossing Review

City of Greater Sudbury

## Final Report

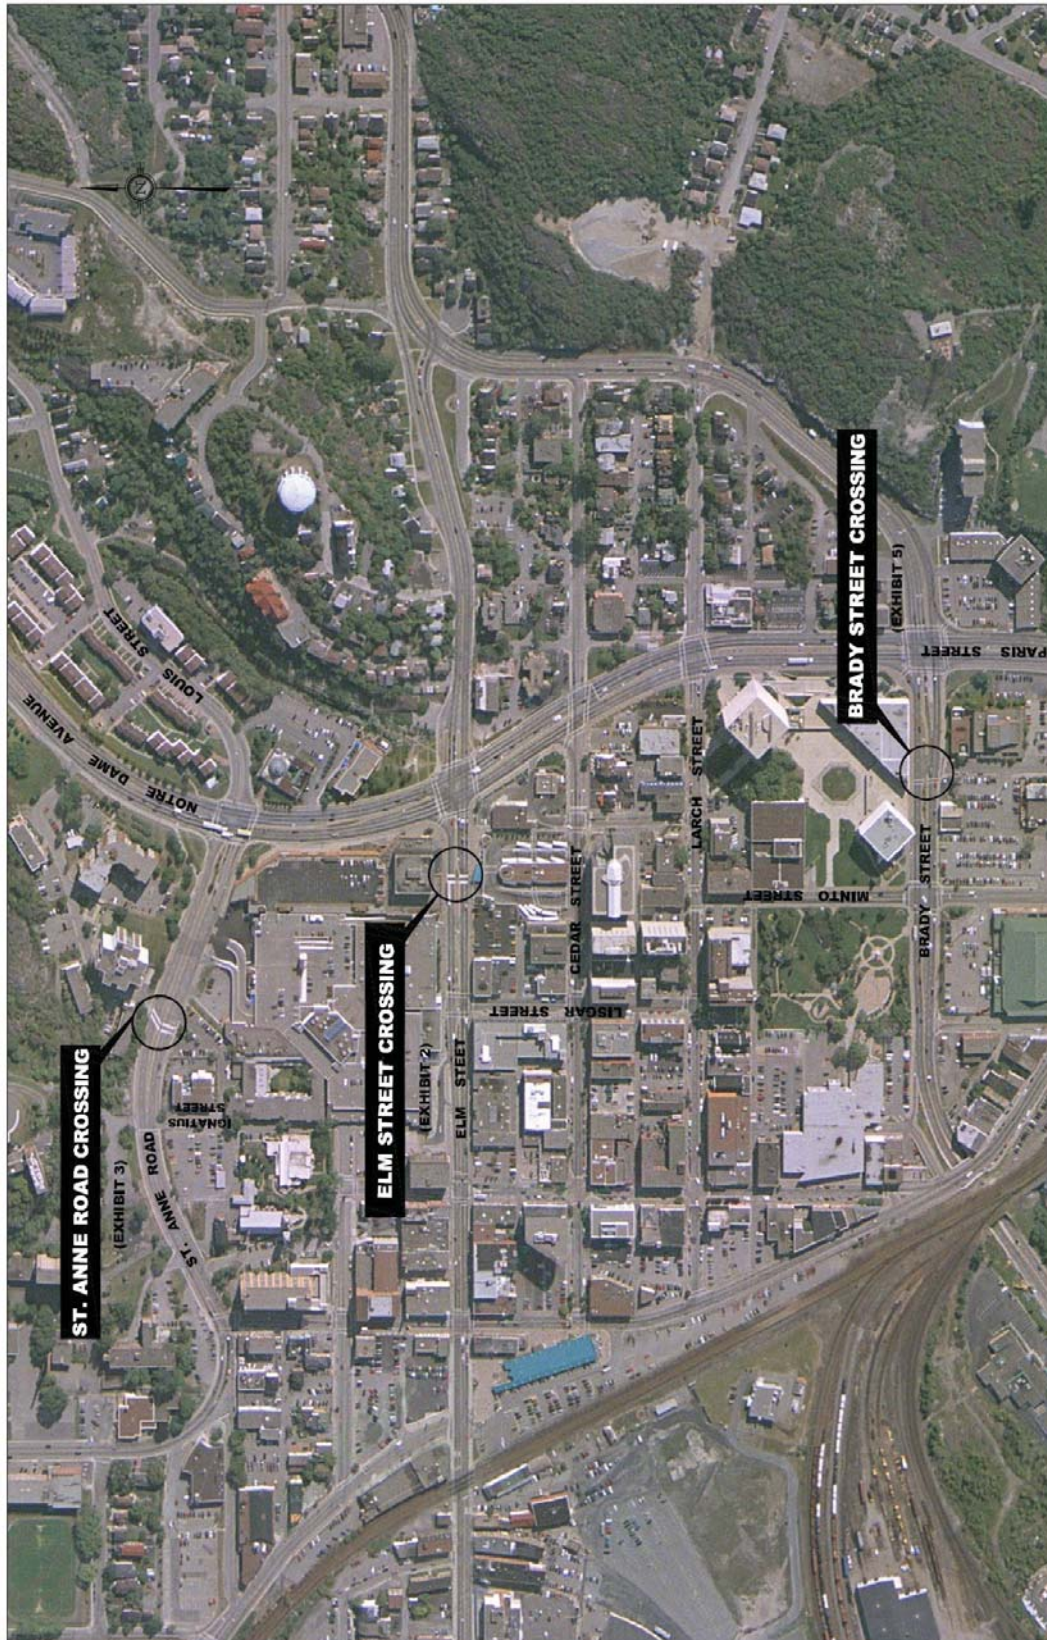
Exhibit 1: Site Locations

This report presents the findings of the pedestrian review for three specific crossing locations in the downtown area, identified below and indicated in **Exhibit 1**:

- Elm Street (west of Notre Dame Avenue between City Centre and Sudbury Transit Terminal)
- Ste. Anne Road (between Ignatius Street and Notre Dame Avenue), and
- Brady Street at Shaughnessy Street

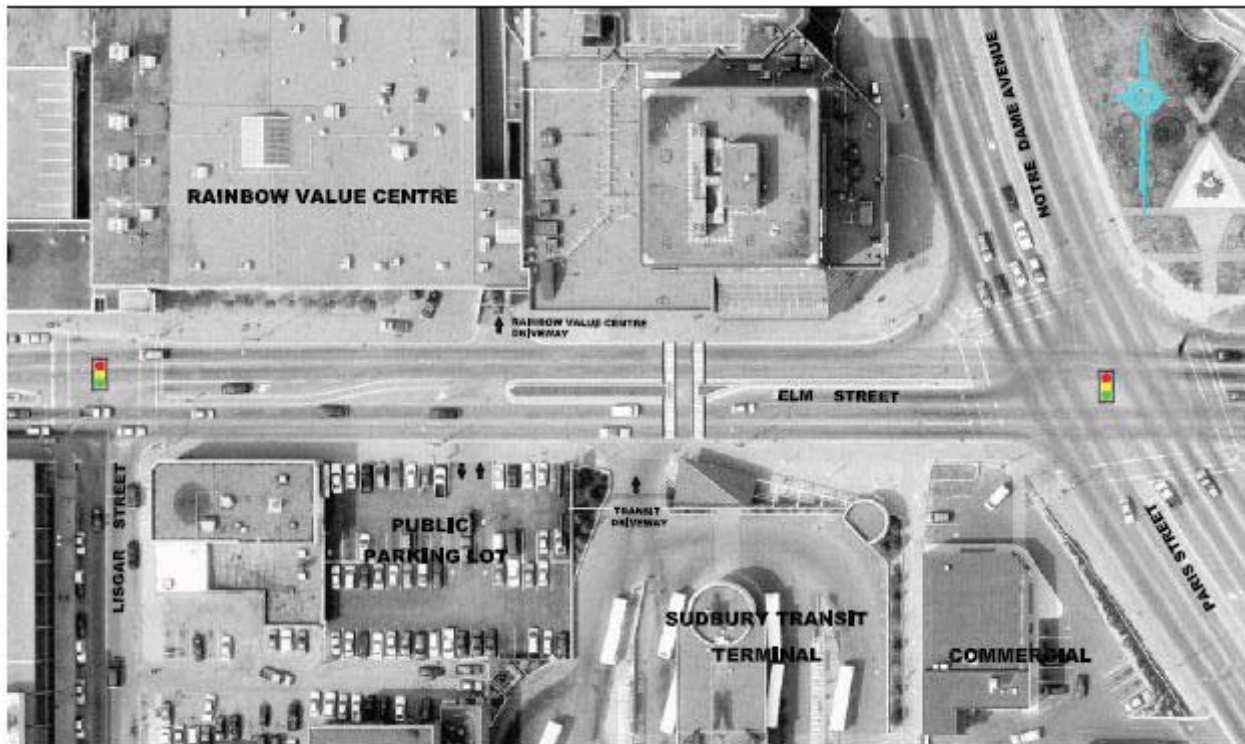
Exhibit 2: Elm Street Crossing

The Elm Street crossing is an unprotected marked mid-block crossing located between two signalized intersections, Notre Dame Avenue – Paris Street approximately 50 metres to the east and Lisgar Street approximately 100 metres to the west. Elm Street is a 5-lane road with centre left turn lanes at the intersections. The posted speed on Elm Street is 50 km/h and carries a daily traffic volume of 16,000 vehicles. There are sidewalks along both sides on Elm Street with roadway illumination. Parking is prohibited within the vicinity of the crossing.

The surrounding land uses and buildings are illustrated in **Exhibit 2**. They include:

- Rainbow Value Centre (northwest corner of the Elm Street and Notre Dame Avenue – Paris Street intersection)
- Sudbury Transit Terminal (southwest quadrant of the Notre Dame Avenue and Elm Street intersection)
- Public parking lot located west of Sudbury Bus Terminal
- Commercial retail, offices and government buildings
- Residential and senior's home.

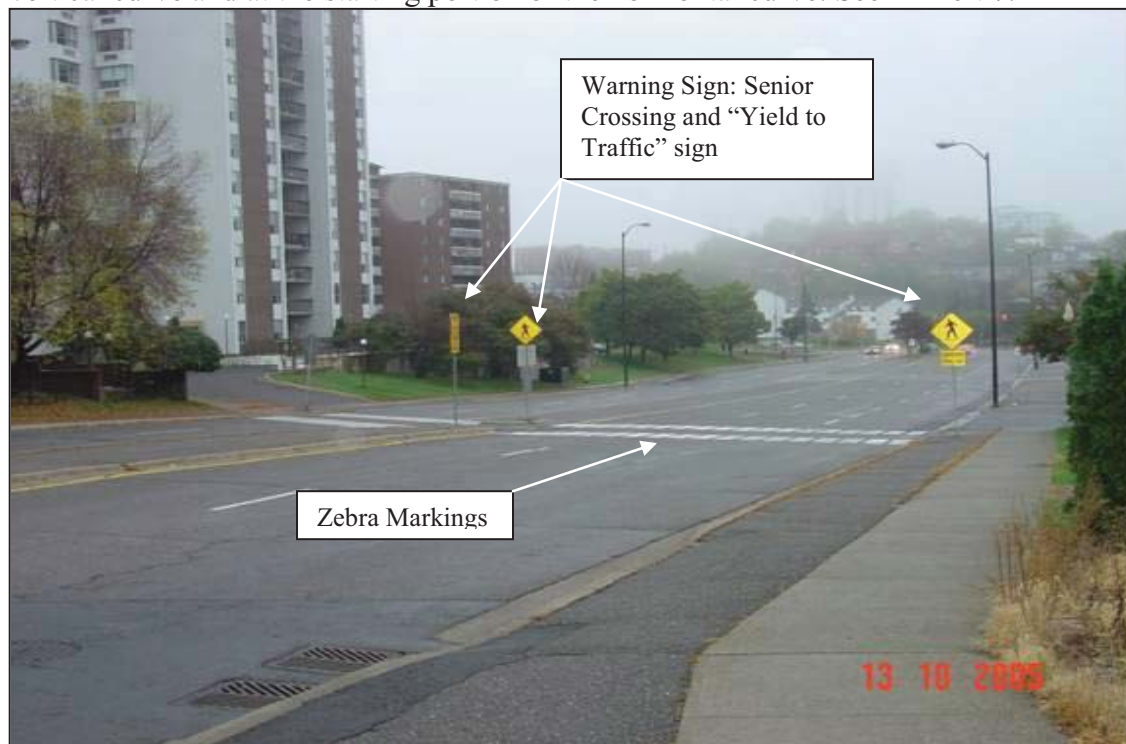
**Exhibit 6:** Former Ste. Anne Road Crossing Facing East

The posted speed on Ste. Anne Street is 50 km/h and carries a daily traffic of 7,100 vehicles. There are sidewalks along both sides on Ste. Anne Street with roadway illumination. Parking is prohibited within the vicinity of the crossing.

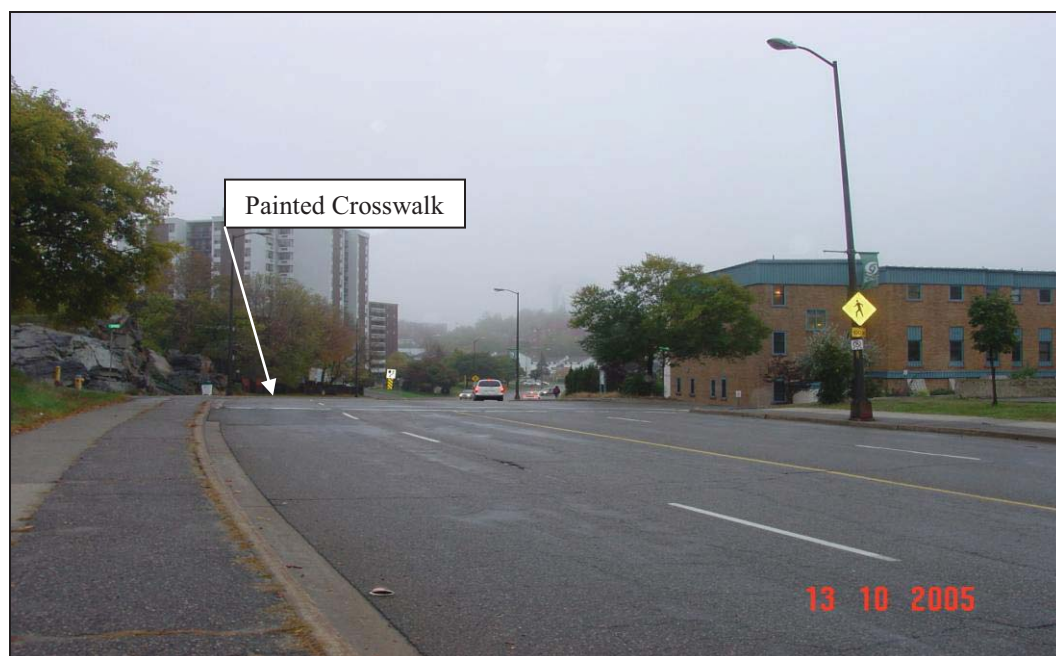
**Exhibit 7: Former Ste. Anne Road / Ignatius Street Crossing (West of Subject Crossing)**

There was a painted, but unsigned crosswalk at the west leg of the Ste. Anne Road / Ignatius Street intersection approximately 45 metres west of the subject crossing at the crest of the vertical curve and at the starting portion of the horizontal curve. See Exhibit 7.

As part of this study, it is also recommended that the existing unsignalized crossing at Ignatius Street, west of the Ste Anne Road crossing be removed along with the curb depressions since this crossing is in close proximity to the new signalized intersection at 200 Ste. Anne and does not serve any significant pedestrian generators.

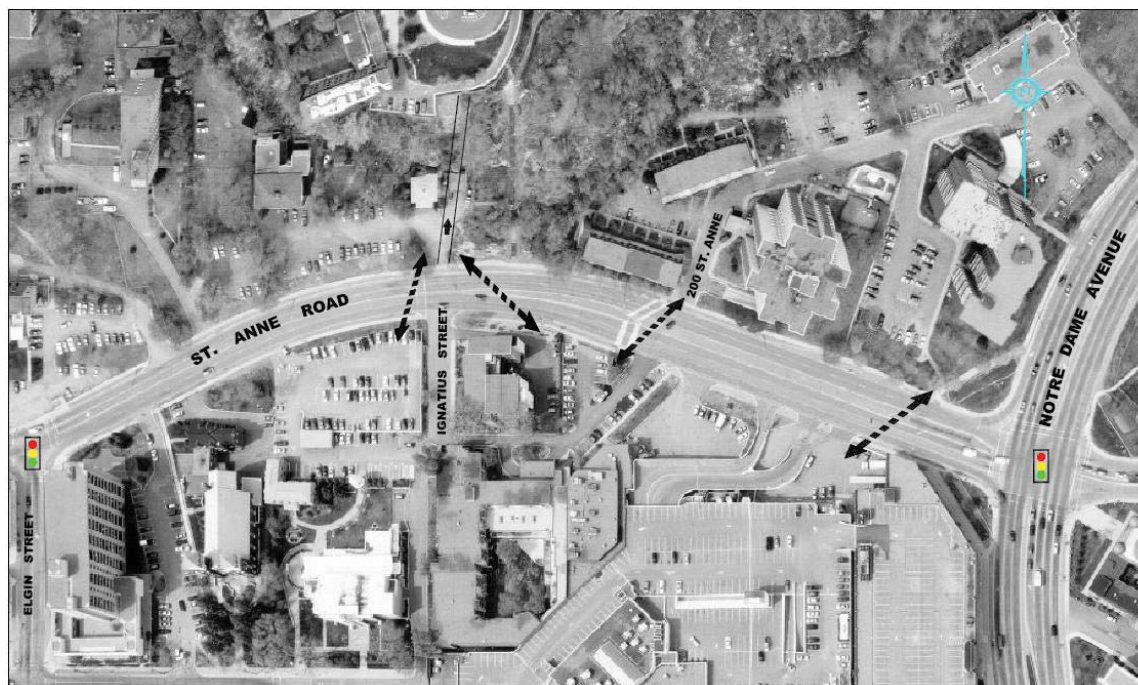
### Exhibit 8: Pedestrian Desire Lines

The interaction between the residential area/schools to the north and the Elm Street downtown area to the south results in several pedestrian desire lines along Ste. Anne Road as illustrated in **Exhibit 8**.

Crossings at the subject crosswalk are generally to/from the 200 Ste. Anne Road (Apartment complex). The pedestrian activity at the crossing as indicated in a June 20, 2003 count shows a pedestrian volume of 55 during the peak hour from 3:15 p.m. to 4:15p.m.

Meanwhile, there is high frequency of mid-block pedestrian activities outside of the marked crosswalks and in particular, at the foothill of the staircase, east of Ignatius Street crossing, leading to the schools on the hilltop on the north side; and at the east end of Ste. Anne Road, where crossing at mid-block between the Seniors home and the Rainbow Value Centre were observed. The daily traffic volume of 7,084 vehicles at Ste. Anne Road is considered low.
