Pedestrian Crossing Policy Study

Overview of Presentation

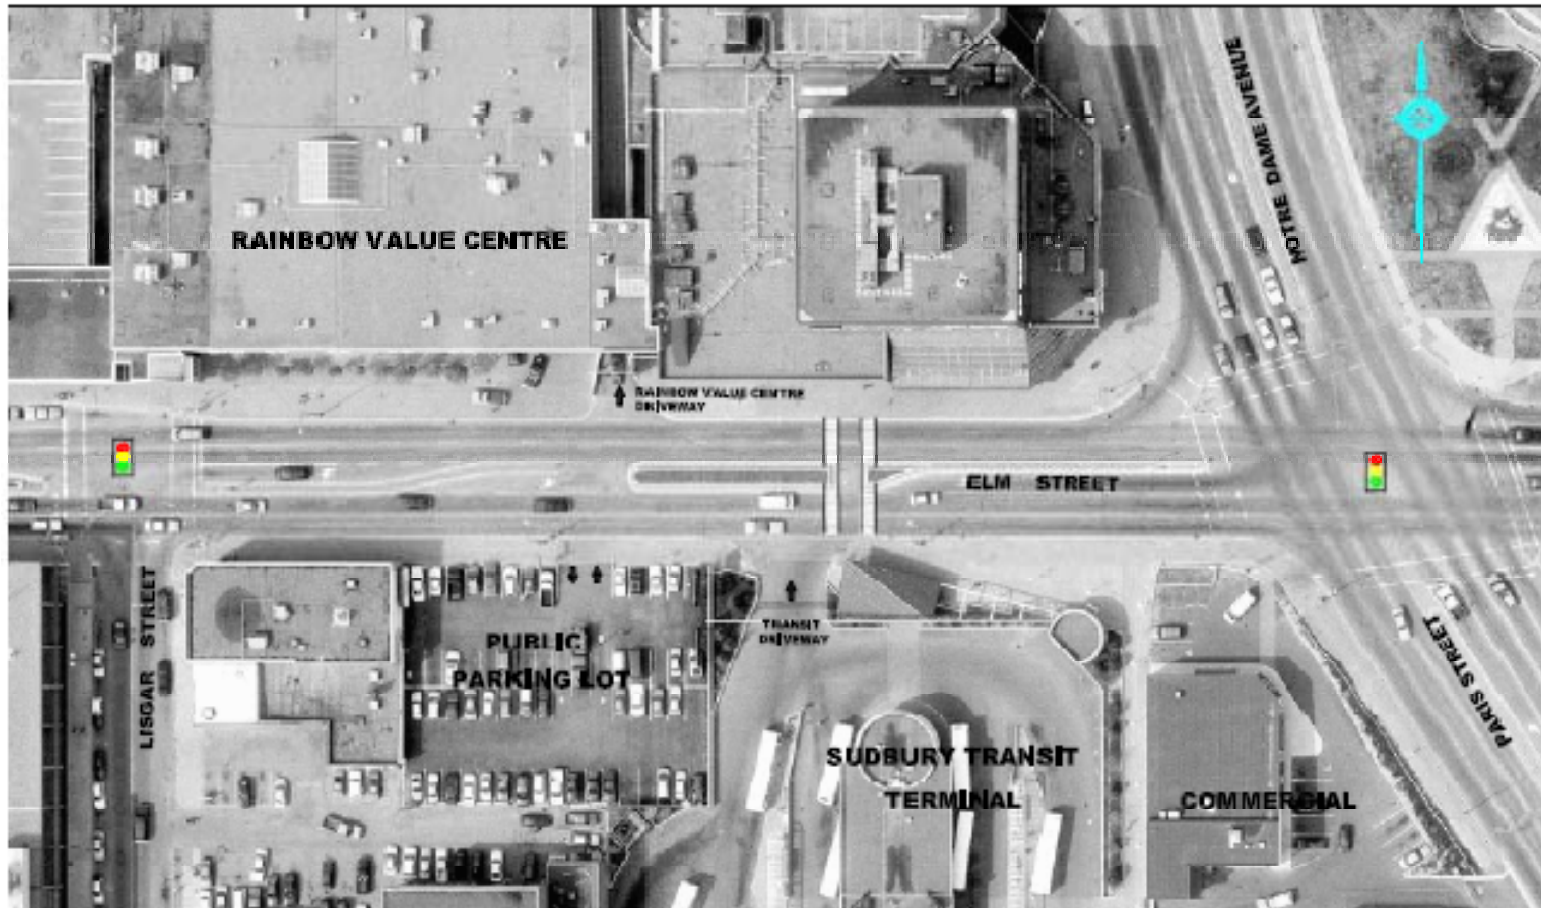
Elm Street Crossing

- Traffic signals cannot be installed:
 - Too close to signals at both Notre Dame and Lisgar Street (215 m recommended). Current spacing is between 50 and 80 m.
 - Driver confusion of signal indications
- Stop control would “flip” right-of-way, but does not promote driver expectation (being mid-block location)
- Result – leave as unprotected crossing

- Shift west to Rainbow Value Centre Driveway
 - Shift does not align crossing and pedestrian desire line
 - More time for westbound drivers, but marginal
 - Conclusion – leave in current location

- At time of initial review:
 - Southbound channelized right turn at Notre Dame – made a recommendation to remove
- Do not remove zebra crossings
- Routinely maintain signage
- Monitor recent change to use of Rainbow Value Centre entrances by pedestrians

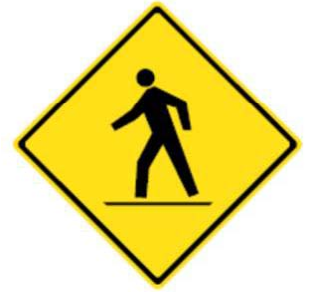
Brady Street Crossing Suggested Modifications

- Consider a median barrier to channel pedestrians to the crossing
- Consider signs and markings similar to the Elm Street Crossing
 - Zebra markings
 - Pedestrian warning signs
 - “Yield to Traffic” signs
- Implement and enforce a “Pedestrians Cross Other Side” by-law for the east leg of Brady and Shaughnessy Streets
