Presented To:	Operations Committee
Presented:	Monday, Jul 07, 2014
Report Date	Tuesday, Jun 24, 2014
Type:	Managers' Reports

### All-Way Stop Control - Bancroft Drive at Shelbourne Street

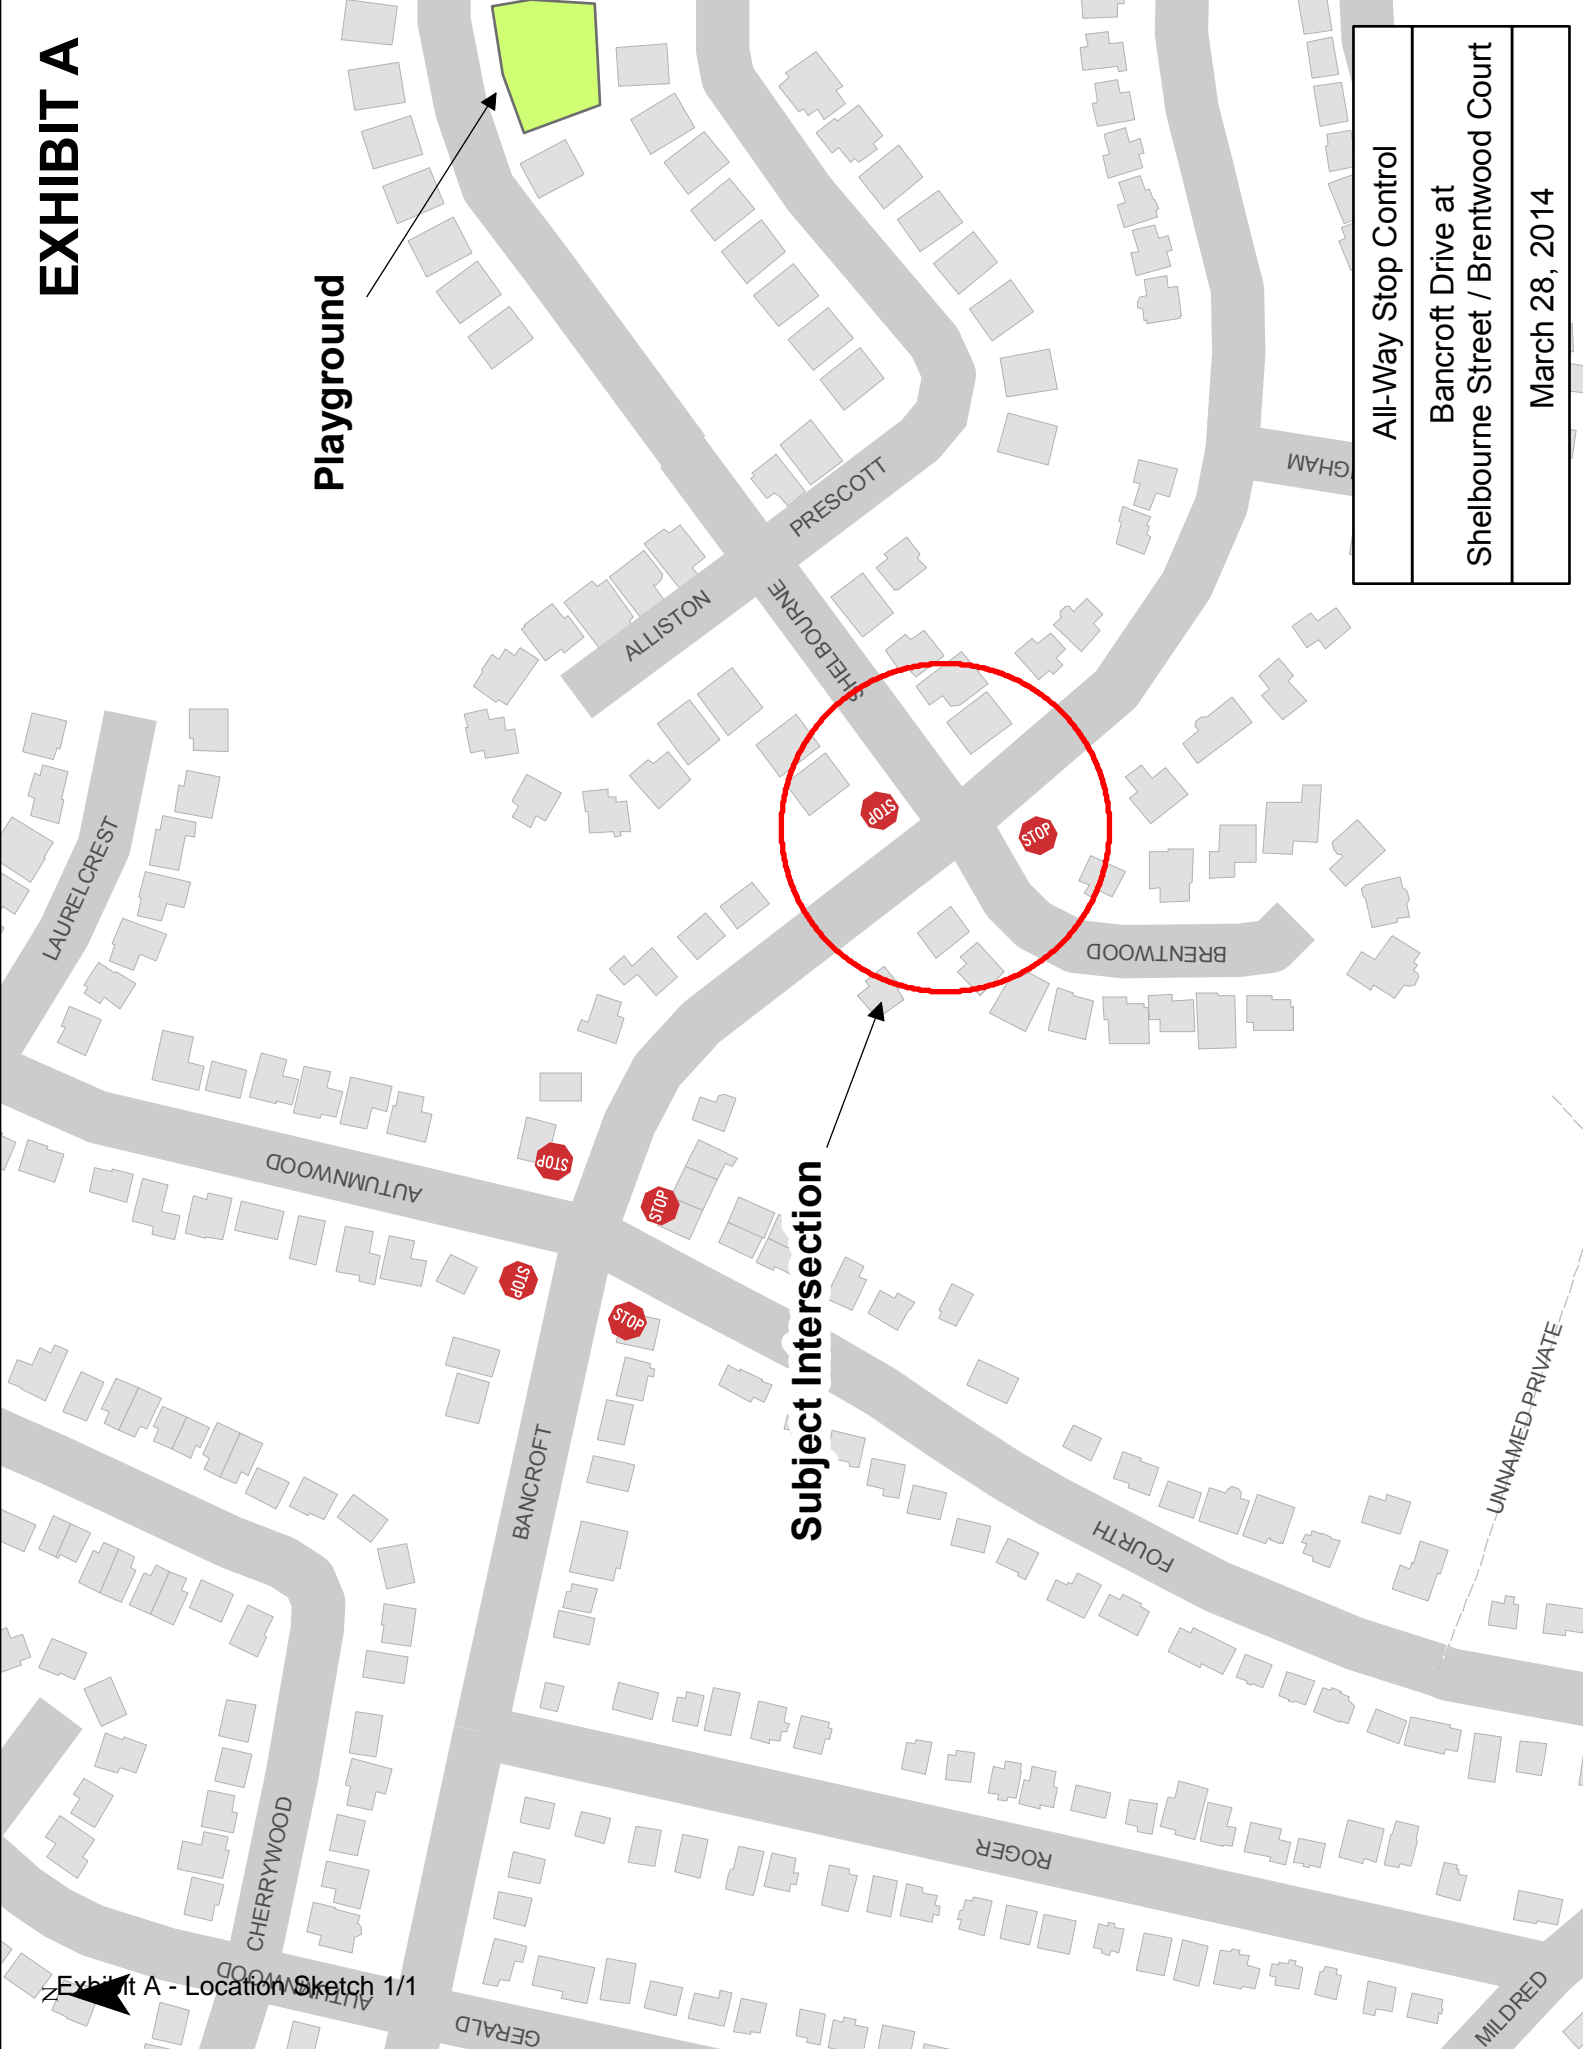
# EXHIBIT A

Playground

Subject Intersection

Bancroft Drive at Shelbourne Street and Brentwood Court is a cross intersection located approximately 180 metres east of Fourth Avenue within Ward 11 (see Exhibit 'A'). Brentwood Court terminates in a cul-de-sac approximately 100 metres south of Bancroft Drive and has only 15 houses constructed on it. Currently this intersection is controlled with stop signs facing southbound traffic on Shelbourne Street and northbound traffic on Brentwood Court. A City playground is located 270 metres north of Bancroft Drive on Shelbourne Street. Bancroft Drive carries an annual average daily traffic volume of 5,000 vehicles in this area and is designated as a secondary arterial road. The speed limit on Bancroft Drive is 50 km/h.
