Purpose

This report seeks approval to proceed with the partial roof replacement and interior repairs required due to the identified roof failure on the south side of the Sudbury Community Arena to be funded through the Capital General Holding Account reserve.

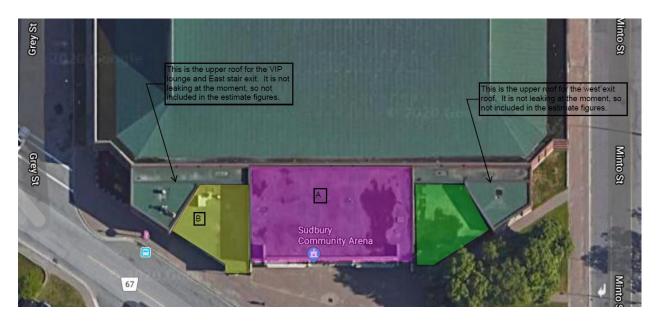
The image below identifies the three areas of the roof that are in need of replacement due to failure. The east and west upper roof areas are currently not leaking and not included in the estimates provided.

The roof failure and leaking have directly affected various sections of operations of the arena and for tenants of the Sudbury Community Arena. It is expected that without roof system replacement, these areas will continue to be affected, cause notable damage and mold development.

'The estimated costs for work are \$310,000 for roof repairs plus \$26,000 for the interior repairs and an additional \$26,500 for remediation totaling \$359,500. Any requests from the capital holding accounts in excess of \$250,000 require Council approval.
