NOTICE OF APPEAL TO PROPERTY STANDARDS COMMITTEE

Case #: 729526

Order to Remedy Non-Conformity with Standards for Maintenance and Occupancy of All Property

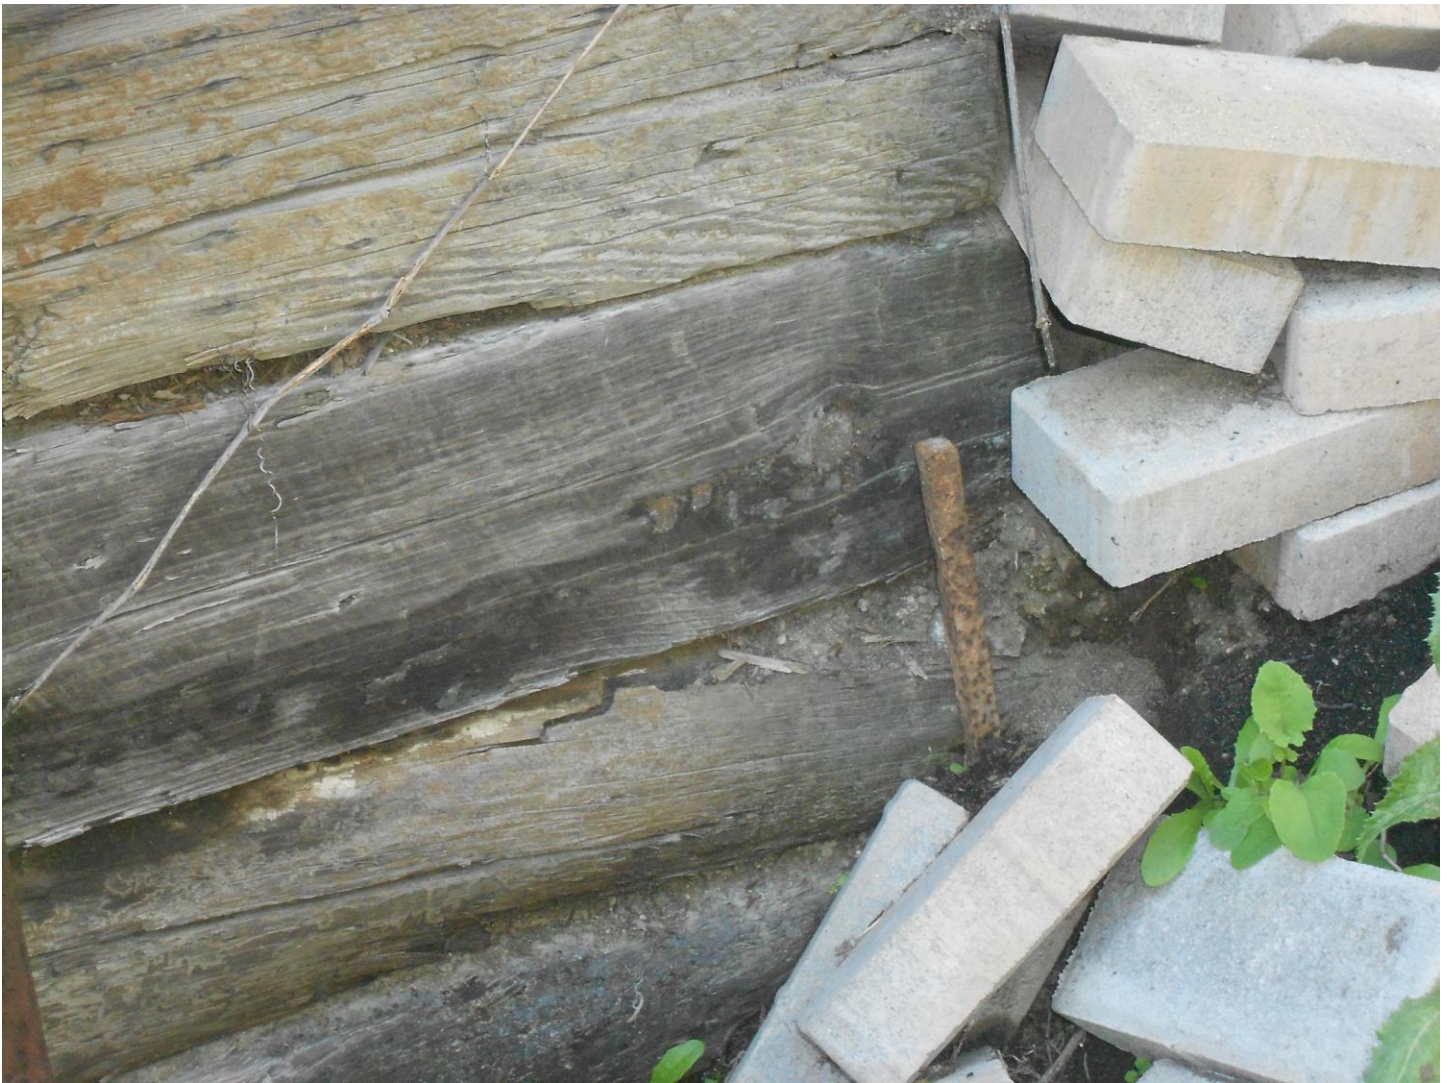
Figure 1

25. In Figure 1, you can see the survey peg that was put into the ground at one end of the retaining wall. That survey peg was put in when one of the previous owners took a survey so that ■ could put in a retaining wall because ■ wanted to bring the property at 633 Lavoie Street level with Lavoie Street. ■ needed the retaining wall to hold the fill that was needed to raise ■ property.
26. At the time I went to the City to complain about the ties being used, but the City told me that it was allowed as long as it was on ■ property.
27. The survey peg was used as a guide to make sure the wall was on the 633 Lavoie Street property.
28. If it would have been on any part of the line, I could have objected and the owner of 633 Lavoie Street would have had to move the retaining wall.

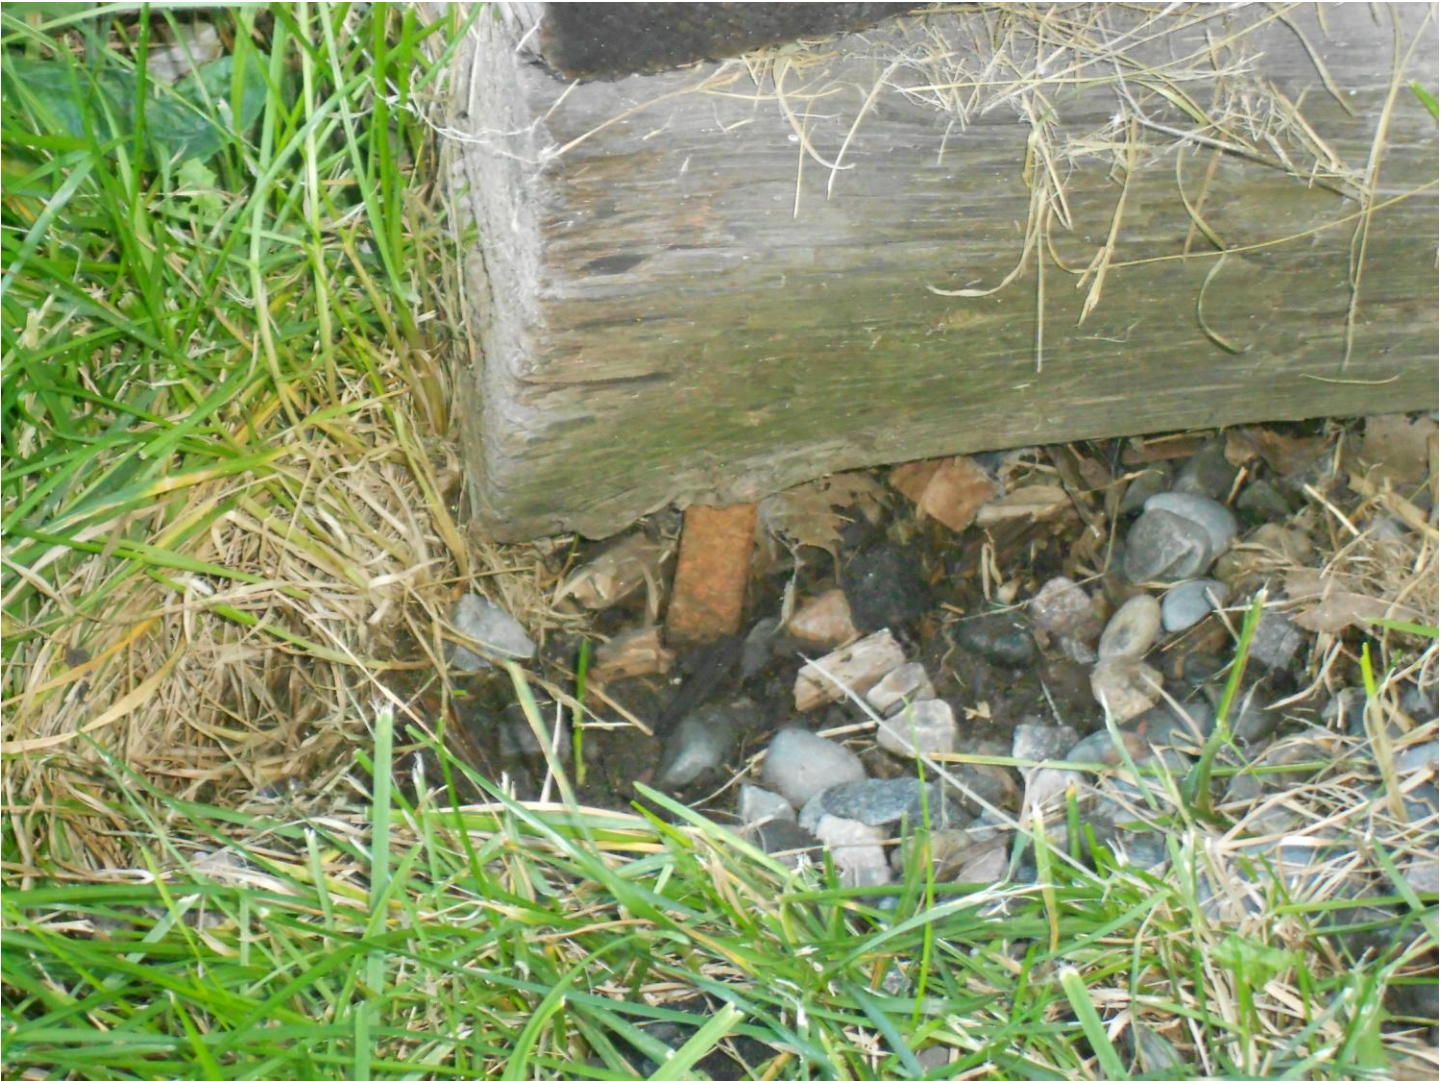
Figure 2

29. In Figure 2, you can see the survey peg near the other corner of the retaining wall. That peg clearly shows that the bottom railway tie is on the 633 Lavoie Street side of the peg. However, over time, the pressure of the soil and the pressure of the large tree that was planted near the wall, has pushed the upper levels of the retaining wall over the top of the survey peg, thus infringing on my property.

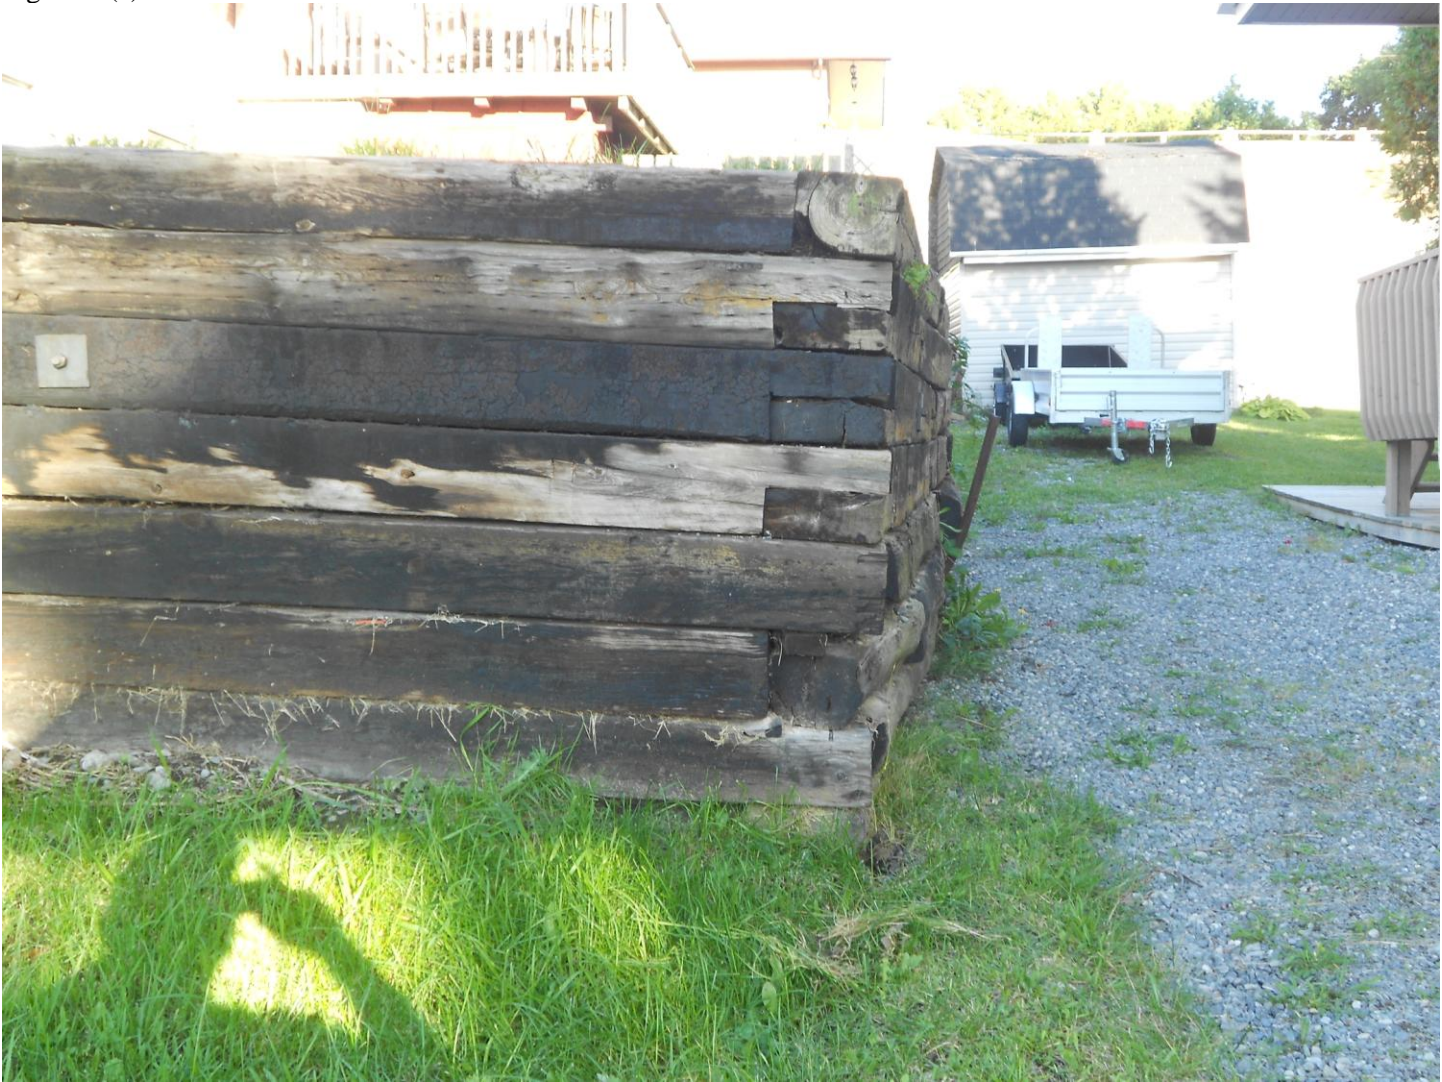
30. In Figure 2 (a) you can see how the retaining wall was pushed from the original location over the years resulting in the corner ties in Figure 2 to be pushed over the survey peg.

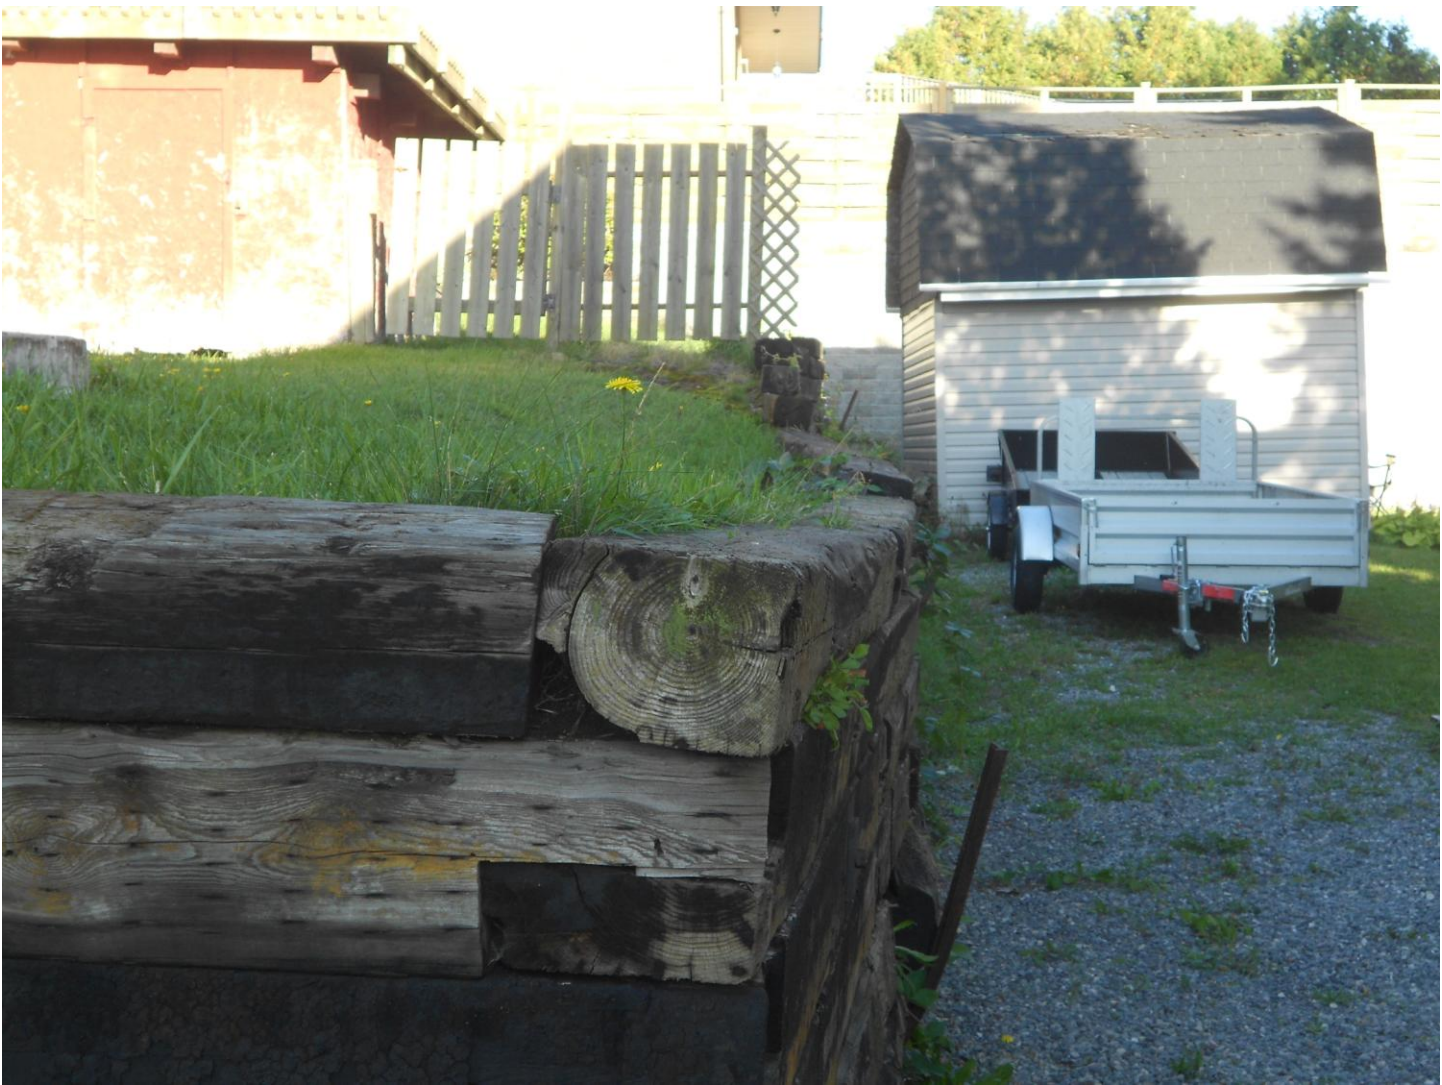
Figure 3

31. In Figure 3, you can see a tree stump at the top left hand side of the picture. That tree was very large and the roots helped to push the retaining wall over the property line. You can see how it has been pushed as you look along the wall from the end.

32. In Figure 3, you can also see how the corner of the retaining wall was tied-back towards the 633 Lavoie Street property. That is further evidence that the retaining wall was built by the previous owner of 633 Lavoie Street for the benefit of improving [REDACTED] own property.

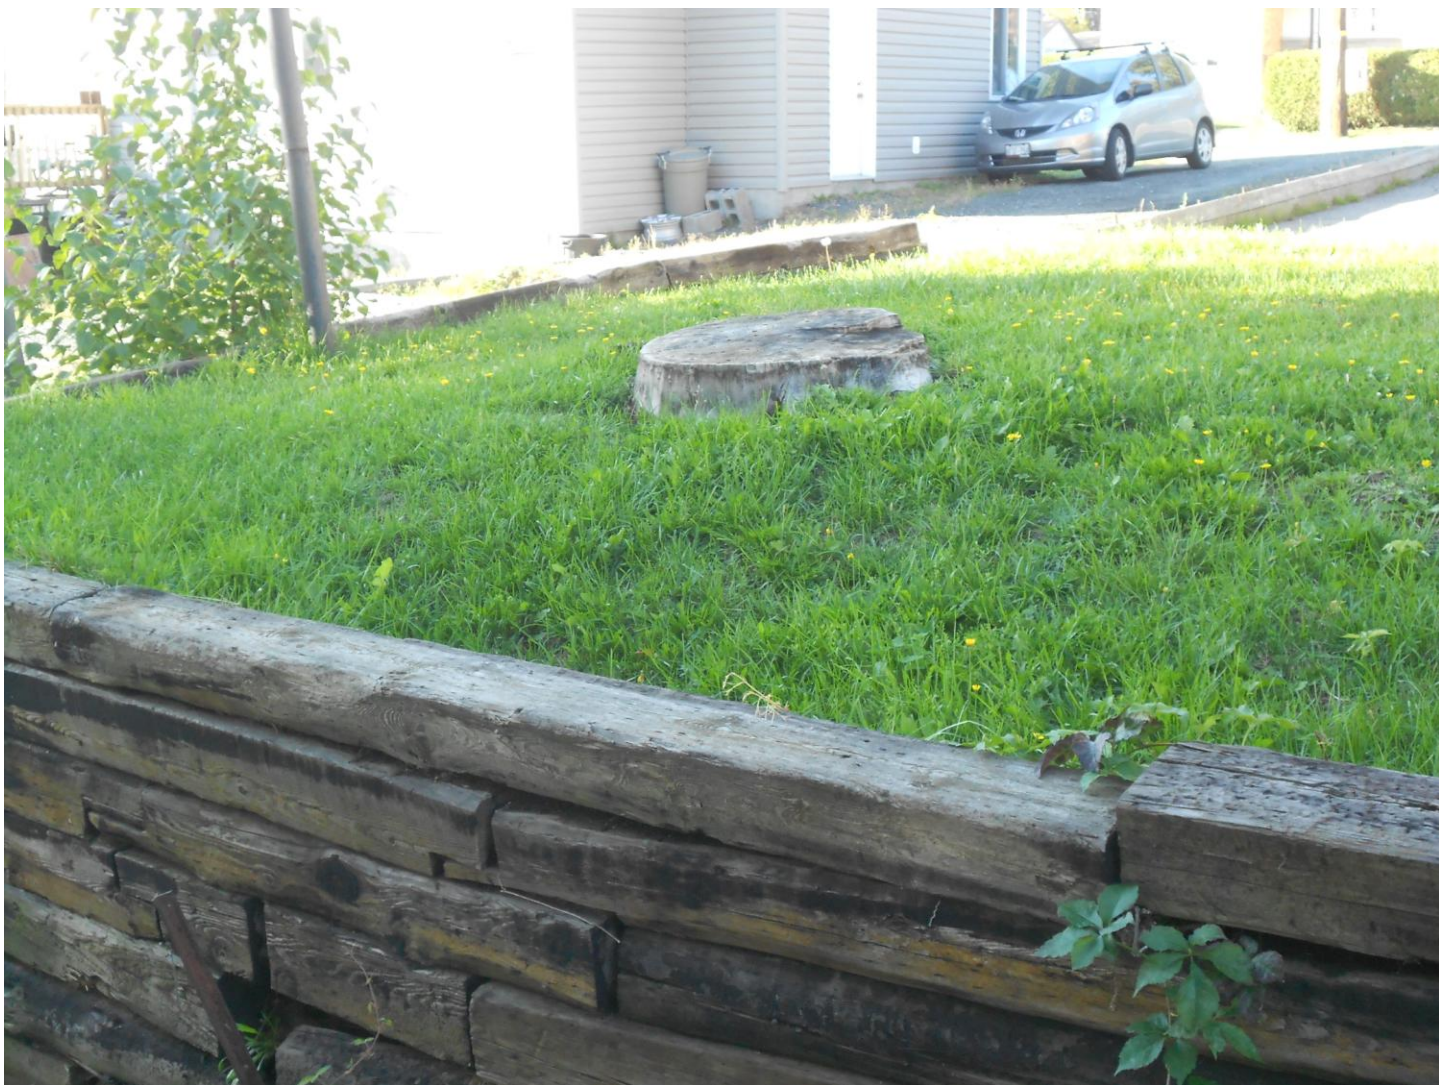
Figure 4

33. In Figure 4, you can see the stump of the tree which ended up pushing the retaining wall towards my property. If you look at the bottom of the picture you can see one of the steel rods that was used to “shore up” the wall. See how much it has been pushed by the force of the wall encroaching on my property.

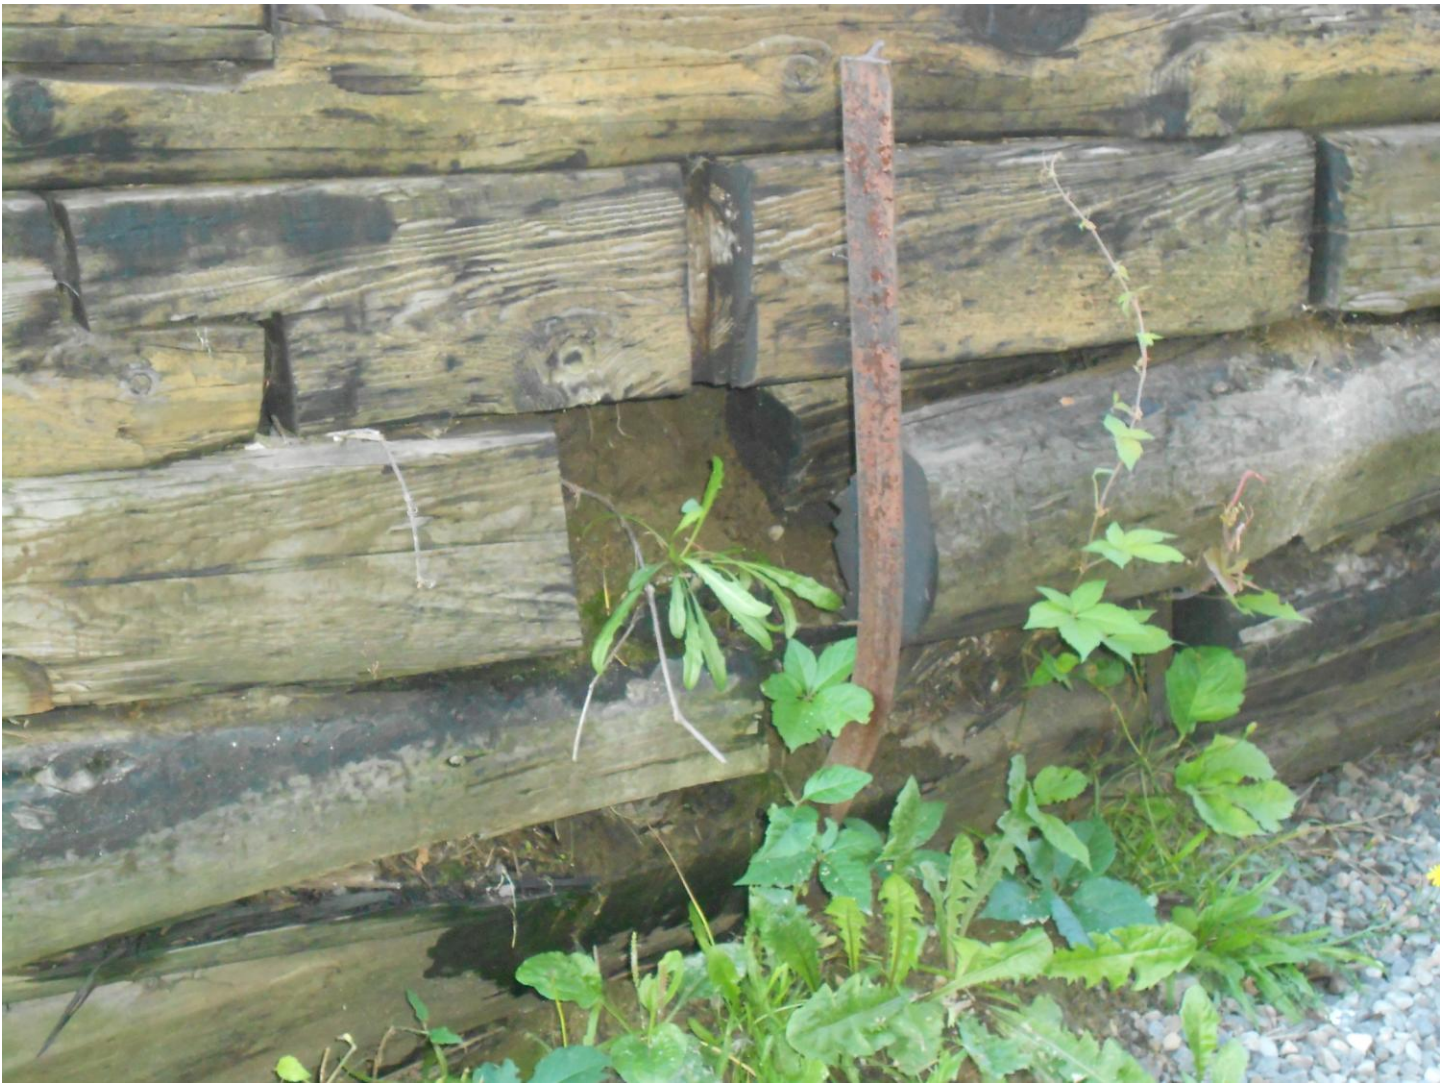
34. Figure 5 is another view of the steel rod that was being used to shore up the retaining wall. Look at how much it has been bent by the force of the fill and the tree trunks over the years. You can tell this is the same picture as in Figure 4 by looking at the vegetation in both photos.

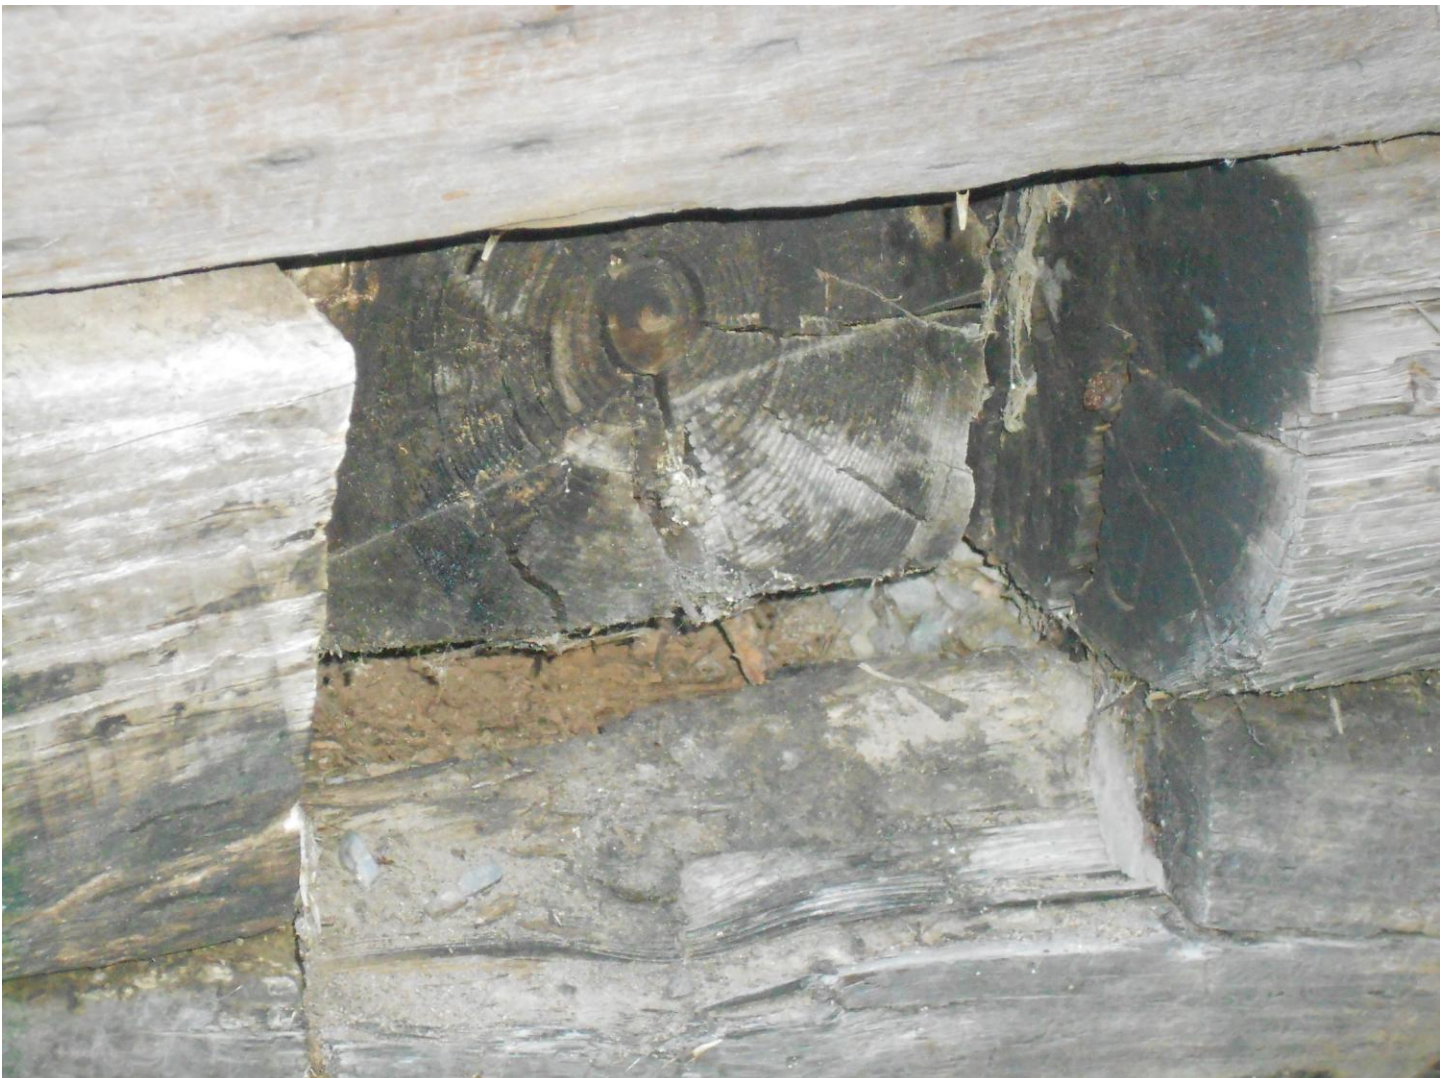
44. Figure 6 shows a “tie-back” that is still in place from the original location of the retaining wall. You can see how much this part of the wall has been pushed out from the original position, evidence that the retaining wall was once on the 633 Lavoie Street side of the property line.

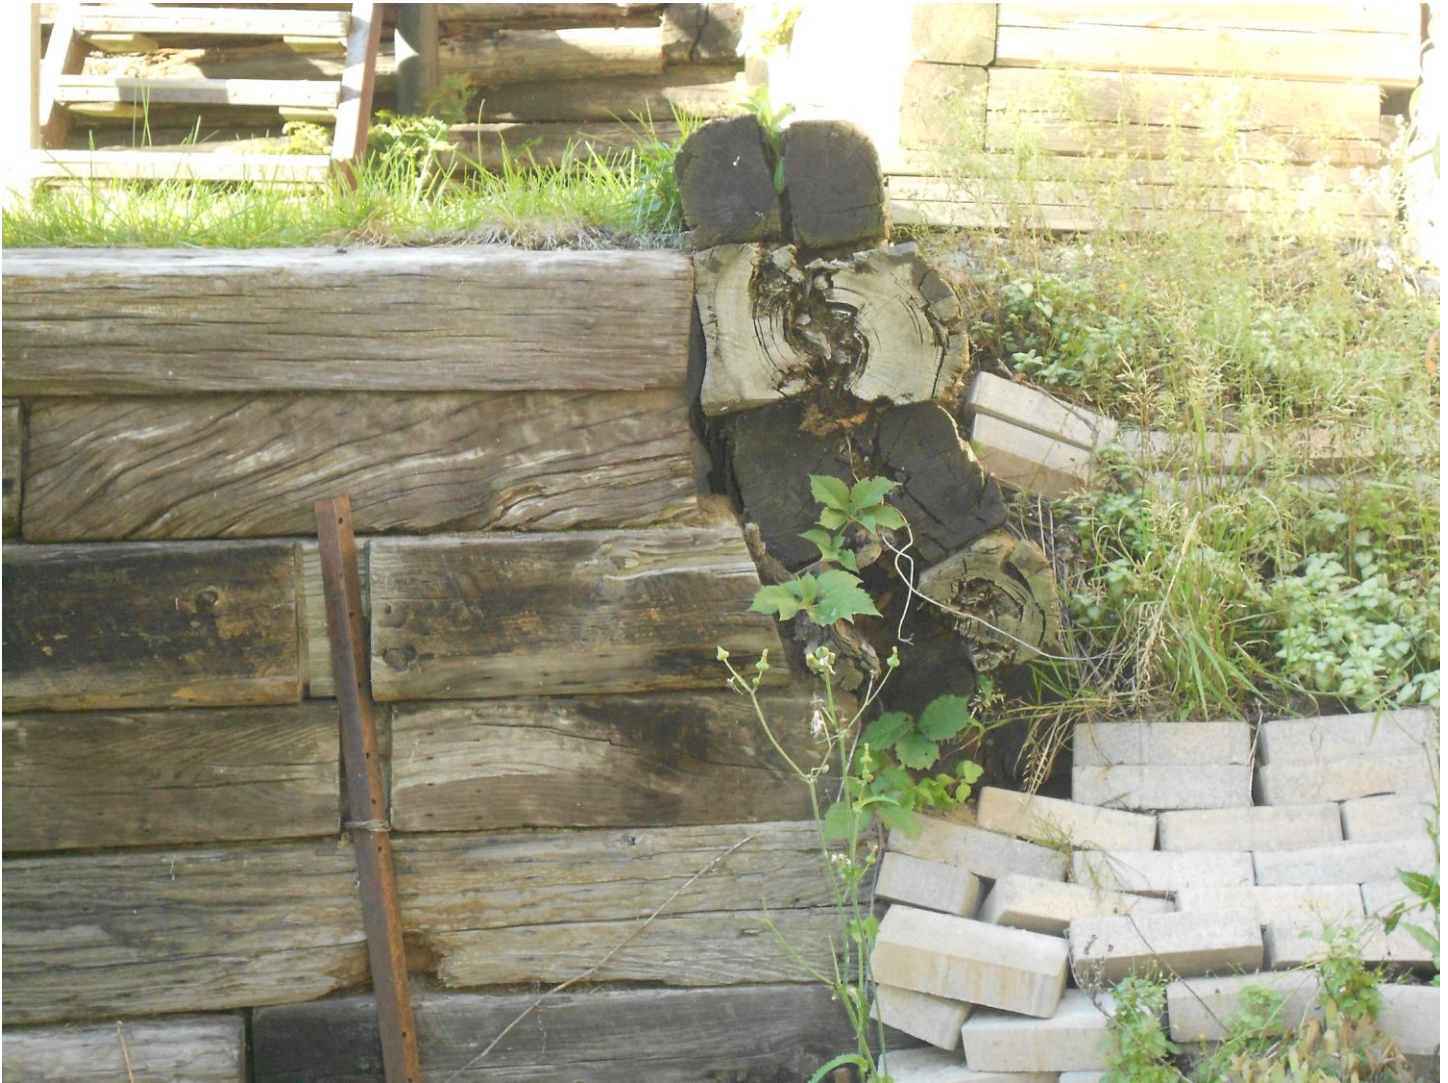
45. Figure 7 is taken at the far end of the retaining wall. If you look closely beside the bricks, near the centre of the bottom, you can see the tip of survey stake that is shown in Figure 1. You can tell that is the survey peg if you look at the formation of the bricks to the right of the peg and compare them in both Figures.

46. In Figure 7, you see a steel shoring rod that is bent slightly to the left, but otherwise it is fairly straight up. If you look in the centre of the photo you can see how the upper ties have moved slightly to the left as a result of pressure from the right, but also because the section to the left of this photo has been pushed towards my property because of two large trees with large trunks that were pushing on the retaining wall over the years. As the ties pushed towards my property, they pulled the ties at this corner in the same direction.

47. However, in Figure 7, it is clear that the retaining wall was on the 633 Lavoie Street property side when it was constructed based on the position of the survey peg.

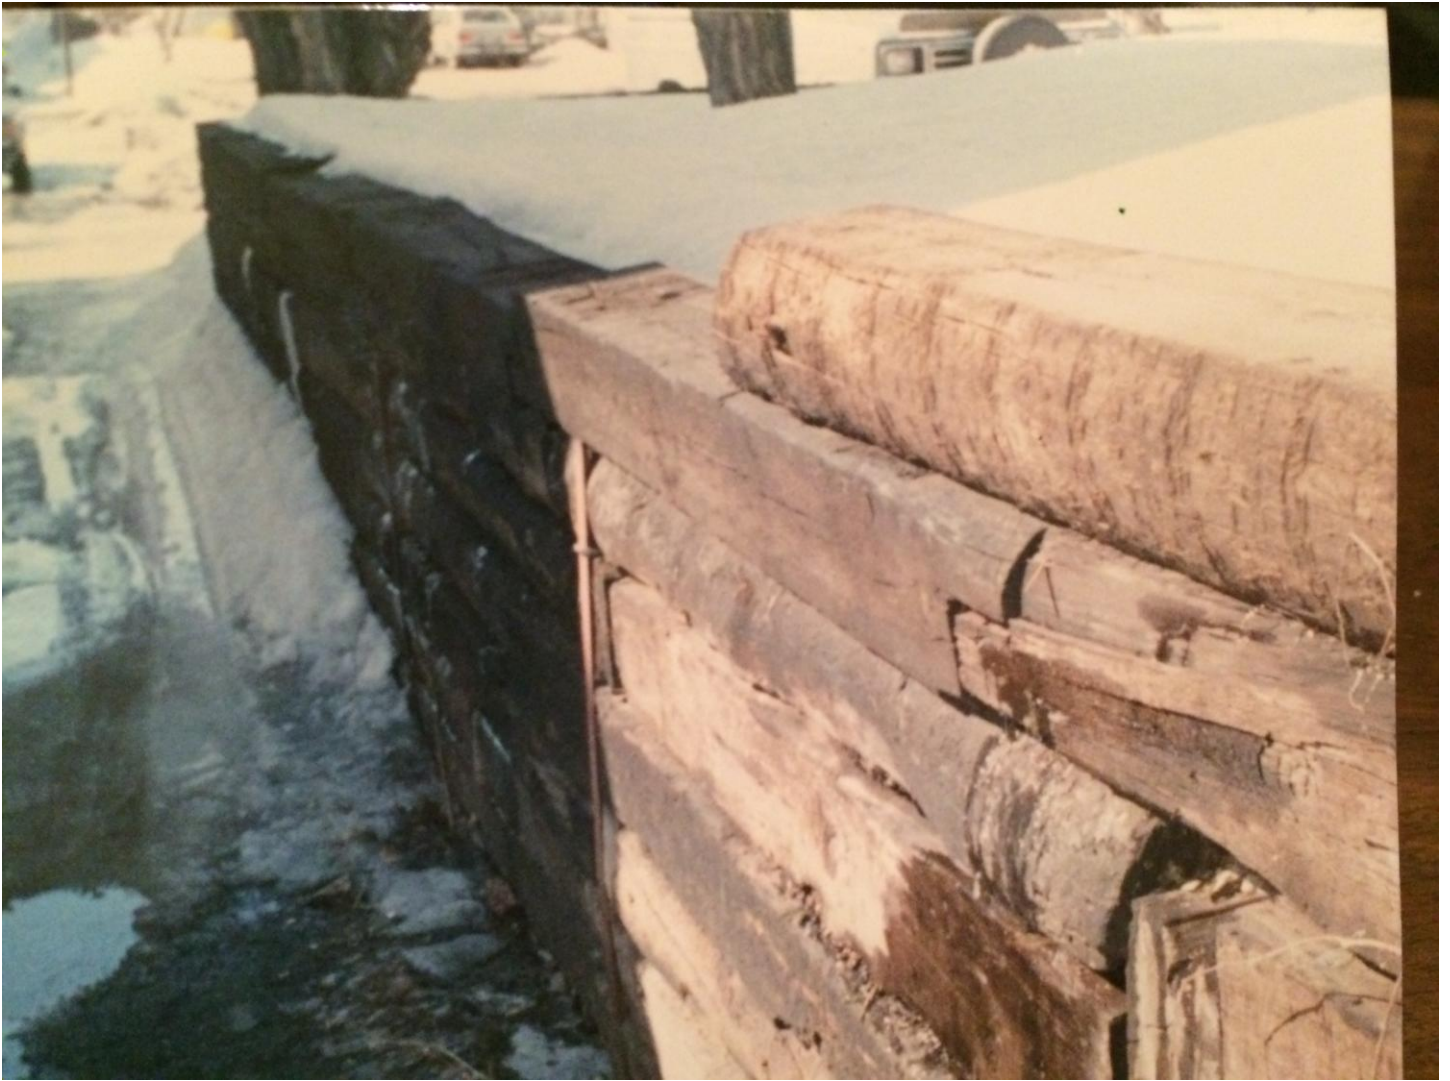
48. Figure 8 is an older photo of the retaining wall showing how it looked when it was straight and not being pushed over onto my property. You can see at the top of the photo how the tree is still small at that time.
