STRUCTURAL CONDITION ASSESSMENT

**SUDBURY COMMUNITY ARENA
240 ELGIN ST
SUDBURY, ONTARIO**

Our Project No.: 23131A

October 16, 2023

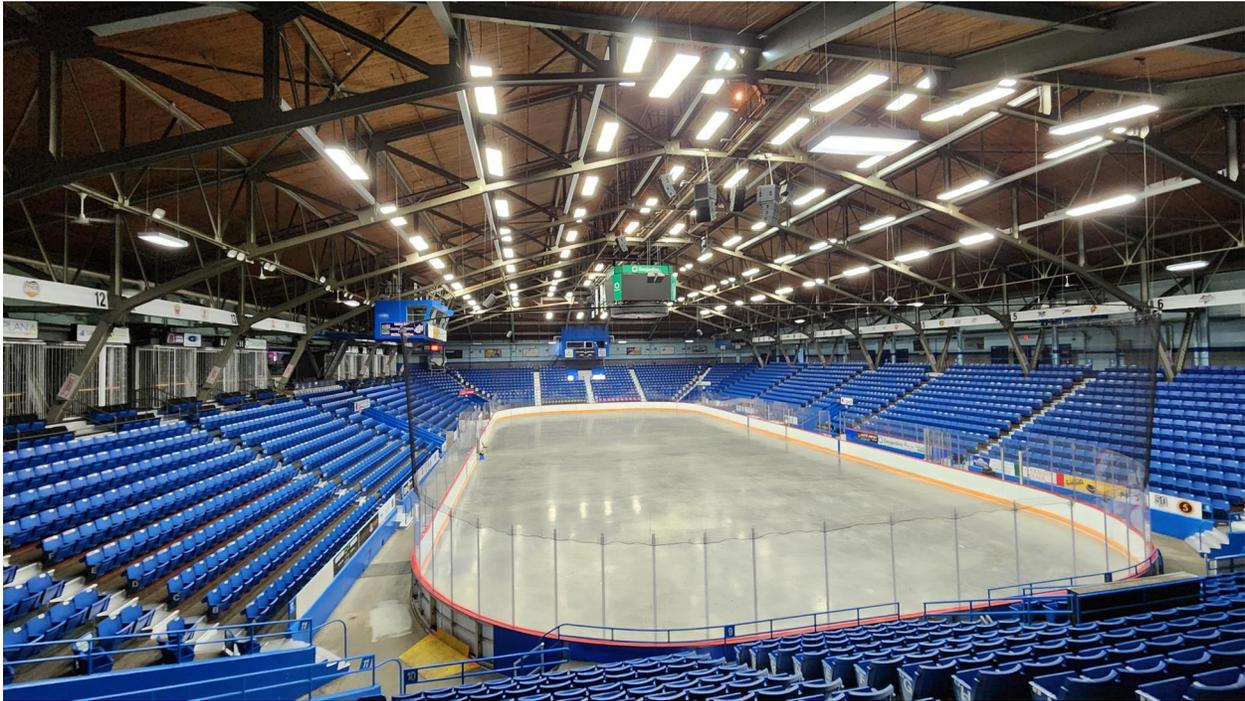
Photo 1: Sudbury Community Arena (c.1951).

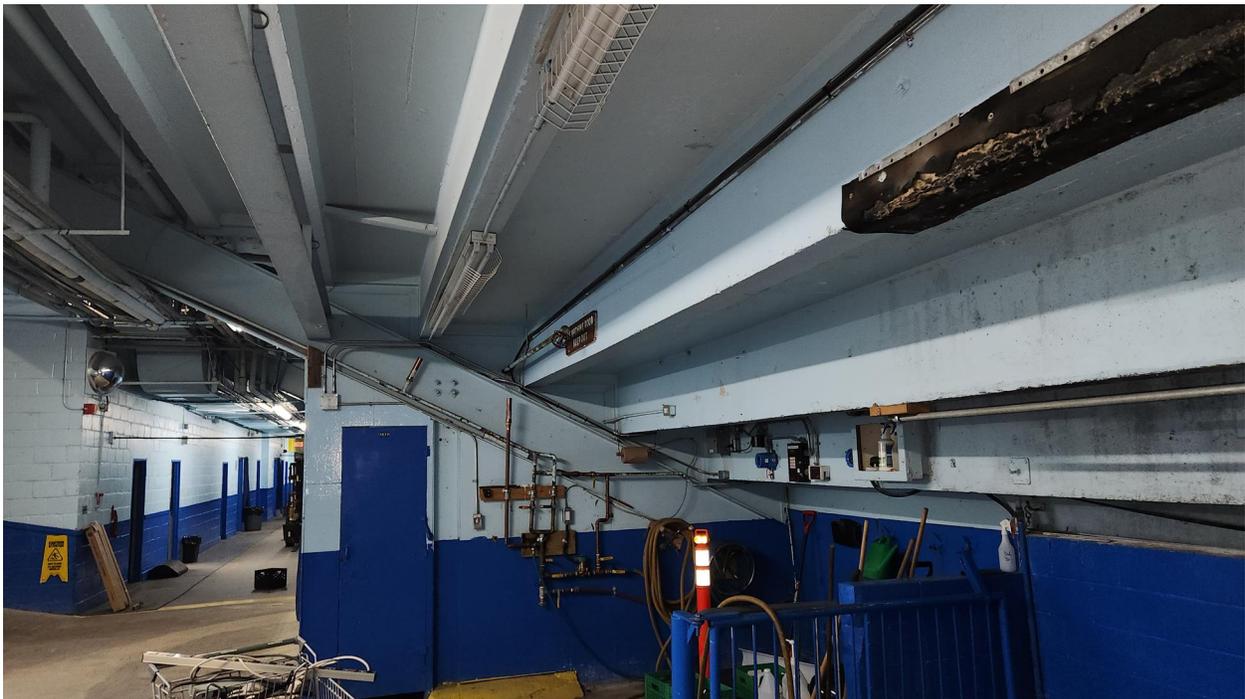
Photo 8: Typical Grandstand seating framing (c.1951).

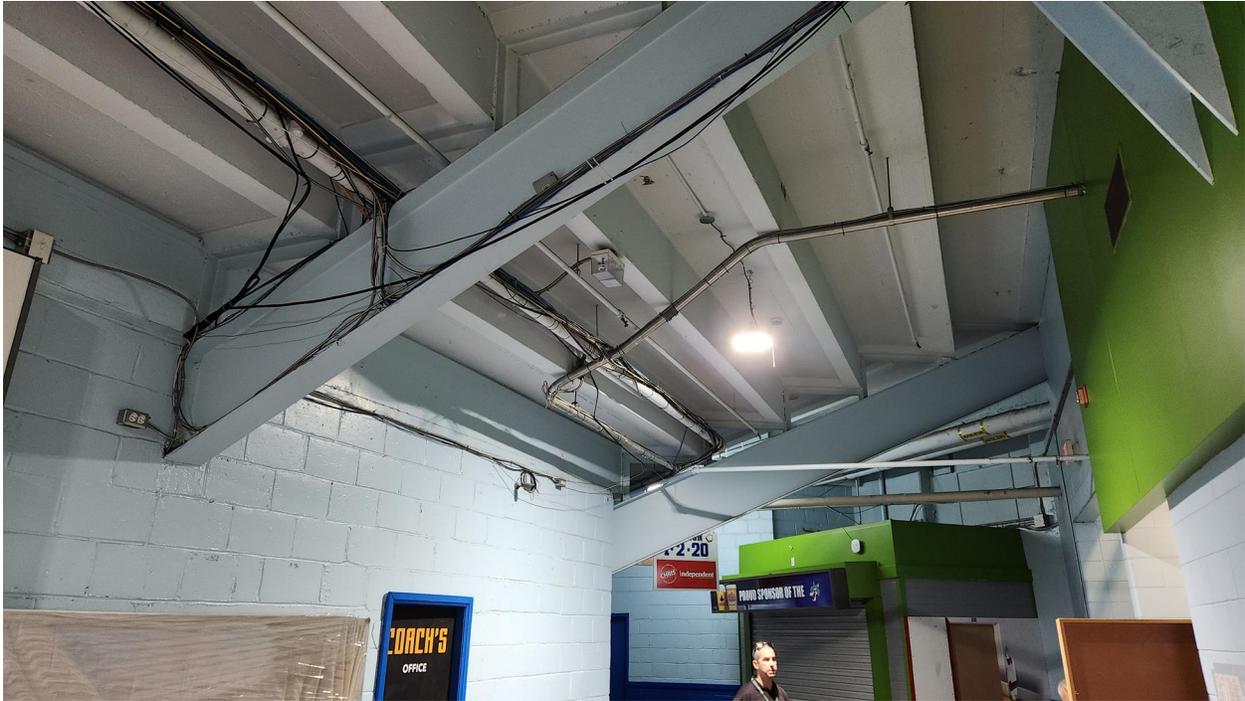
Photo 9: Typical Grandstand seating framing (c.1951).

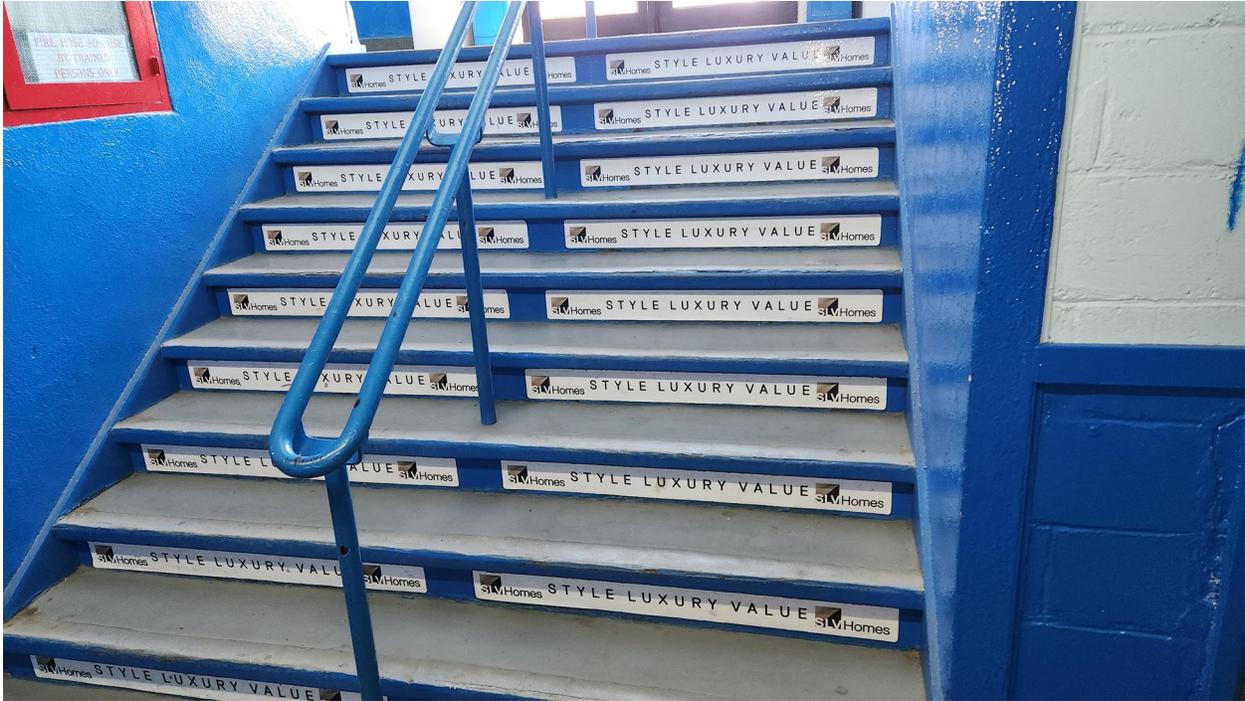
Photo 11: East Entrance (Minto Street) stairs (c.1951).

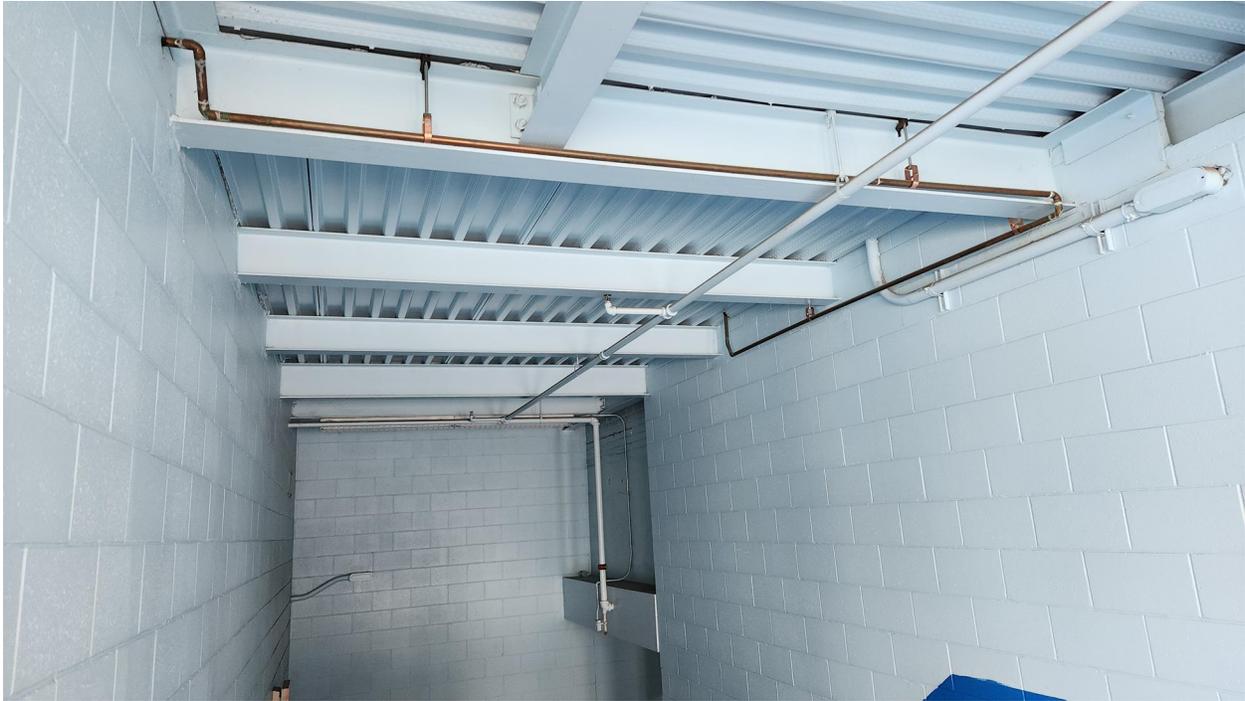
Photo 39: Typical floor framing (c.2000).

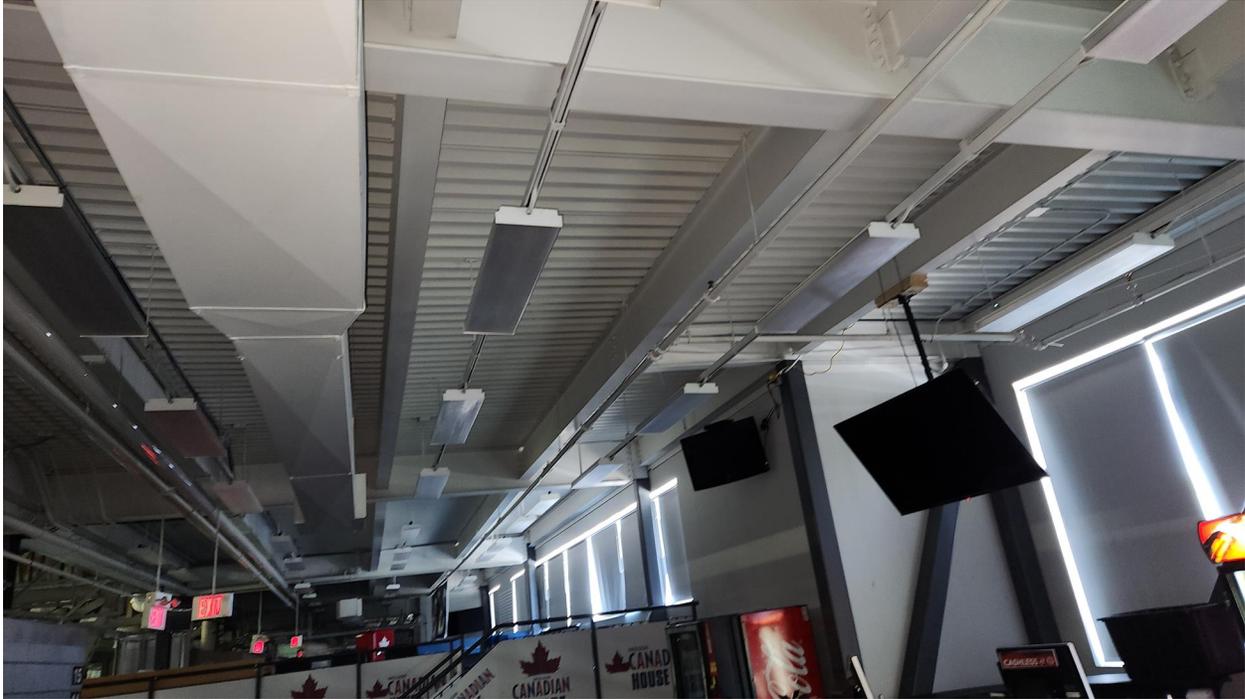
Photo 47: Typical low roof framing (c.2006).

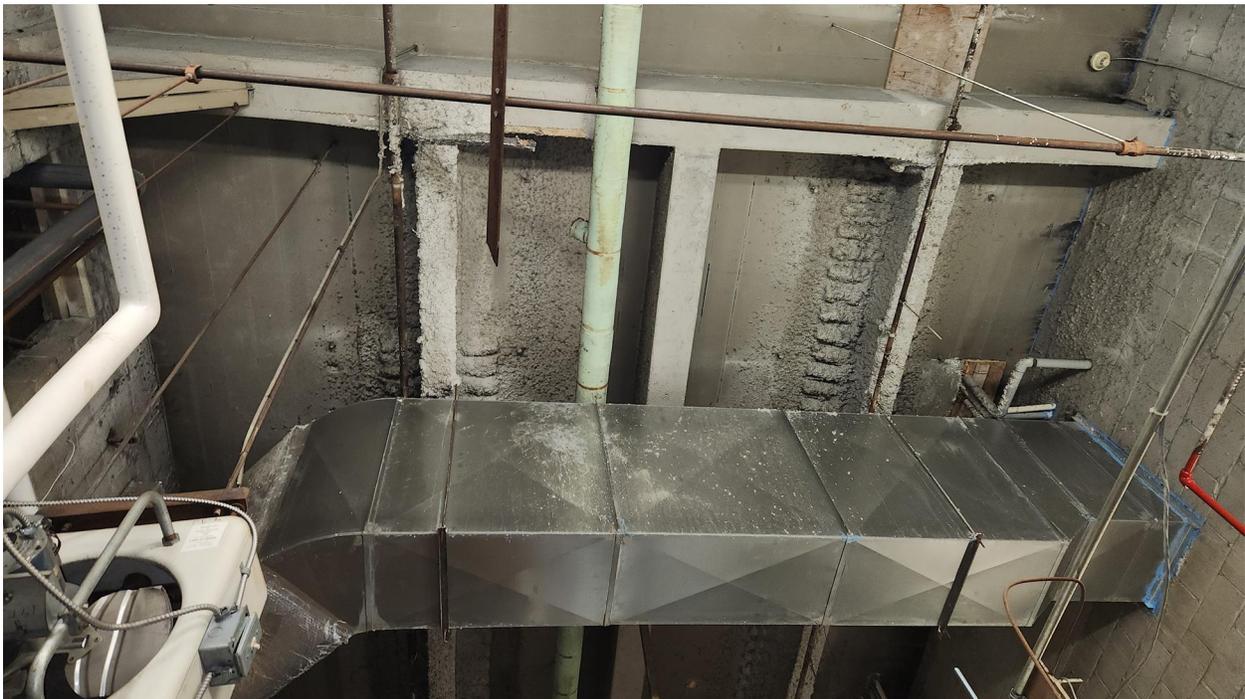
Photo 48: Typical floor framing (c.2006).

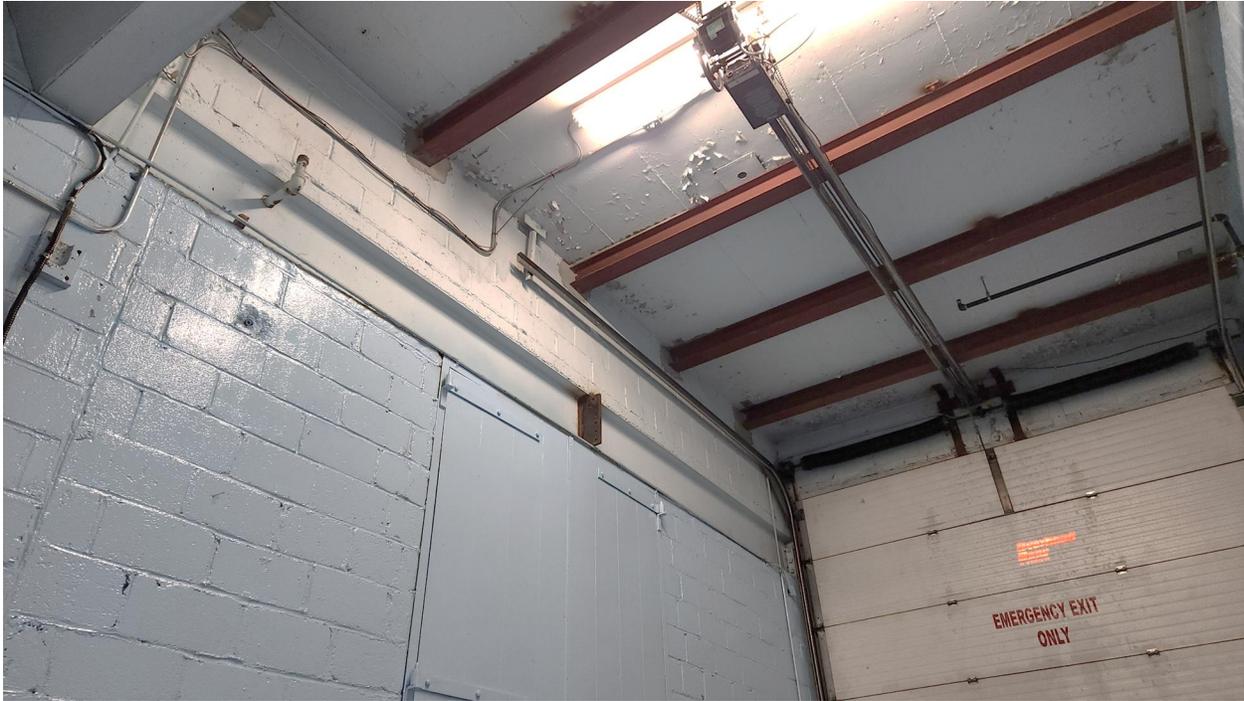
Photo 49: Steel beams below concrete slab believed to be installed as part of the c.2006 addition.

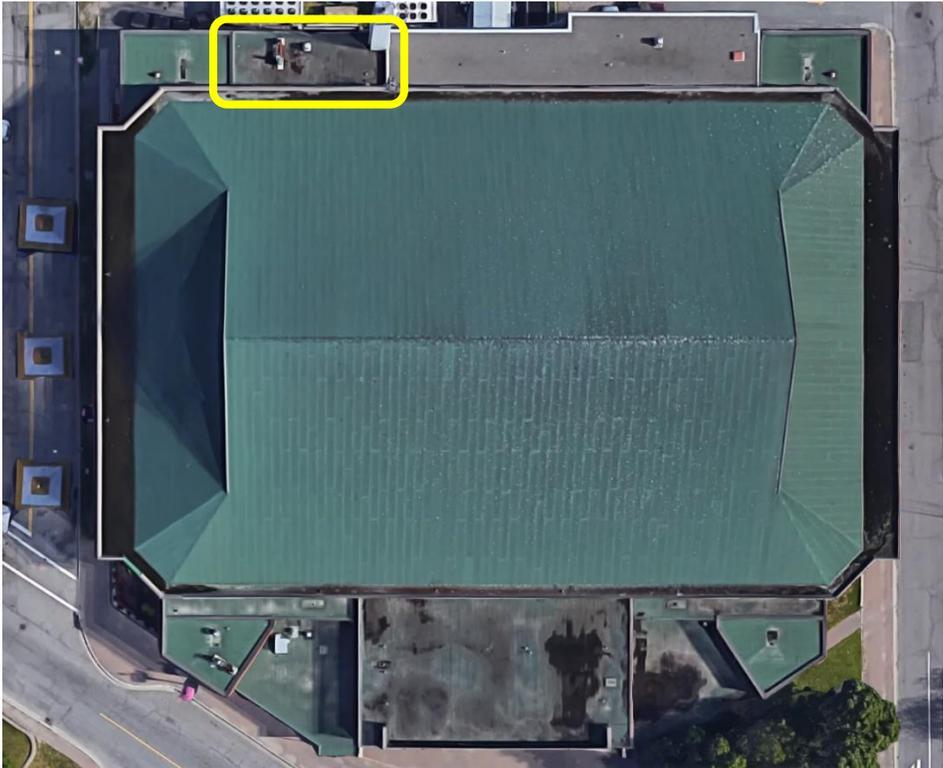
Figure 1: Low roof area scheduled for re-roofing in 2018 (photo courtesy of Google Maps).

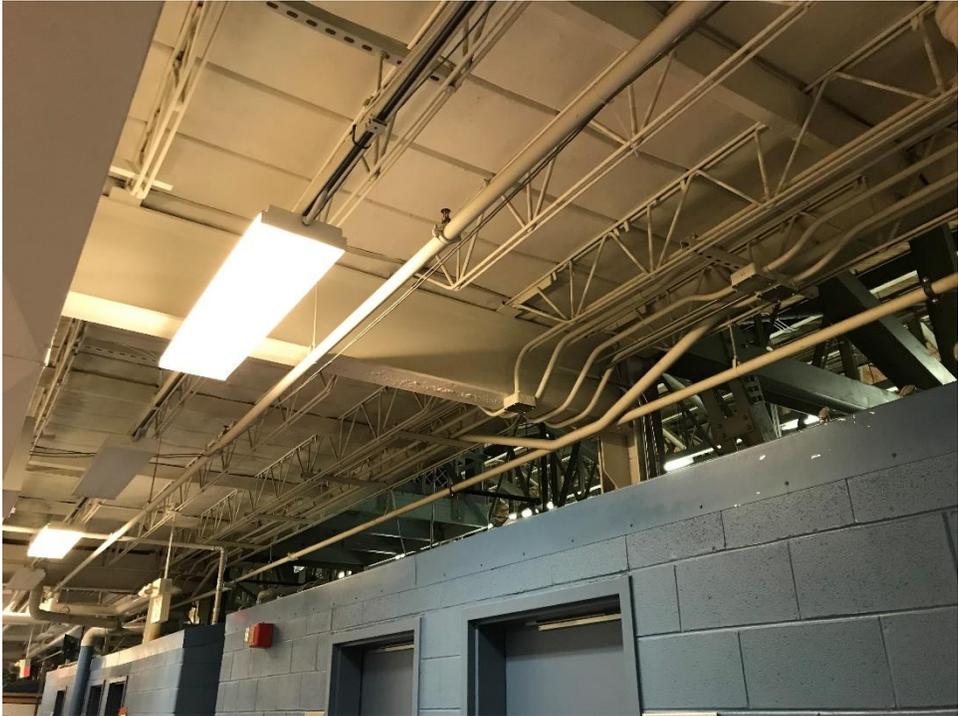
Figure 2: General view of low roof framing.

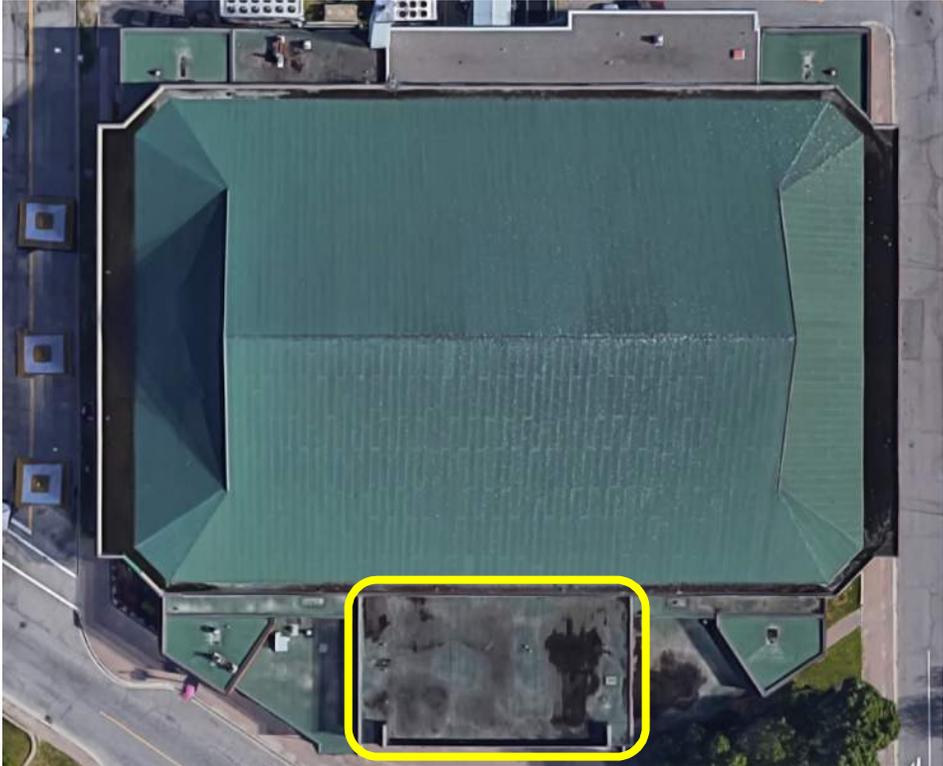
Figure 1: Low roof area scheduled for re-roofing in 2019 (photo courtesy of Google Maps).

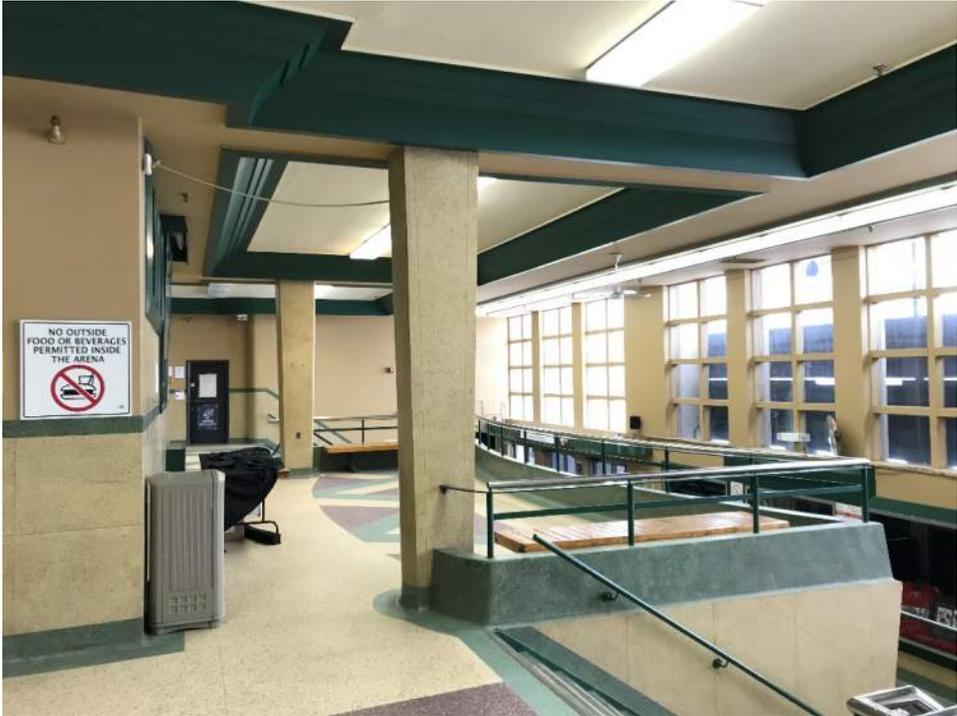
Figure 2: The roof structure is generally concealed by plaster finishes.

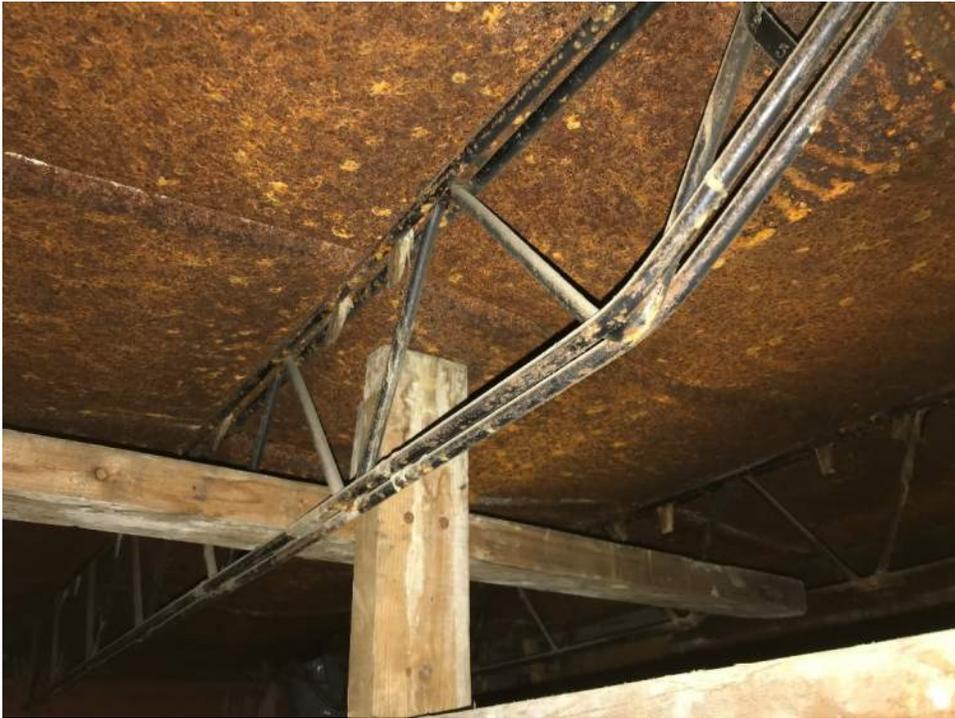
Figure 3: Typical OWSJ framing spanning between steel beams.

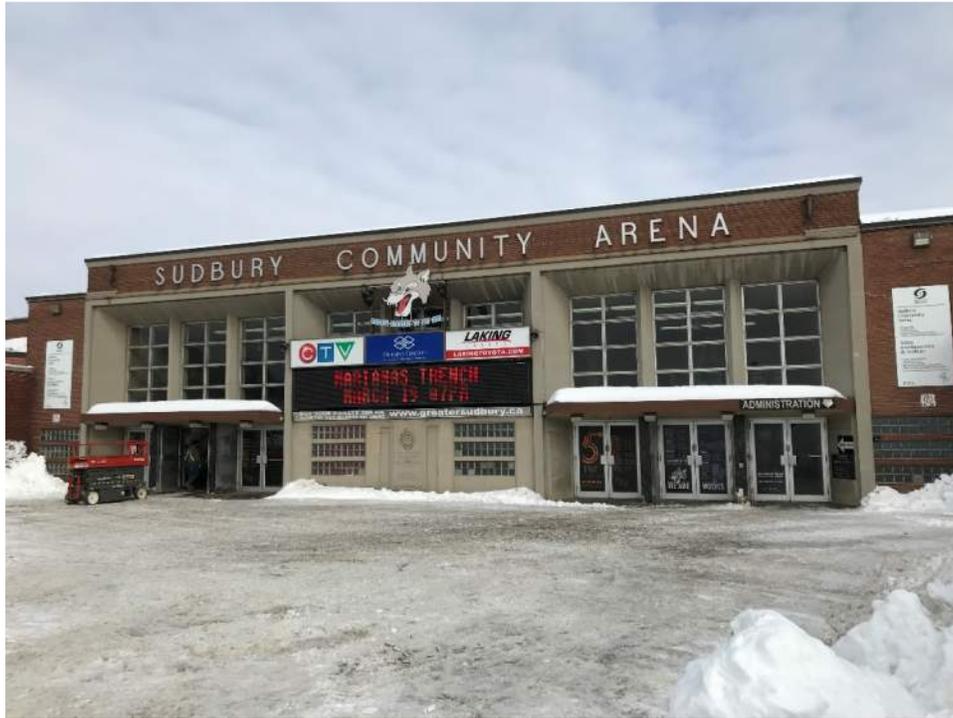
Figure 1: General view of main entrance precast concrete panels.

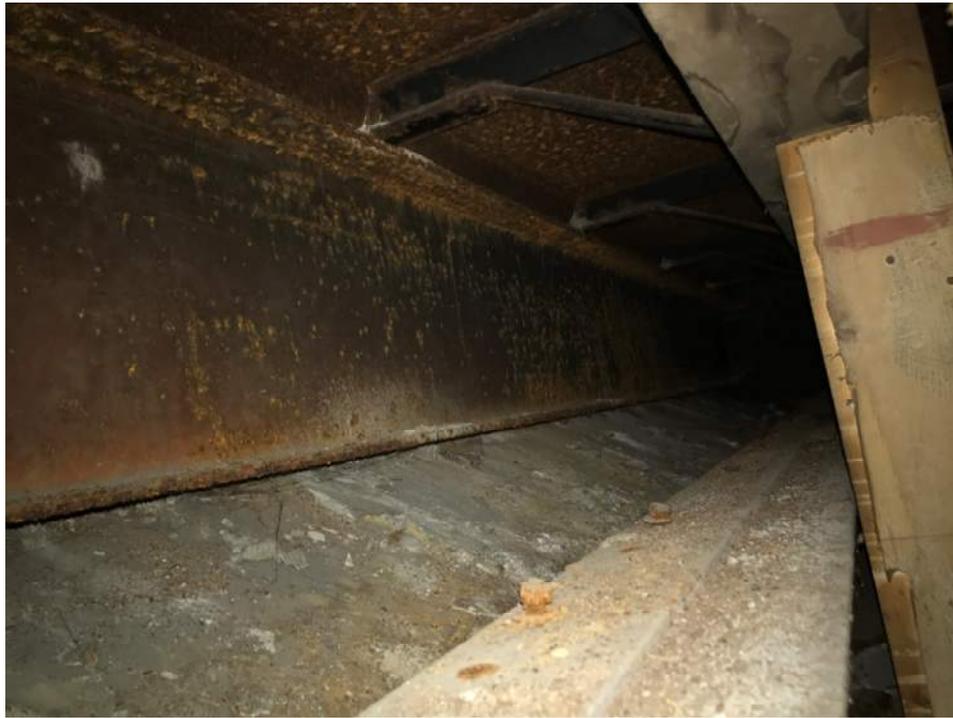
Figure 7: General view of backside of soffit panels.
